Oil Spill Technical Report
Typhoon Haiyan/Yolanda
Estancia, Iloilo Province, Philippines
December 2013

JOINT
UNEP / OCHA
ENVIRONMENT UNIT

Expert: Florence Poncet, CEDRE, with inputs from other entities as indicated

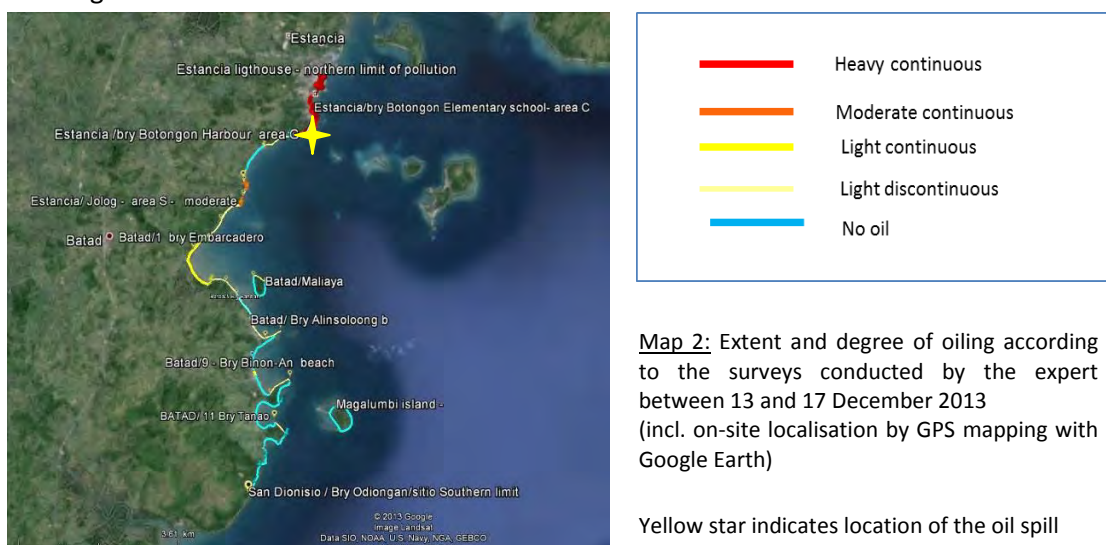
The most heavily oiled area of 1.5 to 2 km of shoreline was located in the town and Barangay Botongon of Estancia municipality, mostly to the north of the damaged barge and a few hundred meters south down to Da'an Banua. The rest of the affected area lay south of the damaged barge.

Two stretches of approximately a hundred meters of shoreline were moderately affected in Barangay Jolog (Estancia municipality). A lot of light contamination was scattered along the shoreline down to Barangay Odiongan (San Dionisio municipality). Within the total affected area (of approximately 10 km) some shoreline segments were not affected at all.

Above map illustrates the observed level of contamination of the shoreline prepared on Google Earth, based on GPS (Global Positioning System) data collected during the survey and indicating heavily oiled areas, moderately oiled areas, lightly oiled areas (continuously or not), and unaffected areas.

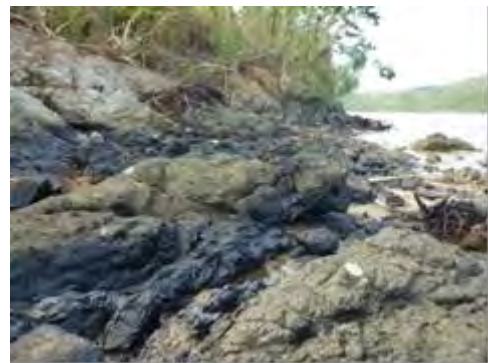
Natural clean-up: scattered oil pollution on a rocky shoreline in Batad being weathered, 19 December 2013

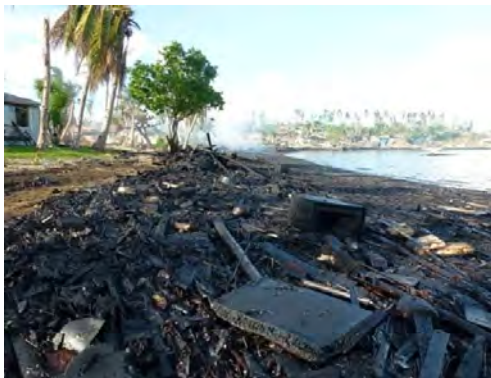
Debris on Estancia Matta Beach, 10 December 2013

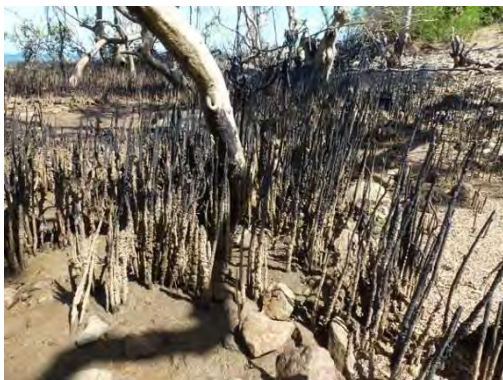
No protected area was affected by the spill. The small areas of mangroves scattered along the shoreline were lightly affected, with an oil film covering the aerial roots and part of the trunks. Dead branches were observed, but no oil layer was seen on the ground neither infiltration in sediment. The main area of mangroves is located in Barangay Embarcadero and the whole area had been also lightly oiled. All the mangroves suffered typhoon damage, and as reported an expert for the authorities, Dr. Resurreccion B. Sadaba, they were already defoliated due to the typhoon, before being oiled. Dr. Sadaba reported that recently planted mangrove trees died after the two events. On all observed sites, by mid-December new leaves were appearing. However, impact on mangroves may appear after weeks or months afterwards and monitoring is needed.

Weathered oil on Avicenia roots on Maliaya Island, 13 December 2013

As it is not possible to clean the roots and trunks (mechanically or by cleaning agent) without the cleaning action being more harmful to the trees, no clean-up action is recommended for the mangrove trees. The authorities' expert Dr Sadaba had regularly monitored the status of the mangroves, some of which are bearing new leaves.

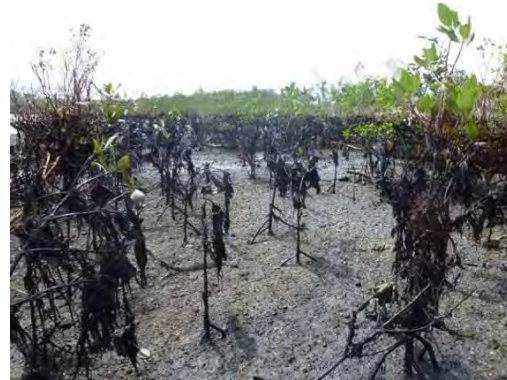
Lightly oiled mangrove shrubs in Batad /Embarcadero, 15 December 2013

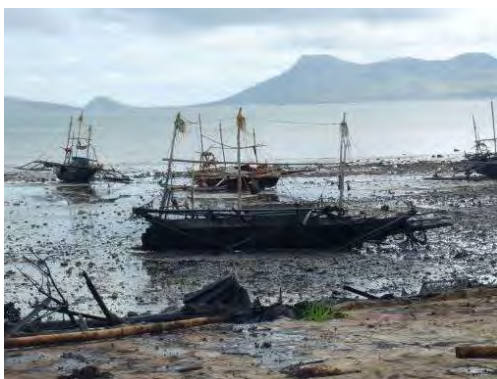
Many oiled and broken fishing boats were observed in the area of the oil spill, with lots of fishing equipment visible among the oiled debris. In Embarcadero, Batad, fixed fishing nets (*puenots*) were totally oiled. During the oil spill Committee meeting of 2 December it was mentioned that the Bureau of Fisheries and Aquatic Resources (BFAR) had started an inventory of affected fishermen, damaged fishing boats and equipment. The question of compensation was still to be resolved as of the date of the departure of the oil spill expert.

Damaged and oil-contaminated boats in Estancia, 8 December 2013

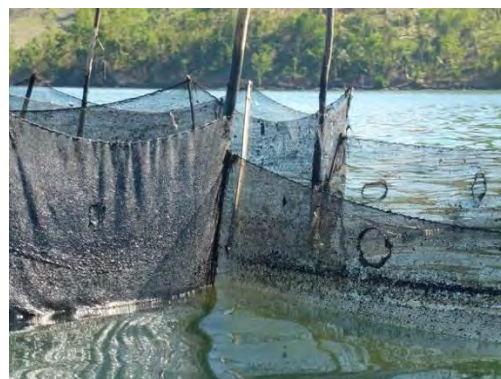
Oiled fixed nets (puenots) in Embarcadero, Batad, 18 December 2013

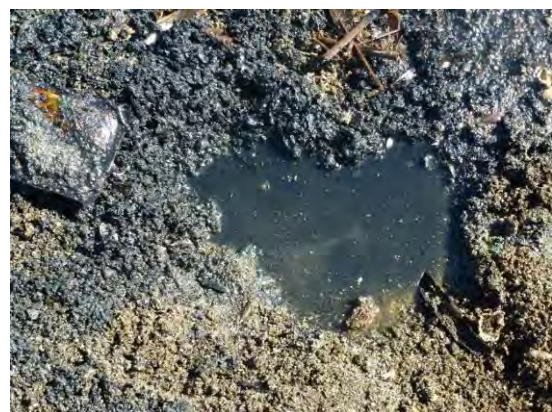
Black colour of sediment due to natural lack of oxygen in muddy sediment (anaerobiose)
Embarcadero/Salong 17 December

muddy sediment and should not be confused with oil.
