Share the Road

UN Avenue Report:
Kenya Showcase Project

Nov 2011 – April 2013

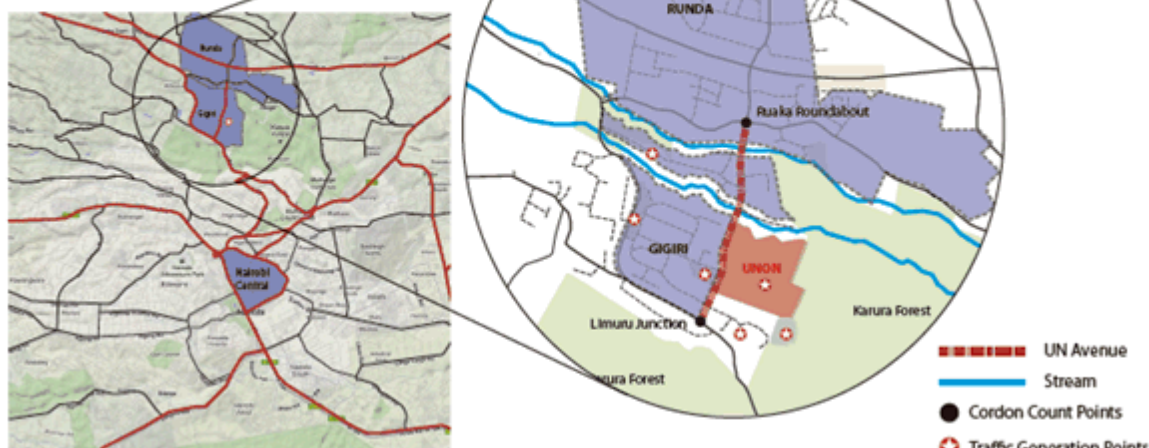
Figure 1: Project area an location within Nairobi

Gigiri is a self-contained neighbourhood with low connectivity to the surrounding areas. Access in and out the neighbourhood is possible through UN Avenue, or through a pedestrian access adjacent to the Village Market commercial centre at the western boundary of Gigiri. Runda, the adjacent neighbourhood presents similar characteristics; although its land use is predominantly residential. Runda inhabitants use UN Avenue as one of the main access road to the neighbourhood. Residents and workers of Runda and Gigiri become the immediate beneficiaries of the project.

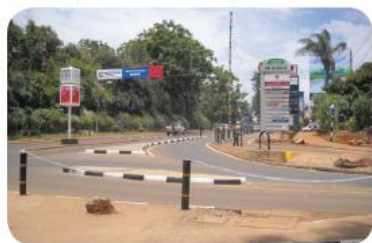
Figure 18: Slip-lanes with medians to facilitate pedestrian crossing

The majority of pedestrians using UN Avenue arrive to the area by public transport. Prior to the road upgrade, the matatu stage was a frequent factor of congestion at the Limuru Junction. The relocation of the bus terminus to the north side of the road, away from the junction, has led to reduced congestion for vehicles accessing Limuru Road. This is due to the incorporation of slip lanes for vehicles entering and leaving the UN Avenue. Slip lanes were design to be narrow and with a reduced radius. The design is a traffic-calming strategy that, together with a raised pedestrian crossing, keeps vehicle speeds low improving road safety. To reduce the risks for pedestrians when crossing to the bus stop on opposite side of Limuru road, additional raised pedestrian crossings and the necessary signage were also incorporated at about 100 metres from the junction. Details and images of the Junction can be seen in figures 18 to 20.

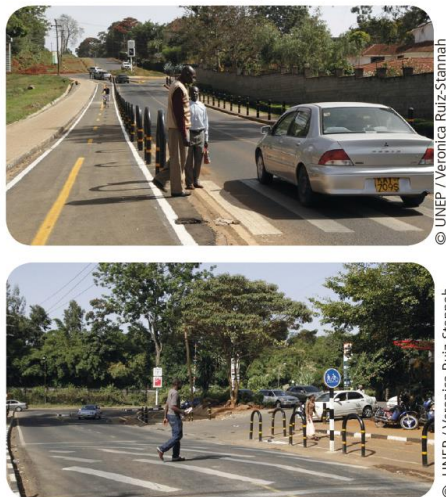
Figure 29: Raised zebra crossing vs. painted-only crossing. The second ones do not act as traffic calming devices.

The raised pedestrian crossings have been effective in allowing safer crossing, as vehicles reduce their speed. These also reduce the waiting time for pedestrians. At crossing points, road signage and marked pedestrian crossing points have made it easier for drivers to spot probable areas of interaction. However, those painted-only crossings do not succeed in reducing speeds and become more risky as they create a false sense of security for pedestrians. From the number of raised pedestrian crossings originally planned, only three of them were built. Crossing UN Avenue continues to be a threat on these points, particularly when the motorised traffic is at its lowest point, and the vehicles circulate at a higher speed: another risk factor for pedestrians.

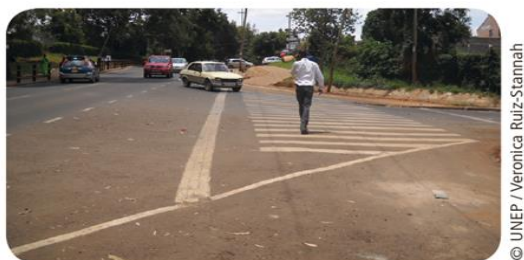
Figure 30: Large turning radius of intersection enlarge the distance for pedestrian and cyclist crossings, and facilitate cars turning at high speed.

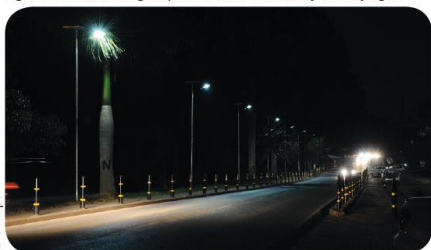
Figure 31: Solar-led lights provide environmentally friendly light

The lights have proved to be an efficient, reliable and cheap road lighting alternative that can potentially generate up to 100% energy savings. The use of energy-efficient lamps can bring significant environmental, safety and economic benefits. Funds invested in energy-efficient lamps can be recovered through savings in electricity, maintenance cost and longer lifespan of the equipment. A wider use of solar-lighting, along the avenue and on Nairobi roads in general, would be beneficial for road safety and personal security. It would extend the use of non-motorised facilities beyond dusk.

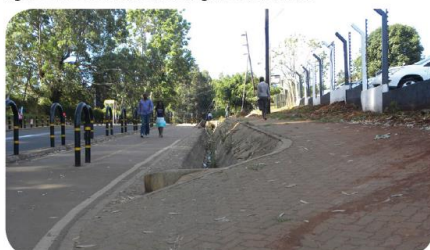
Figure 32: Detour and different grade of sidewalk

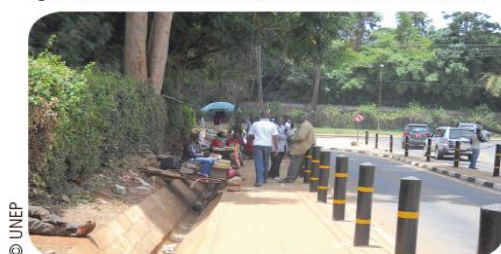
Figure 34: Road business over the drain

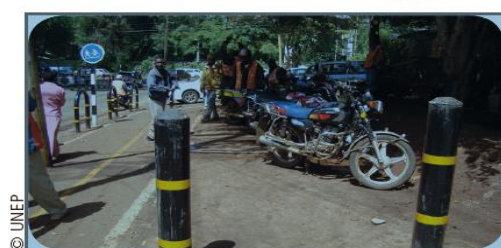
Figure 35: Encroachment of Boda-boda drivers over the sidewalk.

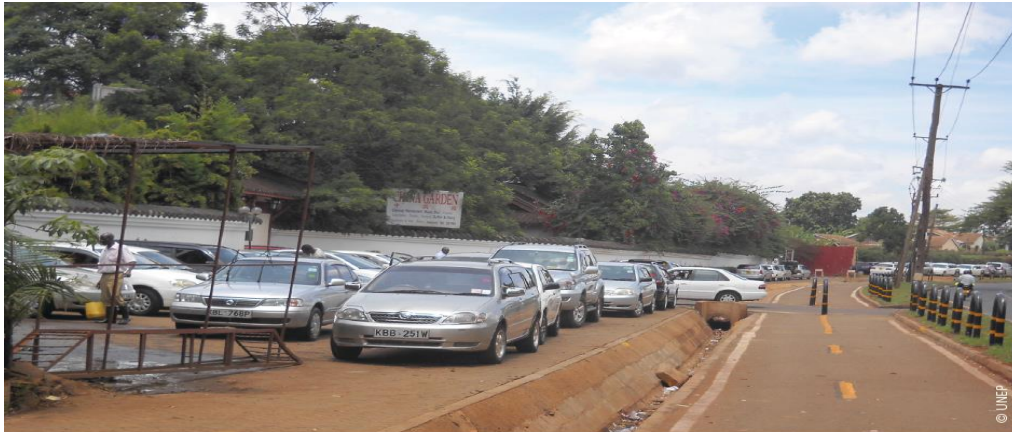
Figure 36: Taxis and autos using sidewalk as parking plot

For future projects, the incorporation of the needs of other road users will be beneficial. Designing specific spaces for taxi or motorcycle-taxi operators could turn into an income-generating activity for the city. Likewise, the provision of space for commercial kiosks adjacent to the bus stage or at strategic points that respect the sidewalk can become an asset to the city. Participation and inclusion of all stakeholders can turn threats into opportunities.

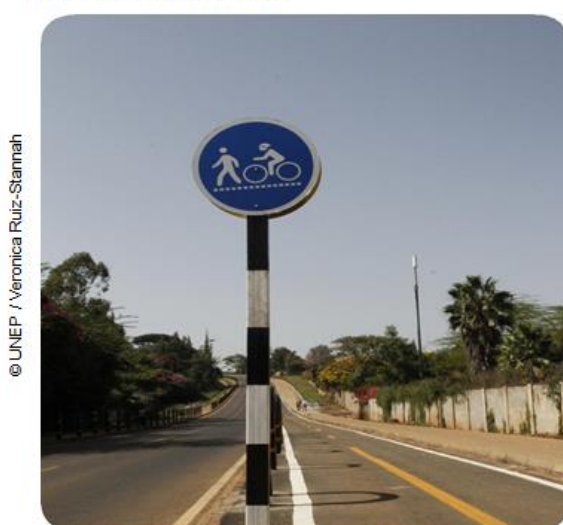
Figure 41: Vertical road signage

Star Rating results showed that features such as adequate delineation and proper design of intersections provide warning to drivers and keep them within the driven lane, therefore improving safety for all road users. Proper signage keeps drivers aware of the conditions of the road and warns them of any sudden changes in road condition. It also makes them aware of probable interaction with other road users, making the road safer for all users.
