ENVIRONMENTAL AUDIT OF THE SITES IMPACTED BY THE “PROBO KOALA” TOXIC WASTE DUMPING IN ABIDJAN, CÔTE D’IVOIRE

This series of fact sheets was prepared as part of UN Environment's environmental audit of the sites impacted by the “Probo Koala” toxic waste dumping in Abidjan, Côte d'Ivoire. The fact sheets provide complete analysis results, observations and the recommendations for each of the sampling sites. They should be read in conjunction with the full assessment report, available at: www.unep.org/CotedIvoire

Site name: Akouédo 3

UN Environment site reference no:13

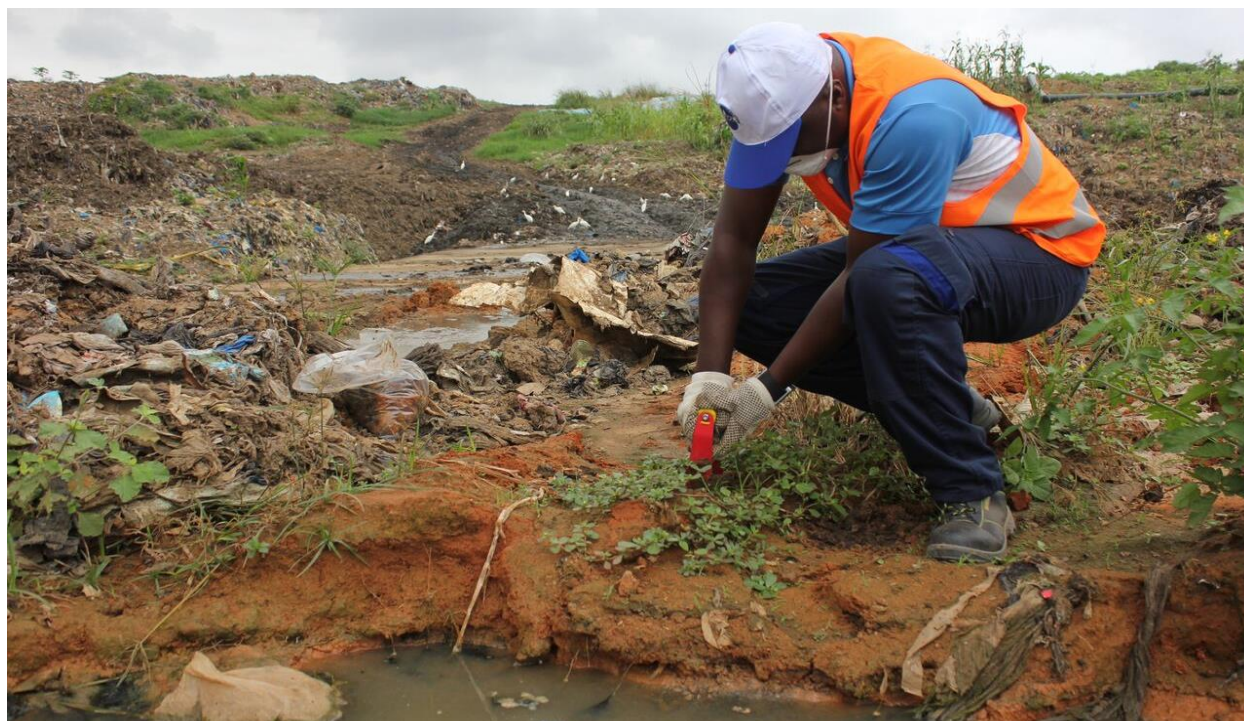
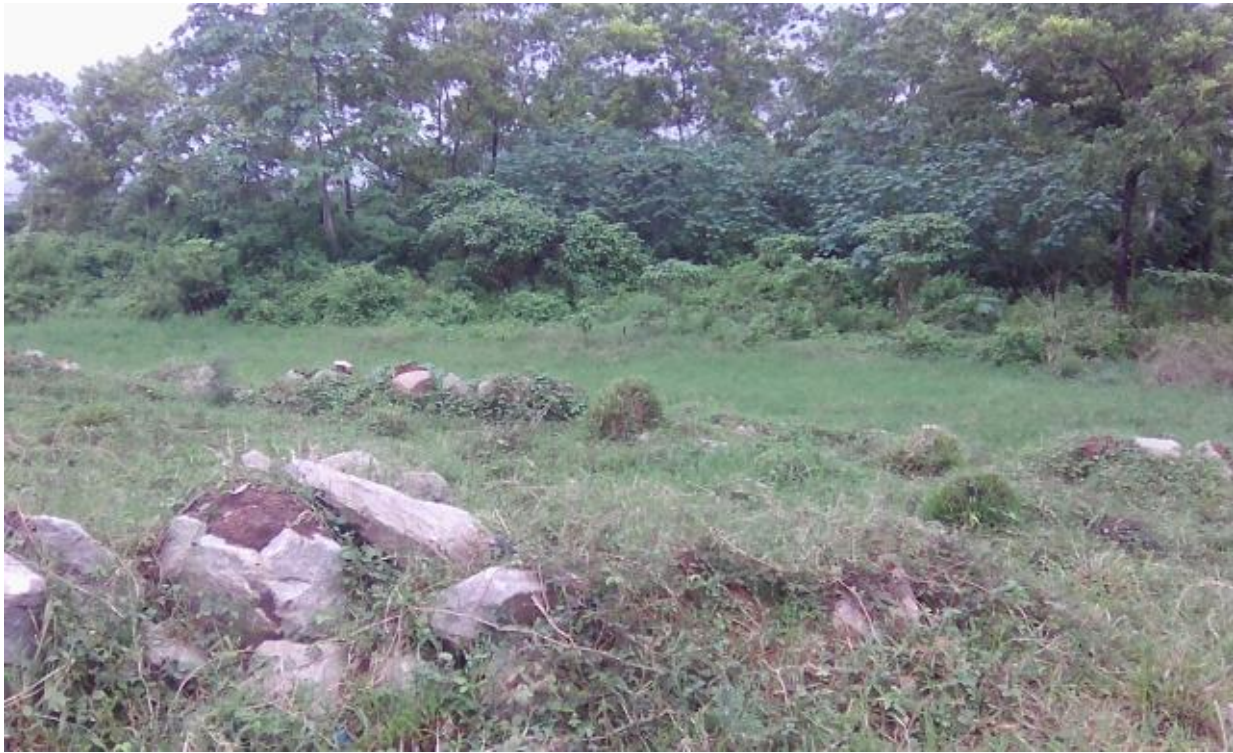
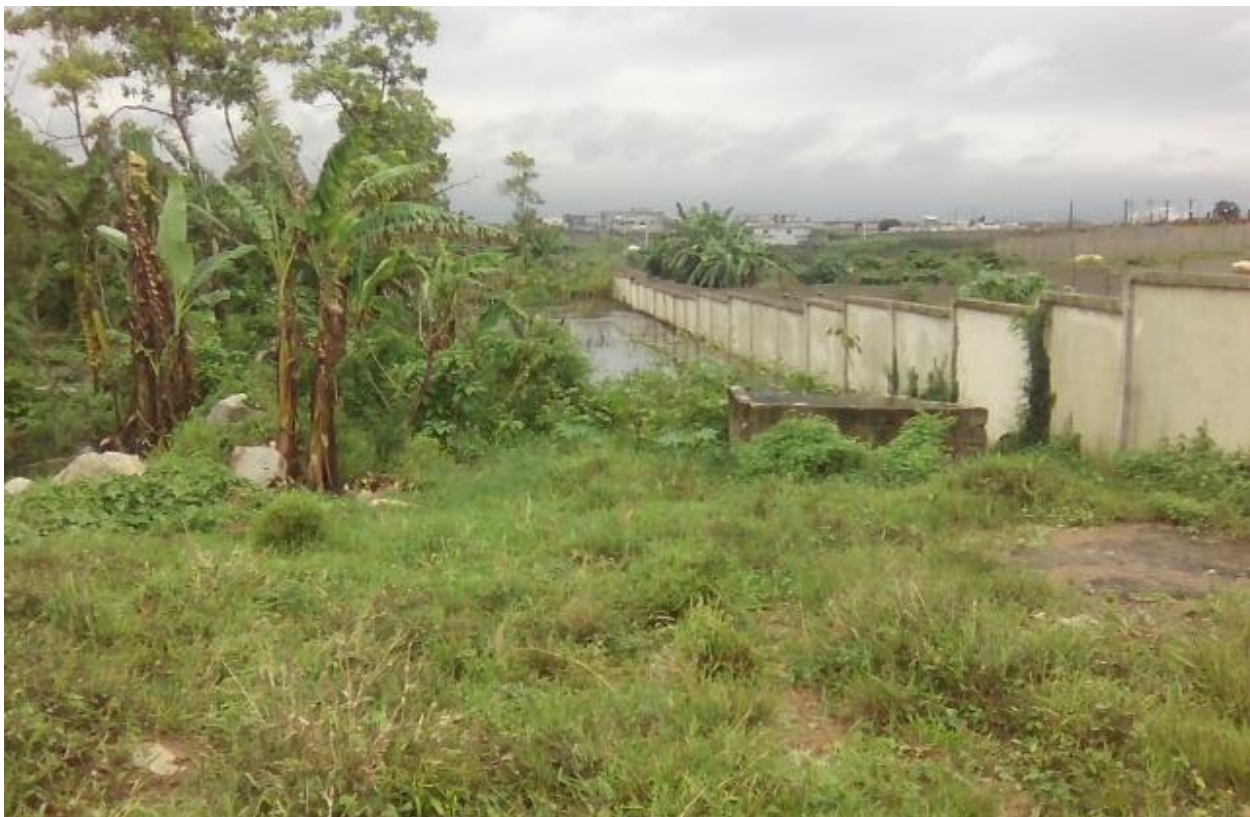
Site Photos

This spill site is the third within Abidjan's municipal waste disposal site at Akouédo. It is located in a low-lying depression close to the walled eastern boundary of the site. Wastes from the Probo Koala were not actually dumped here; rather, they flowed downstream from Site 11 nearby – approximately 200 m to the west. It is reported that during clean-up operations by Trédi in 2006-2007, contaminated materials were excavated and treated on site.

Two surface (0-20 cm) soil samples were taken near the concrete perimeter wall where the spilled material flowed to from Site 11 to the west.

In addition, two surface water samples were collected from a pond, and one sample of comestible vegetation (gombo/okra) was taken from a plant growing at the site.

The laboratory results show that the current concentrations of the contaminants of concern in soil are all below the standards set by the Government of Côte d'Ivoire for clean-up. Likewise, hydrocarbon levels in the sample analysed are well below Dutch intervention values. Furthermore, the pH values are not in the caustic range (9 or above), demonstrating that the impact of the disposal of caustic substances can no longer be detected. No further action is therefore needed on this site to remediate the soil impacts of the 2006 toxic waste dumping from the Probo Koala.

Surface water quality analysis shows heavy metal pollution in samples taken at the site, which is to be expected in a municipal waste disposal site. To address this, a leachate monitoring plan should be made for the Akouédo municipal waste disposal site, covering its operational lifecycle, including decommissioning.
