X-PRESS PEARL MARITIME DISASTER SRI LANKA

REPORT OF THE UN ENVIRONMENTAL ADVISORY MISSION

JULY 2021

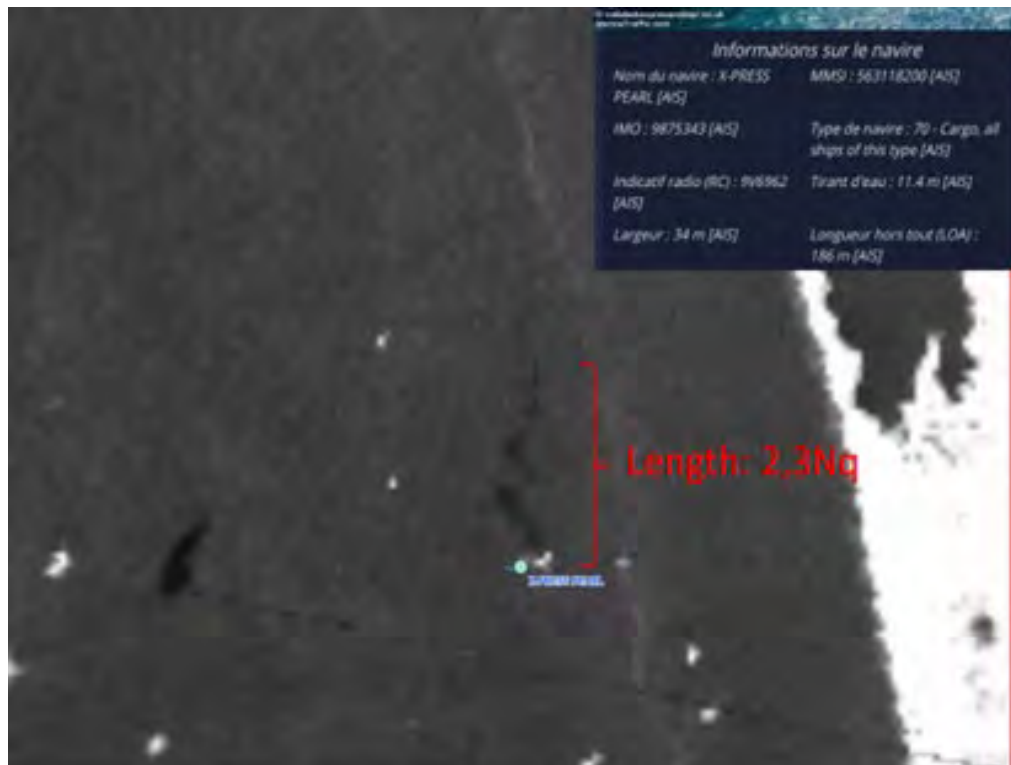
Figure 2.2: Sentinel 1 satellite image (2021-06-14 / 00H24 UTC) processed by CLS and highlighting extent of spill.

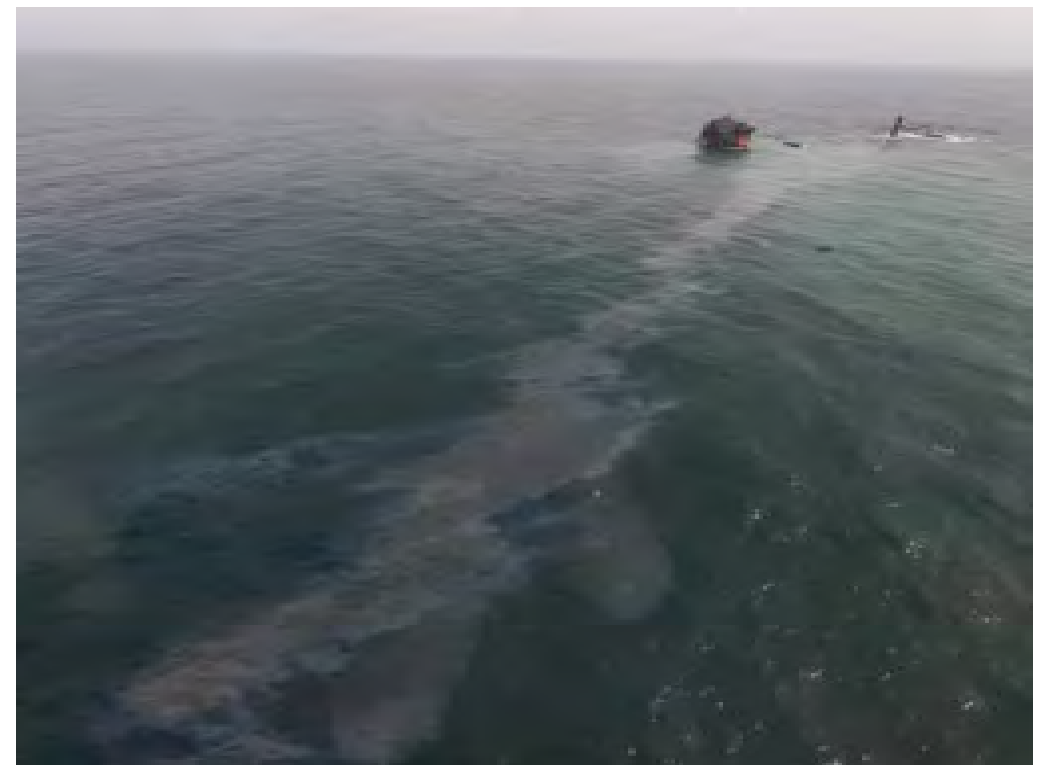
- A continuous release of oil is flowing from the ship for nearly one month (8 June – 4 July);
- Based on the Bonn Agreement Oil Appearance Code (BAOAC), the oil observed from the aerial survey on 20 June is classified as 'discontinuous true colour' (code 4) of 50-200 µm thickness, and in some segments 'continuous true oil colour' of over 200 µm thick (code 5). This situation should normally trigger deployment of oil spill response equipment;
- Furthermore a 'sheen' (code 1) of 0.04-0.3 µm thickness can be seen to be surrounding the main oil slick.

Figure 2.3: The slick originating from the wreck observed by helicopter (2021-06-20).

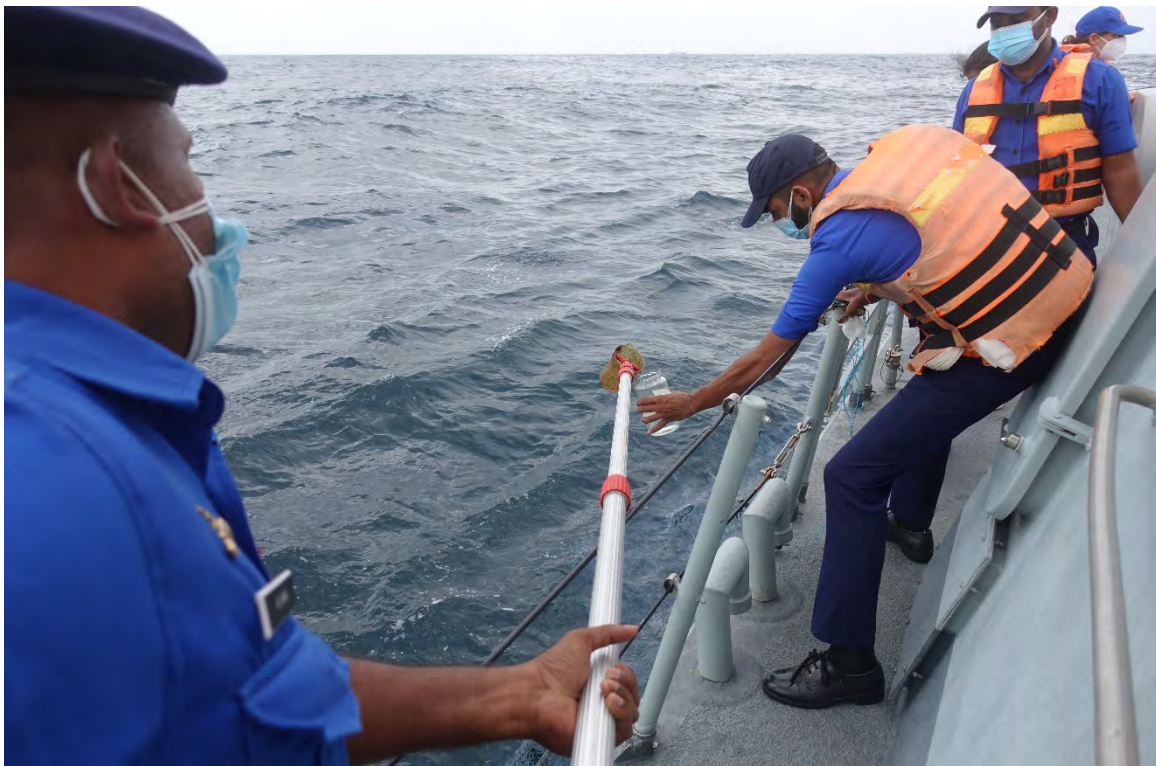
Figure 2.2: Water sampling around the wreck.

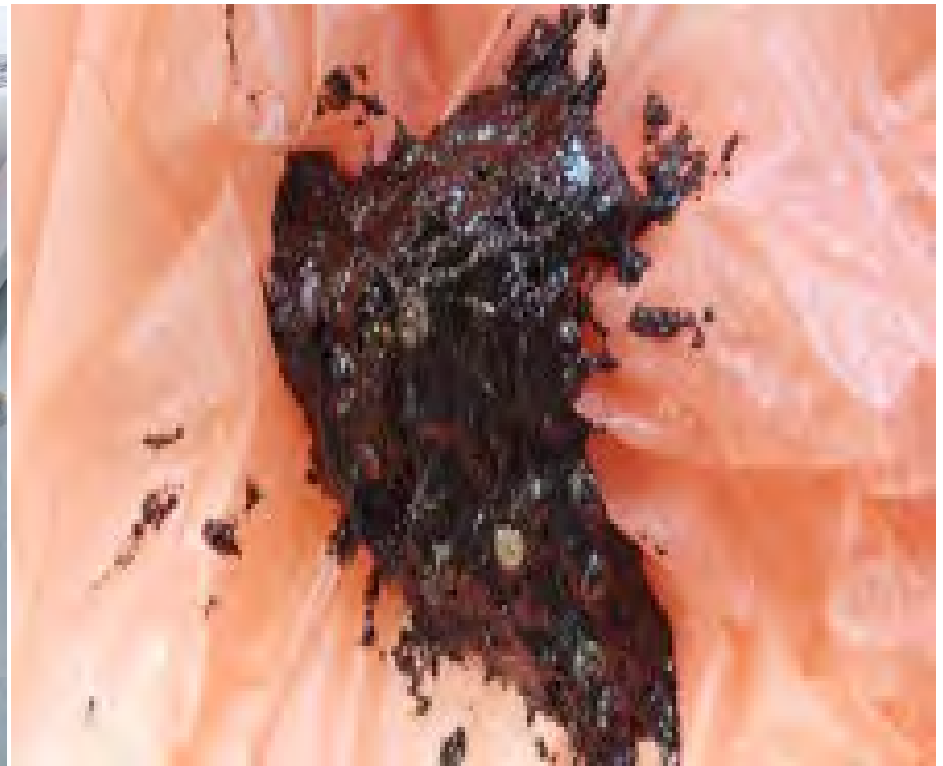
Figure 2.5: Sample of oil and pellets collected on 21 June 2021.

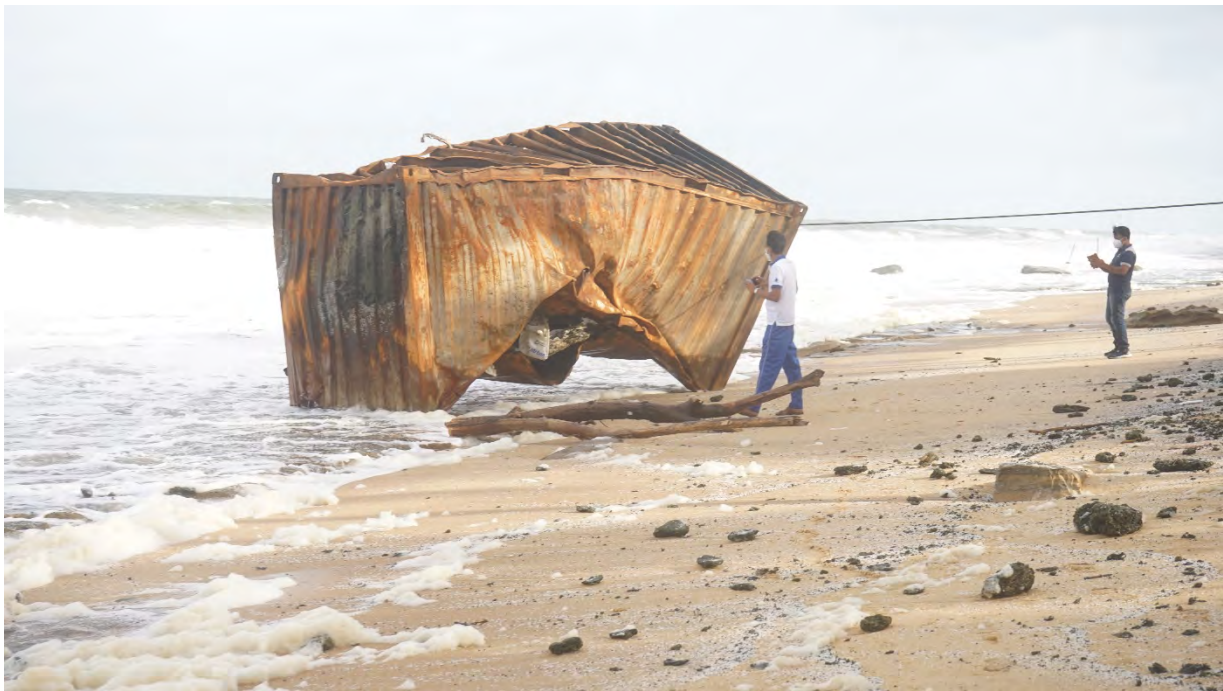
Figure 2.7: Damaged containers washed ashore (credit: MEPA)

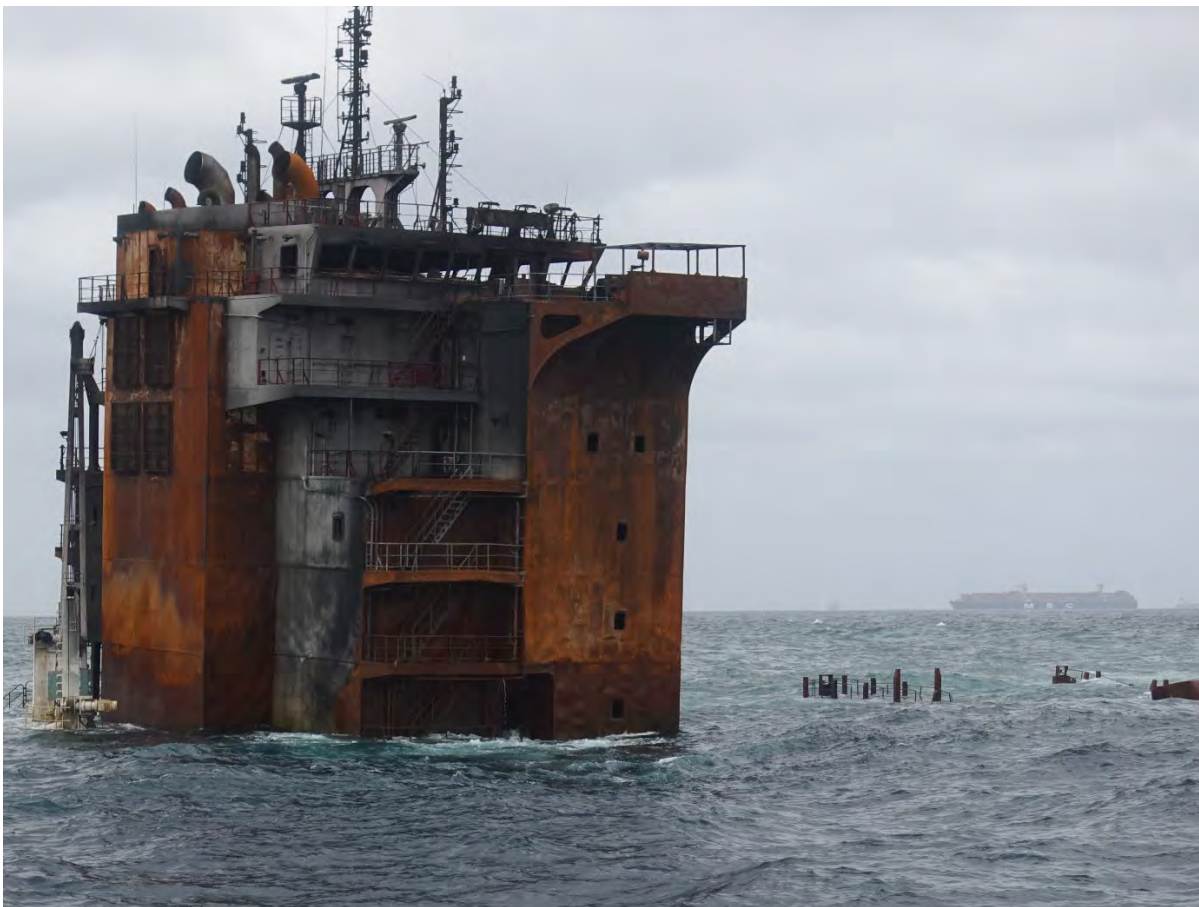
Figure 2.10: Illustration of the traffic intensity in the vicinity of the wreck.

The present location of the shipwreck – which is not fully submerged - close to the approaches of Colombo harbour constitutes a maritime danger (Figure 2.10). In effect, the wreck is a navigation hazard to the dense and growing traffic around the Port of Colombo, which is one of the top 20 busiest ports in the world. As such, it also constitutes an additional risk of business interruption.

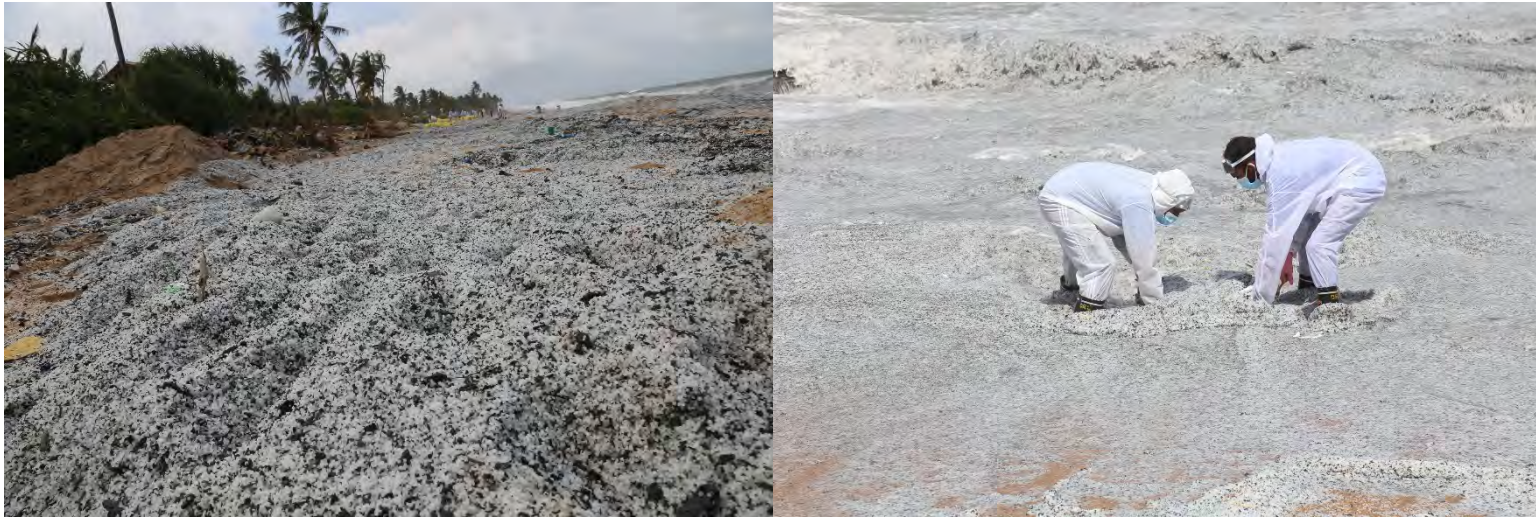
Figure 2.13: Massive arrival of plastic pollution on the west coast of Sri Lanka following the incident (credit: MEPA).

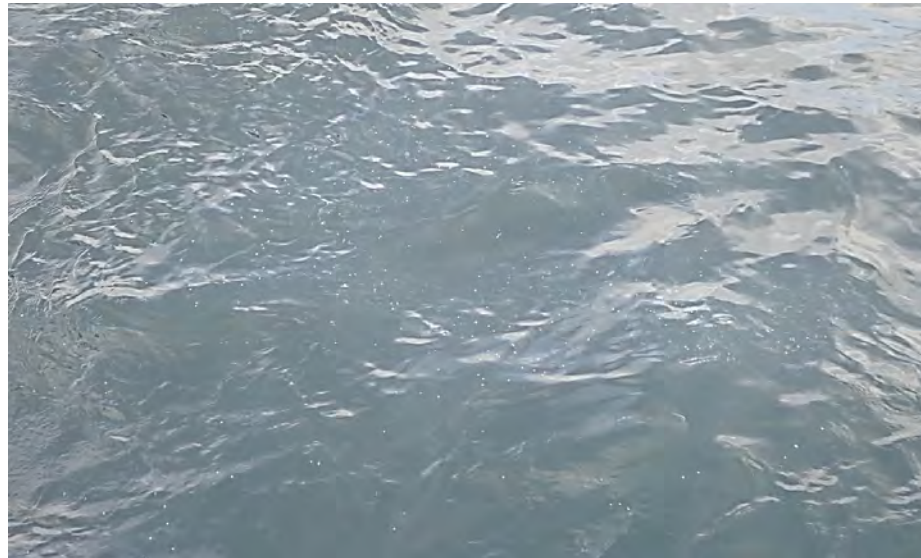
Figure 2.14: Plastic pellets floating in the oil slick near the wreck, boat survey on 20 June.

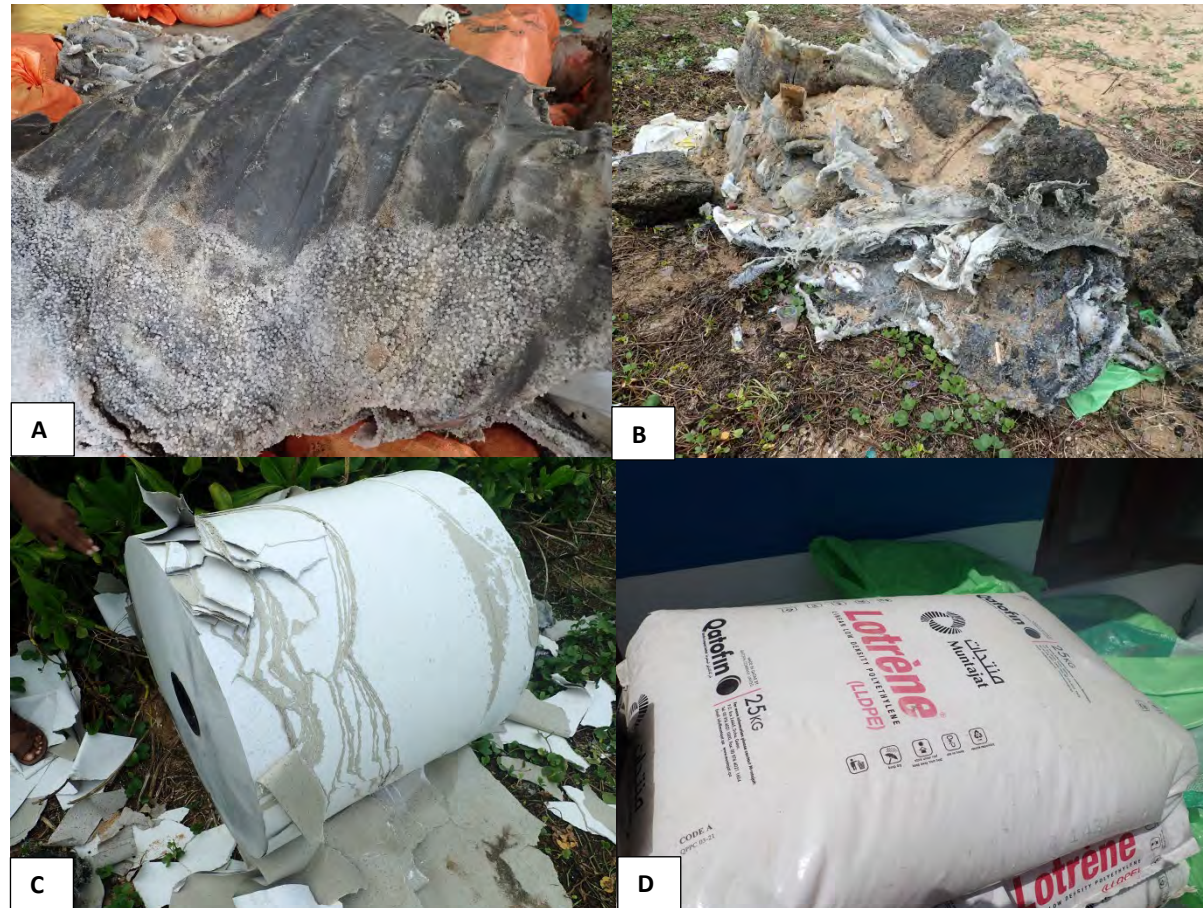
Figure 2.15: Large items collected on the coastline in Sarakkuwa and Dungalpitiya, Gampaha district. A and B: pieces of burnt plastic pellet bags; C: cardboard roll and D: Intact plastic pellet bag.

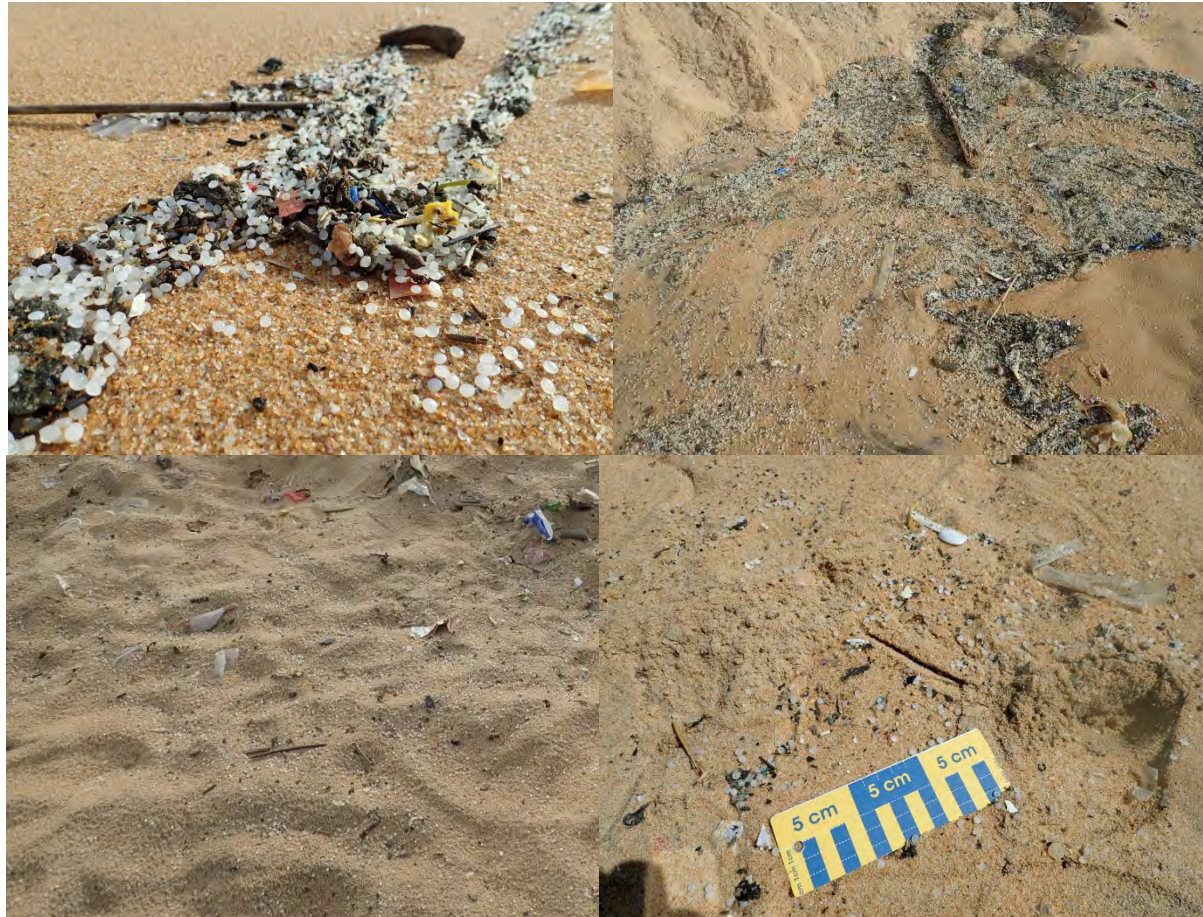
Although mainly deposited on the sand surface, the small plastics easily mix with sand due to tidal changes, trampling by workers and heavy machinery during clean-up operations. Buried plastic pollution is also caused by high wave energy and sand movement, most notably in Sarakkuwa beach; where the UN team observed layers of plastic pollution embedded in several dozen centimetres of sand. On the backshore, pellets were found mixed with coastal vegetation making their recovery more complicated (Figure 2.17).

Figure 2.16: Pellets and small burnt plastic pieces deposited in recent strandlines or mixed in the first layer of sand in Sarakkuwa beach, Gampaha district.

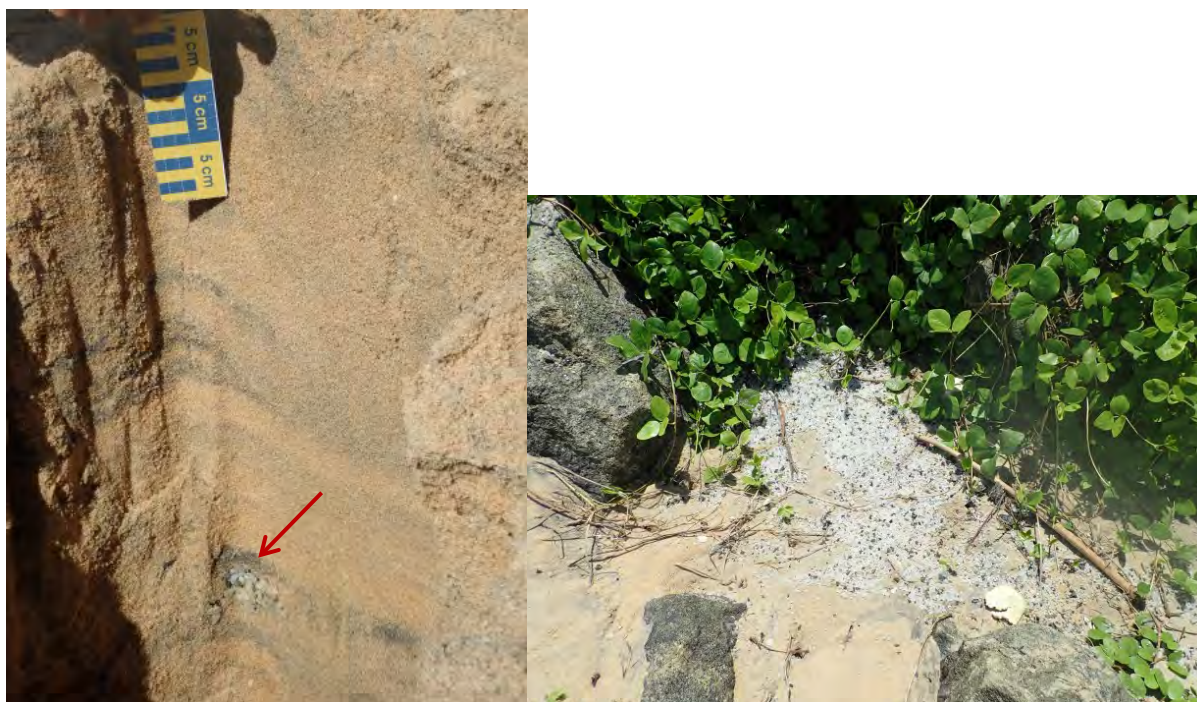
Figure 2.17: Left: buried pollution in Sarakkuwa beach;
right: pollution in the vegetation, Dungalpitiya Gampaha district.

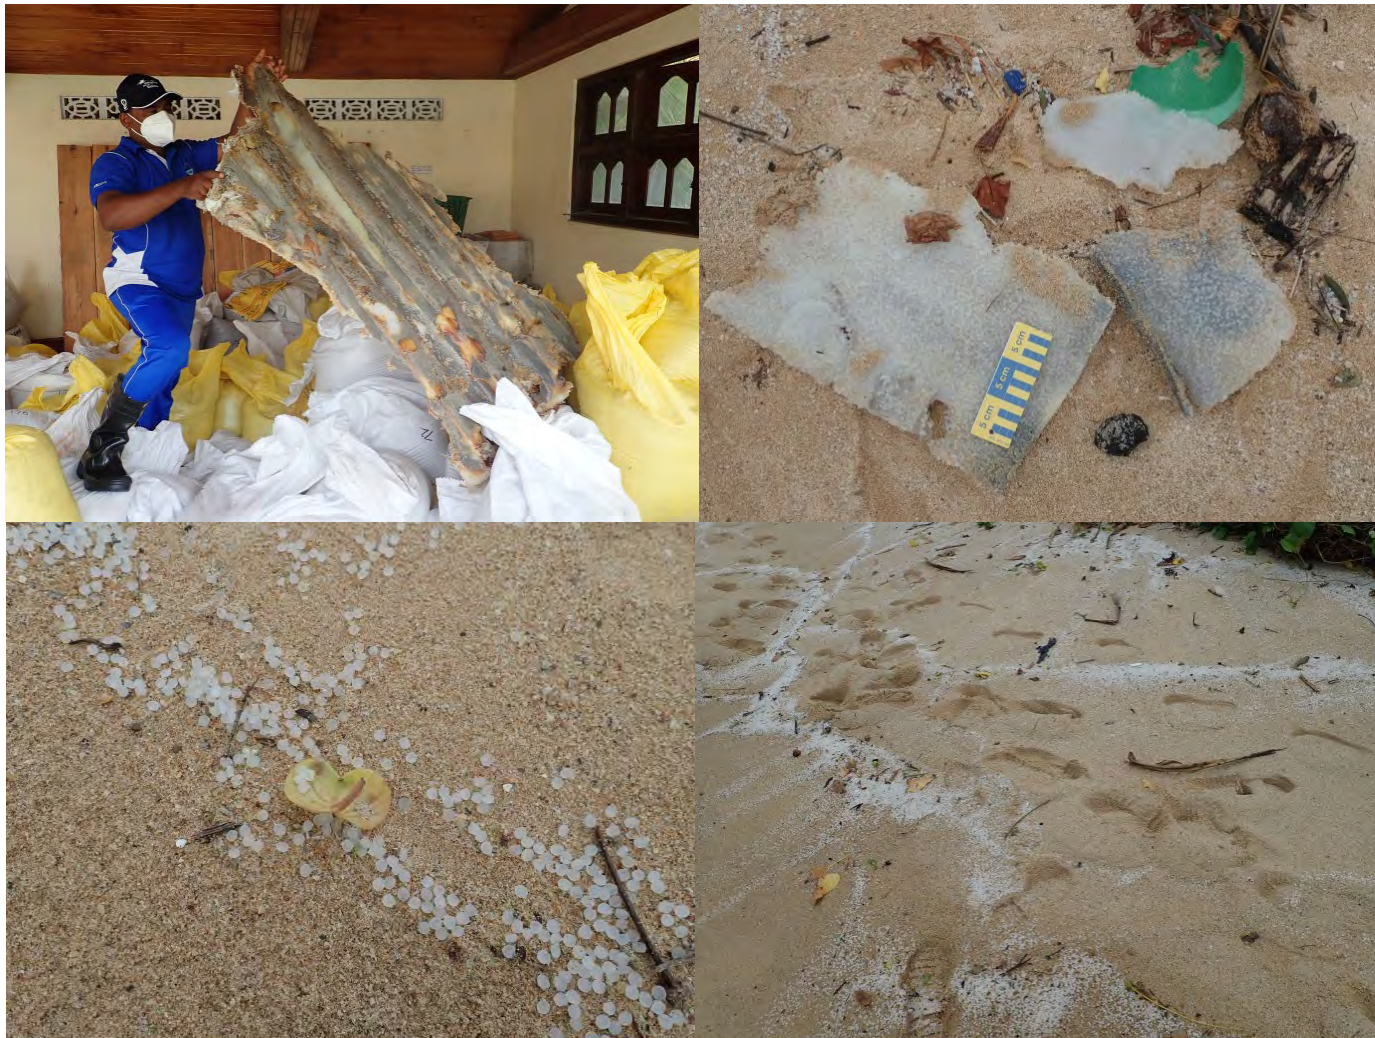
Along the southern coast, the larger debris has been collected and remaining pollution is constituted of virgin LDPE pellets and fragments of melted pellet bags. Though exposed to massive pellet arrivals, the situation along the southern shorelines is relatively less challenging due to the limited diversity of pollutants and absence of burnt plastic pieces.

Figure 2.18: Melted pellet bags and LDPE pellet on the Matara coastline.

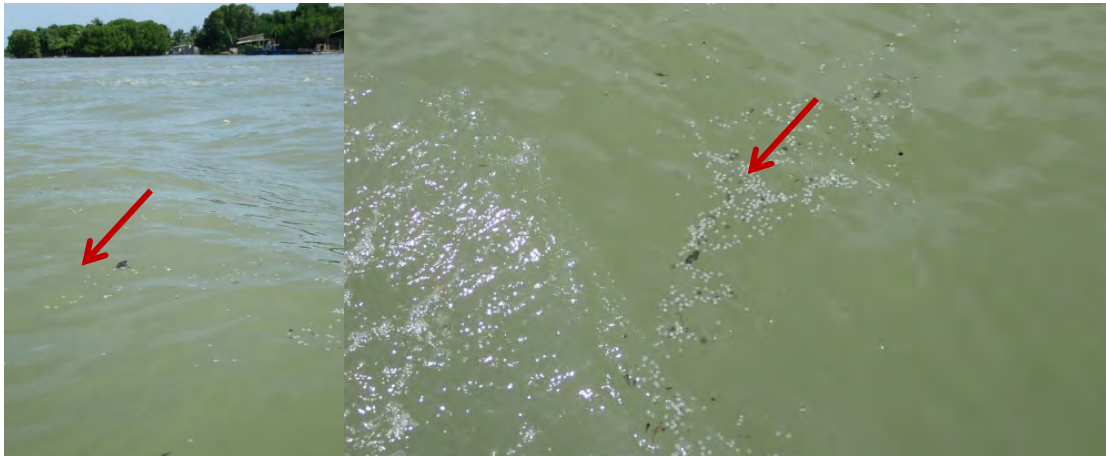
The inlets of the Negombo Lagoon – a major fishing ground situated near the most impacted sites – were partially protected by the deployment of booms along the two entrance channels. It is estimated that the booms may have prevented up to 80% of the plastic pollution from entering the lagoon. These booms had been removed by the time of the UN team's visit. Though clean-up campaigns have been conducted, the UN team was able to observe patches of pellets and burnt plastic fragments during a boat survey in the lagoon on 24 June. Recovery of floating plastic pollution in the lagoon inlet (e.g. using small meshed nets) should be considered before it disseminates deeper in the lagoon or enter mangrove stands. Chronic pollution of lagoon water may also make the microplastics a long-term hazard as pollutants adsorb on them and enter the food chain.

Figure 2.19: Floating pollution in inlets connecting Negombo lagoon with the ocean; pellets and burnt plastic fragments, Gampaha district.

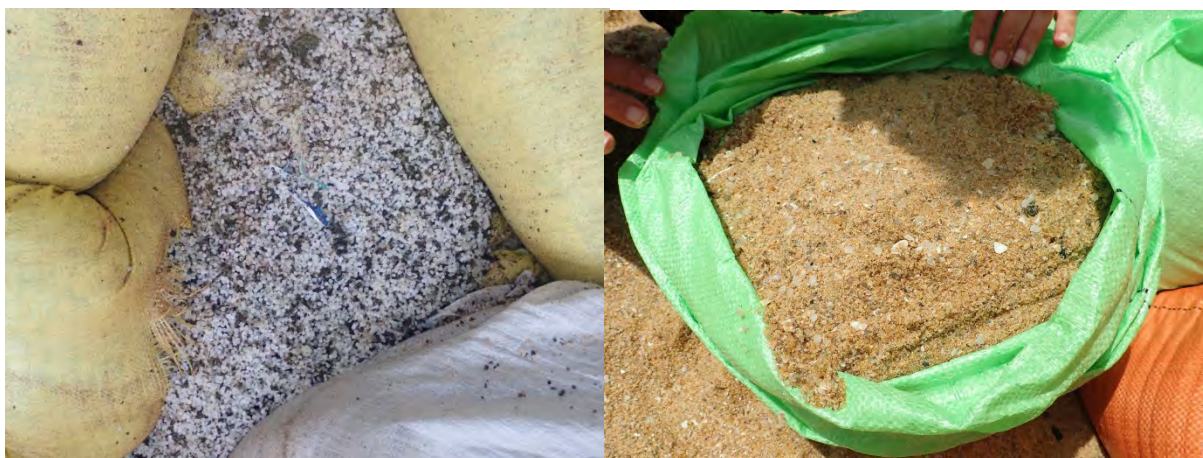
Figure 2.20: Evolution of bag content on Sarakkuwa beach, Gampaha district. On the left, content of bags at the beginning of the clean-up campaign, and on the right after several weeks.

A phased approach is being applied to plastic pellet recovery. Bulk arrivals of nurdles mixed with other debris was initially hauled manually using large baskets and heavy equipment. As the clean-up progressed and reached an advanced stage, the quantity of nurdles collected decreased while that of sand increased, especially when shovels are used to scoop up the pellets. It was observed that a substantial number of bags contain a large proportion of sand, which in some cases can reach up to 80 percent. Additional treatment will be required to separate the sand from the pellets.

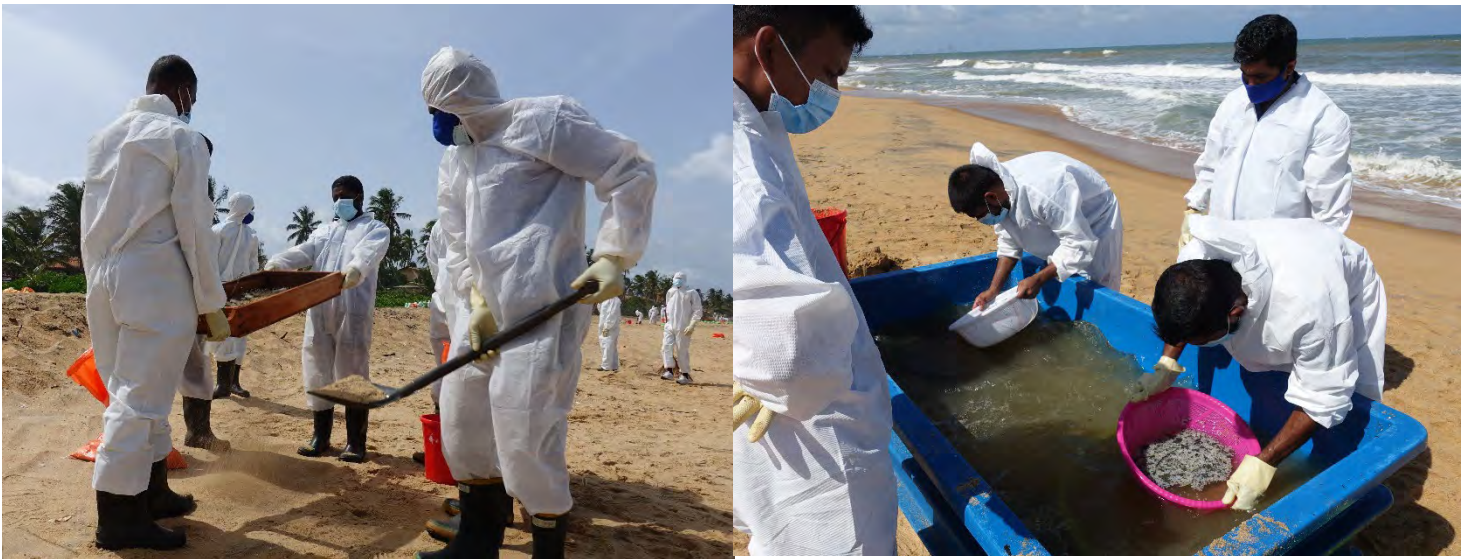
Figure 2.21: Left: Manual sieving, Right: flotation in seawater. Sarakkuwa beach, Gampaha district.

Flotation appears to be the more effective option, reduces the volume of sand collected, and offers the possibility of separating and recovering small burnt fragments. Guidance on scaling-up this density-based separation method is needed.

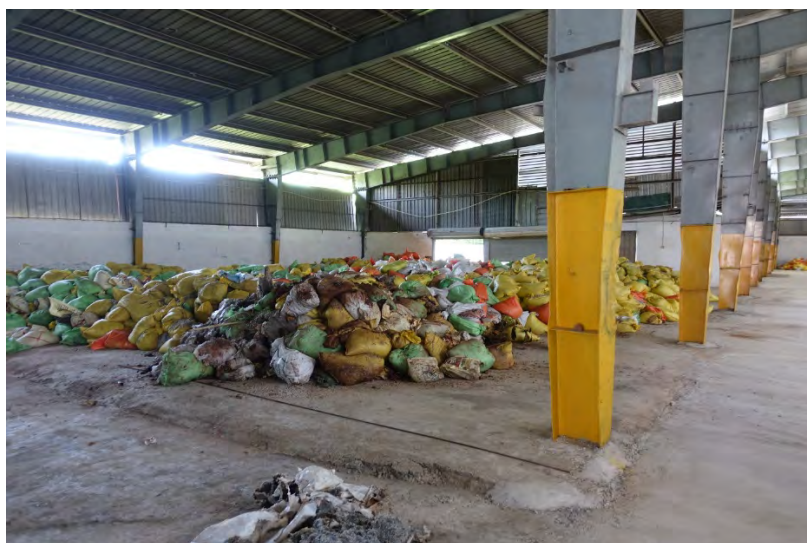
Figure 2.22: A central storage facility for the collected waste in Pamunugama has been hired, where scaled-up mechanical waste segregation operations are also to be implemented.

Trialling of mechanical recovery techniques is underway or planned including use of vacuum cleaners, mechanical sieving, trommels and beach graders. Furthermore, especially designed equipment is being piloted by local entrepreneurs to clean-up beaches with deeply buried plastics as in Sarakkuwa.

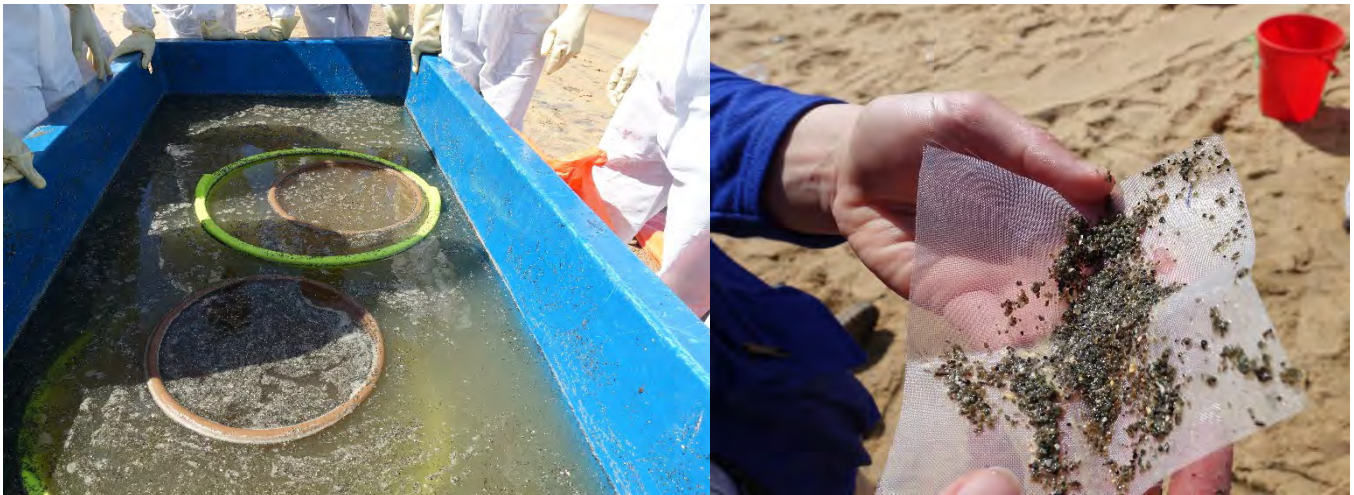
The burnt plastic fragments represent a challenge for the clean-up as they appear to be very brittle and easily breakdown into small irregular shaped particles; whereas pellets are solid, round and of standard size. Significantly, the degradation of the burnt fragments can be augmented by mechanical clean-up techniques. Moreover, the smaller particles with an irregular shape and a size inferior to pellets (3 mm) are generally not recoverable with techniques such as manual flotation or sieving due to large mesh size. Methods to recover these small burnt plastic flakes need to be developed. Furthermore, the extent of the remaining burnt plastic pollution in the sand is currently unknown and needs to be assessed.

Figure 2.23: Burnt plastic particles left after flotation that are too small to be recovered with existing sieves.

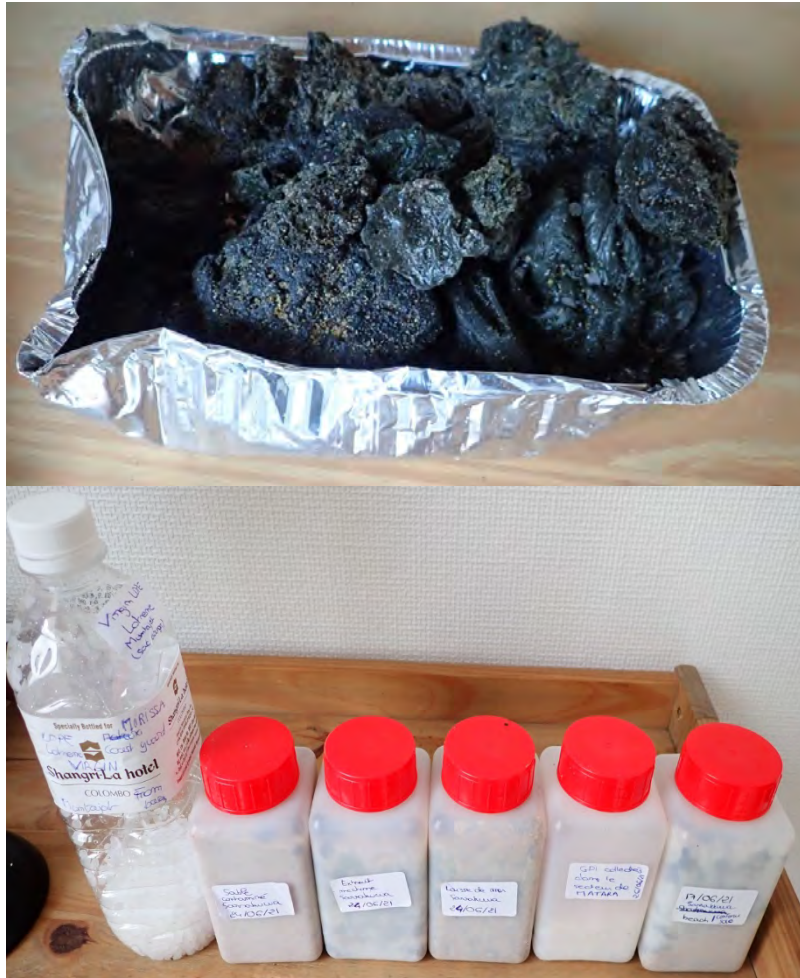
Figure 2.25: Burnt plastic pieces and pellet samples collected on different beaches.

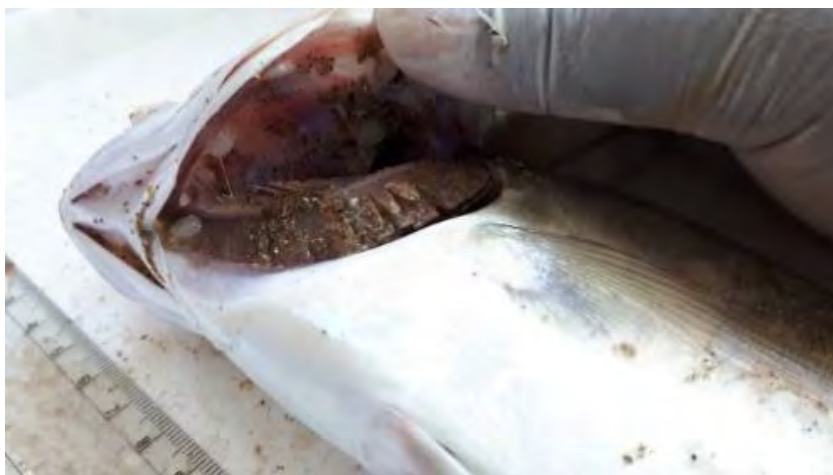
While there is a potential risk of fish accidentally feeding on pellets, there is limited evidence so far that this has occurred. Analysis of dead fish found ashore and live samples collected through experimental fishing by the National Aquatic Resource Agency (NARA) have so far found few specimens with pellets lodged around their gills.

Figure 2.29: Gold silk sea bream (*Acanthopagrus berda*) with plastic pellets in opercle (credit: NARA).

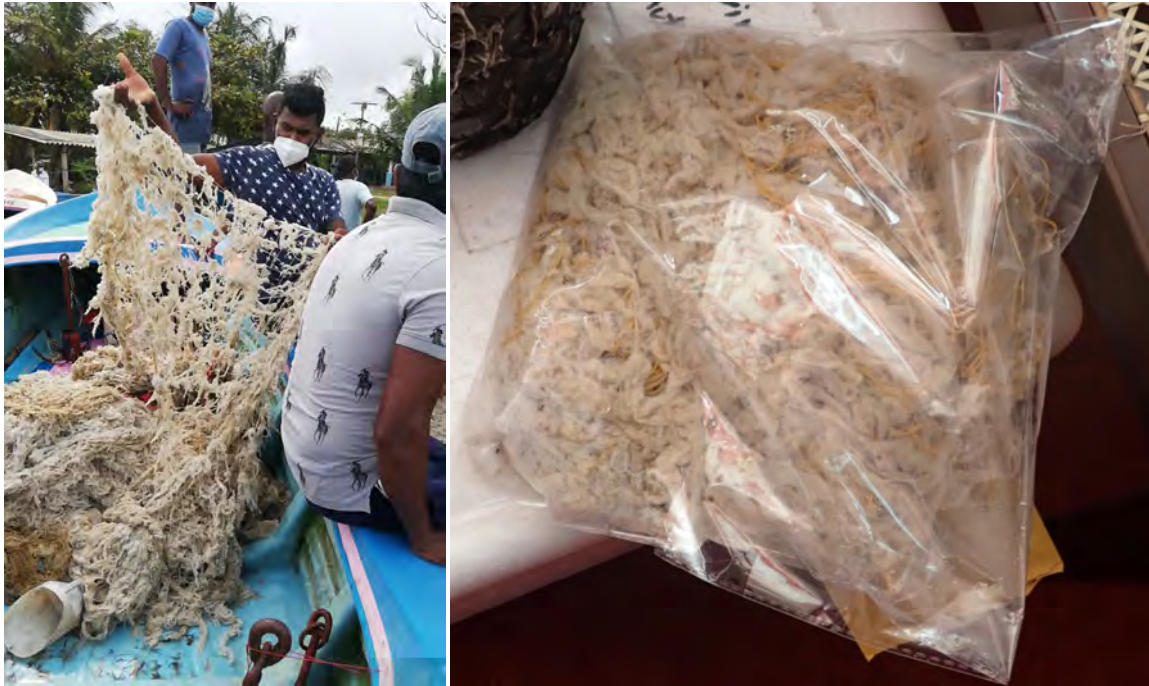
Figure 2.30: Nets entangled with synthetic fibres (left, credit: MEPA).

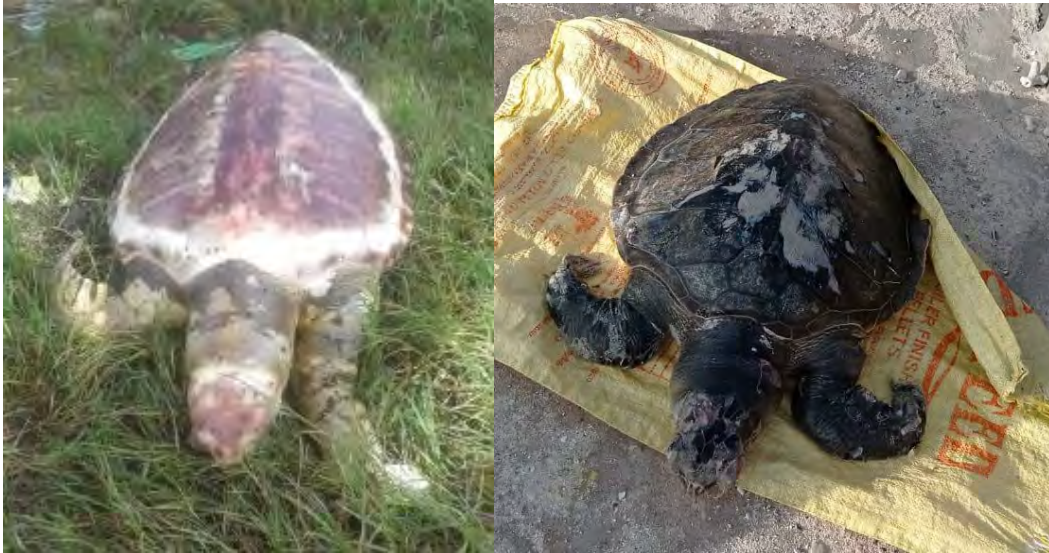
While the high mortality of turtles and marine mammals is a cause of concern, the UN team cautions on causal attribution to the incident without scientific evidence. Two qualifications are worth noting here: i) the deaths coincide with the start of the monsoon season which typically witness a high number of turtle stranding as carcasses are washed ashore by rough western currents; and ii) the increased reporting of turtle deaths may be due to a 'heightened awareness situation' and increased surveillance by both government institutions and the public.

Figure 2.31 (left): Turtle with bleached shell suggesting potential burn (credit: Department of Wildlife Conservation).
Figure 2.32 (right): Turtle with intact carapace (credit: NARA).

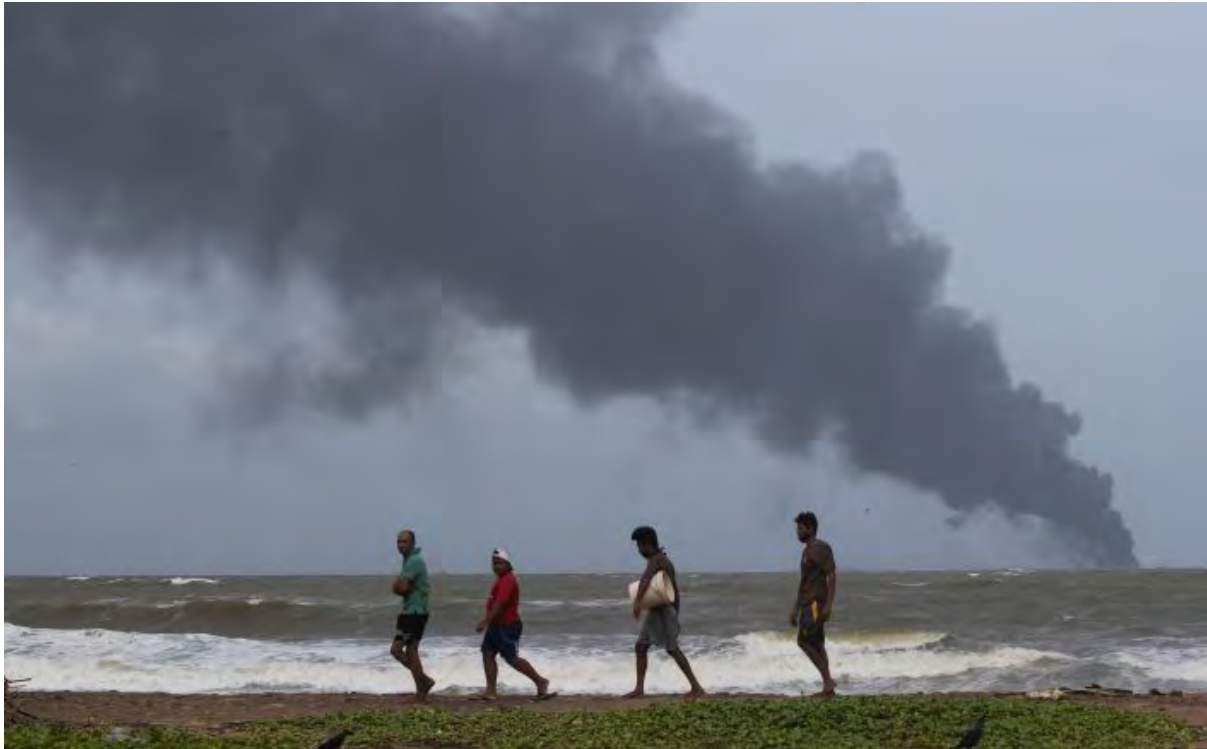
The massive fire and explosions on the ship caused significant air pollution. Lasting for around 10 days, the smoke plume created by the fire extended for several kilometres and was a highly visible impact of the incident. The plume rose and dispersed depending on weather conditions reaching inland when the prevailing winds blew from the west and southwest. By the time the UN team arrived in Sri Lanka, however, all the primary pollutants had disappeared, limiting an appraisal of the issue.

Figure 2.37: The smoke from the incident reached several kilometres inland (credit: AP Photo: Eranga Jayawardena).

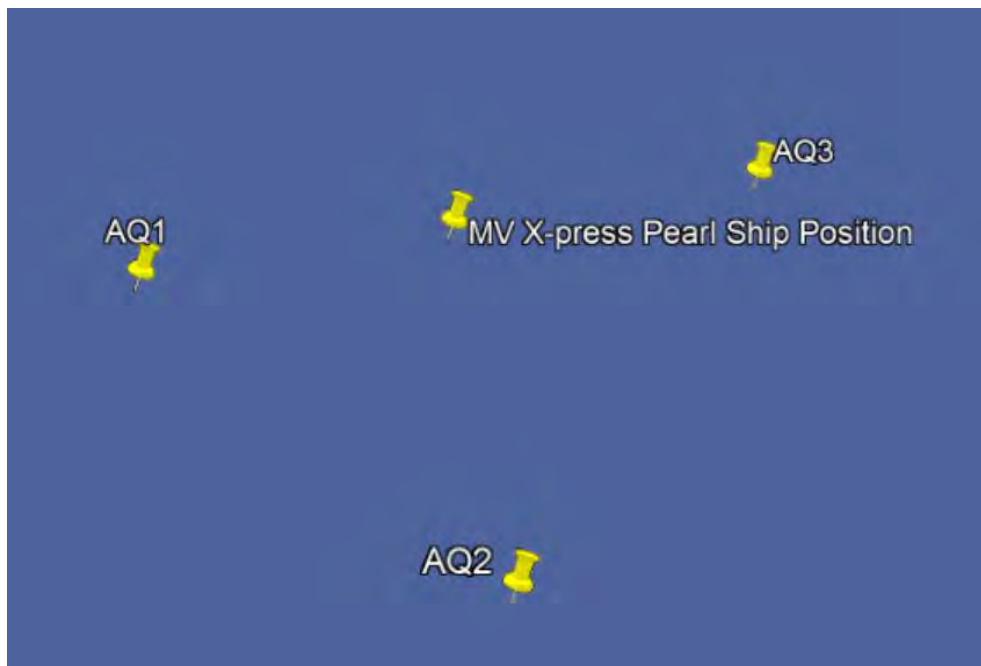
Figure 2.38: Air Quality Monitoring Locations.

Limited primary data was gathered by the National Building Research Organisation (NBRO, Ministry of National Security and Disaster Management) which conducted air quality monitoring using photoionization detectors (PID) about 50 meters from the ship on 23 May. As expected, the results indicated high levels of air pollution within this direct fire zone as shown in Table 2 and Figure 2.38.

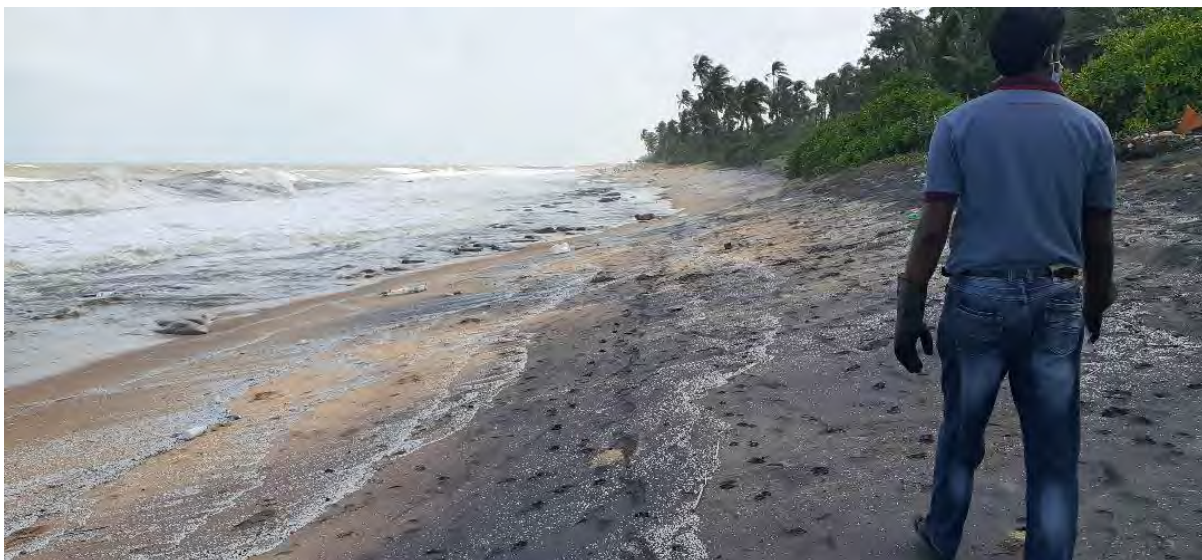
The deposition of fire residue on the sea and on land is one of the important hazards that has not been evaluated. To assess the impact of the soot fallout from the fire, a limited survey of soil quality, smear samples, rain and groundwater within the defined vulnerable area could have been carried out to determine if some of the air pollutants that reached the upper atmosphere may return in the form of precipitation. As one of the main components in the soot, polycyclic aromatic hydrocarbons (PAH) is a key parameter that should be analysed as it is both carcinogenic and mutagenic. Given the lapse of time since the incident, however, the value of conducting such an assessment is now likely to be limited; especially as there are many other sources of pollutants (e.g. combustion engines, stove, waste burning, etc.)

Figure 2.40: Depositor of fire residue on the shoreline (credit: NBRO).

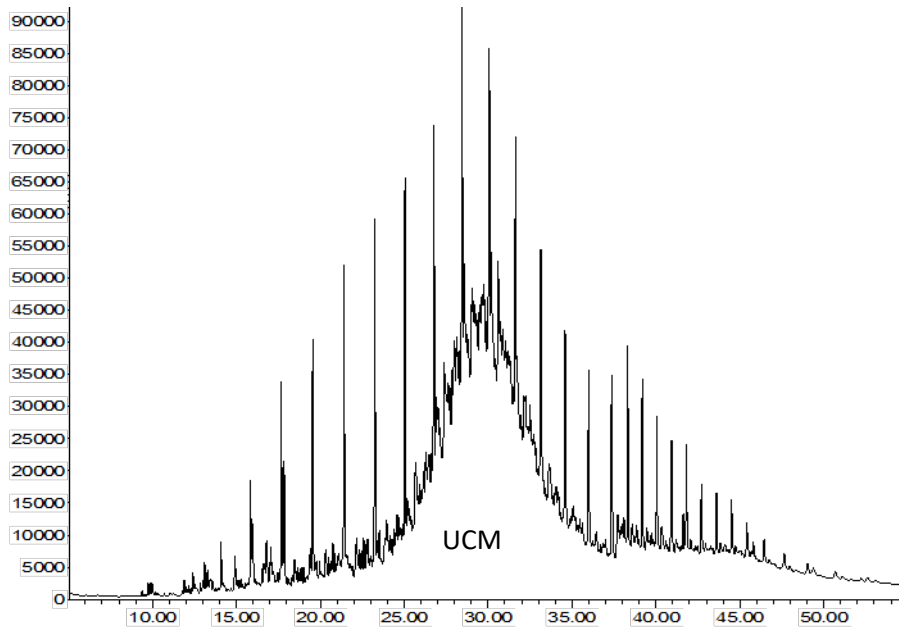
Figure 1: Chromatogram of oil sample taken on 20 June, which is typical of a heavy fuel oil.

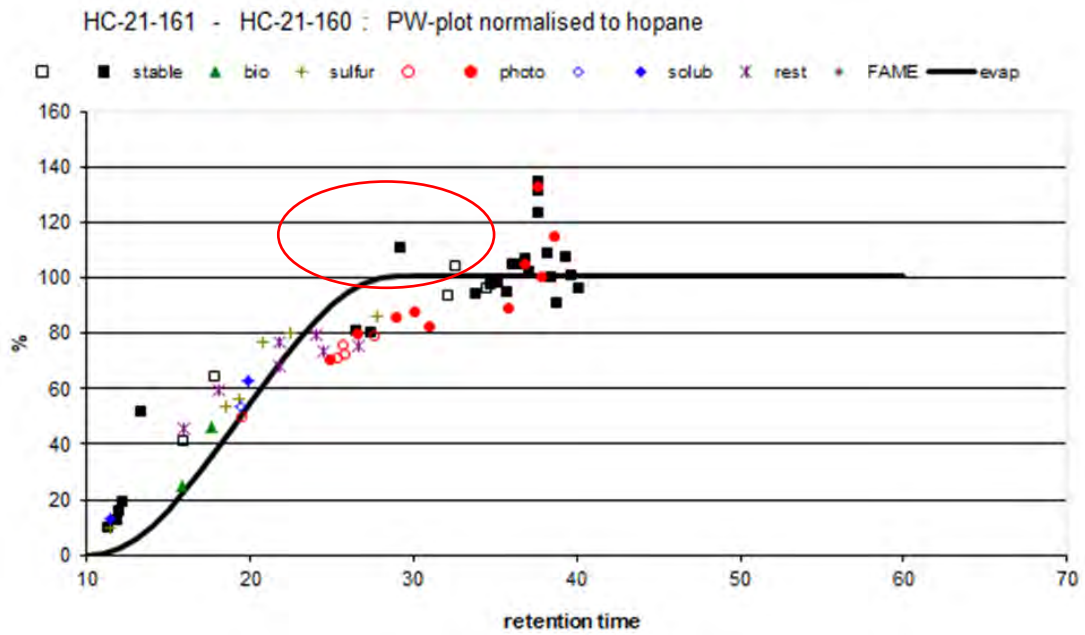
Figure 2: Full concordance for compounds in the red circle. The statistical treatment of analysis does not show significant difference between the two oil samples taken.
