# Environmental Assessment of the Areas Disengaged by Israel in the Gaza Strip

United Nations Environment Programme

*First published in February 2006 by the United Nations Environment Programme.  
© 2006, United Nations Environment Programme.*

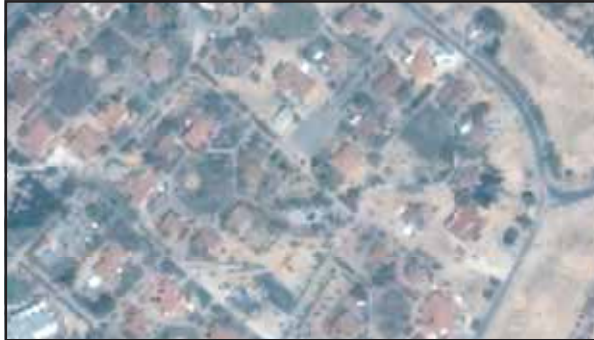
Site 1 – Residential area  
before disengagement

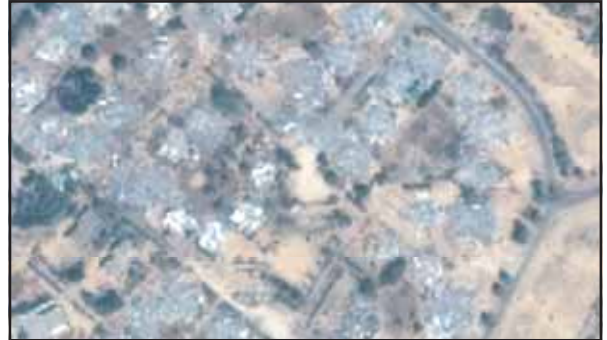
Site 1 – Residential area  
after disengagement

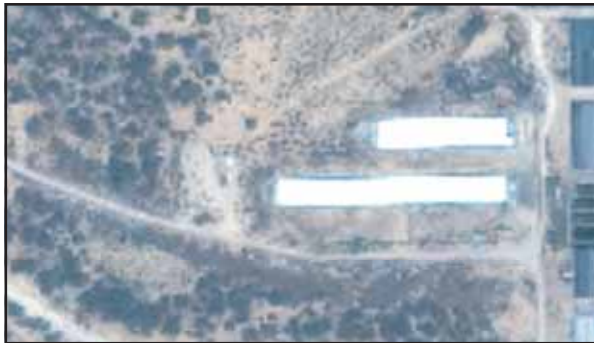
Site 2 – Vegetable processing factory  
before disengagement

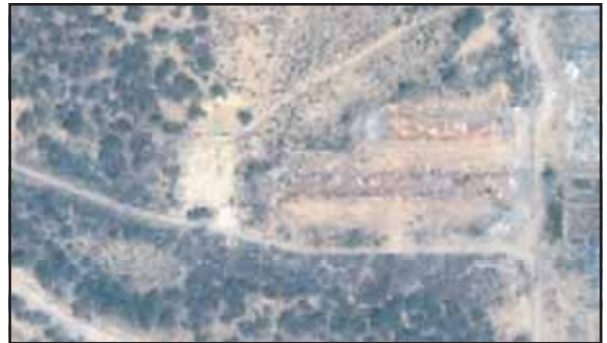
Site 2 – Vegetable processing factory  
after disengagement

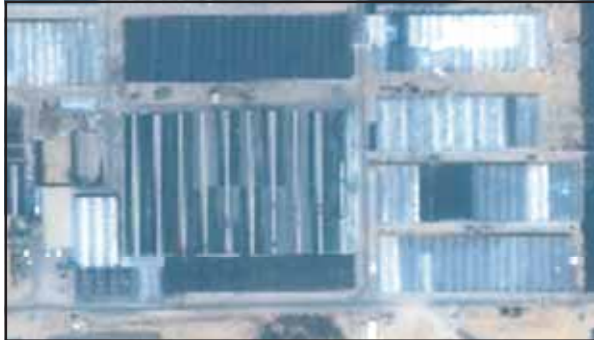
Site 3 – Green houses  
before disengagement

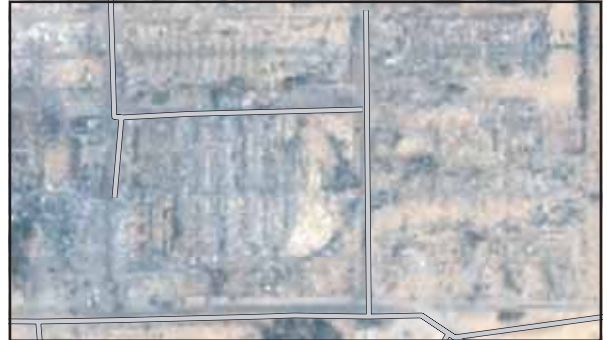
Site 3 – Green houses  
after disengagement

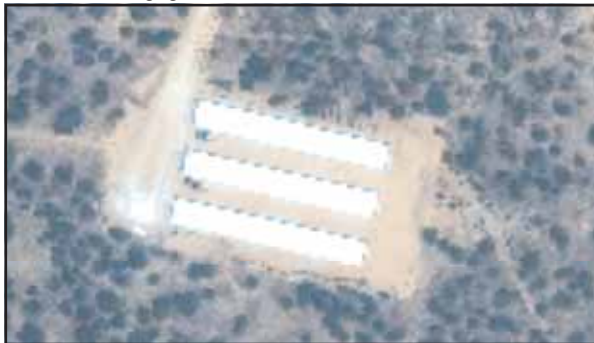
Site 4 – Poultry farm  
before disengagement

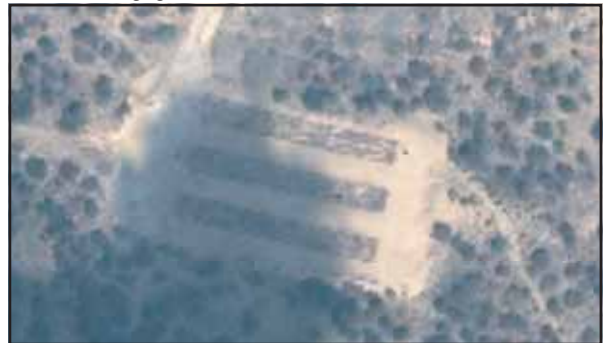
Site 4 – Poultry farm  
after disengagement

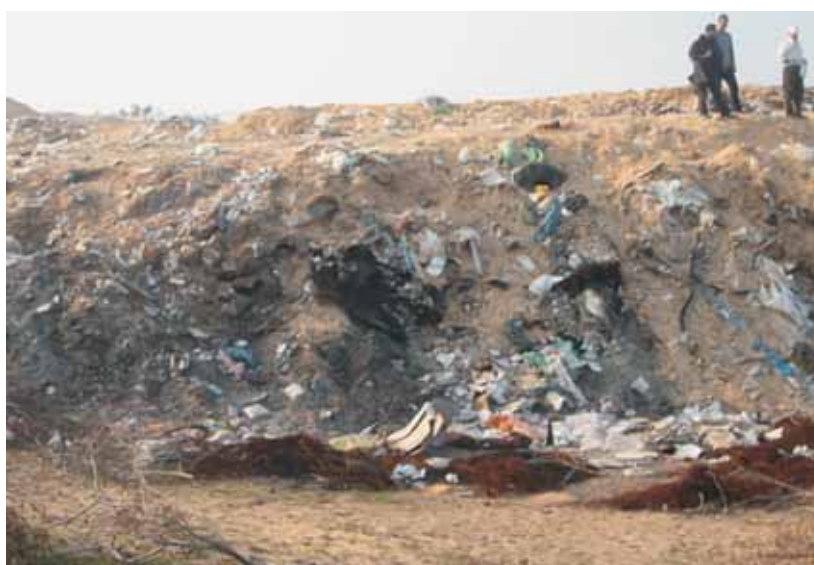
*The exposed operational face of the waste disposal site at Kerem Atsama*

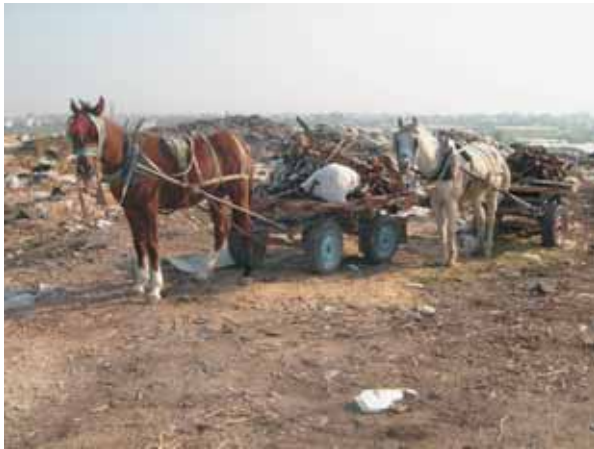
*Horse-drawn carts loaded with scrap metal at the Gadid waste disposal site.*

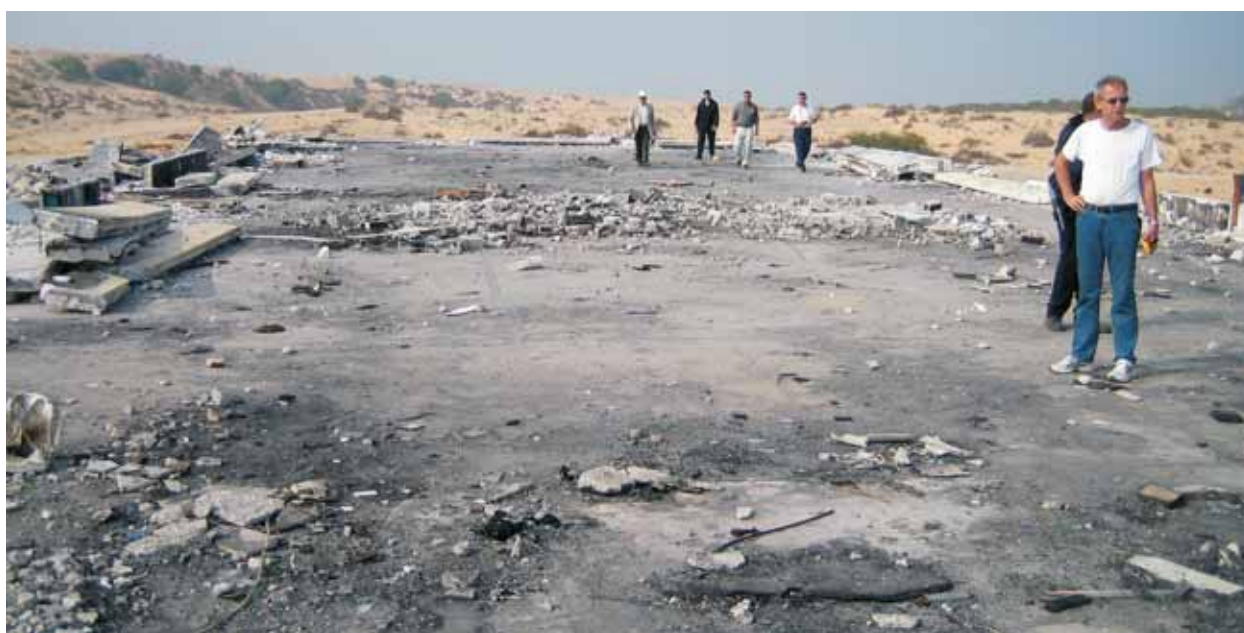
*The concrete slab on location A in Rafiah Yam*

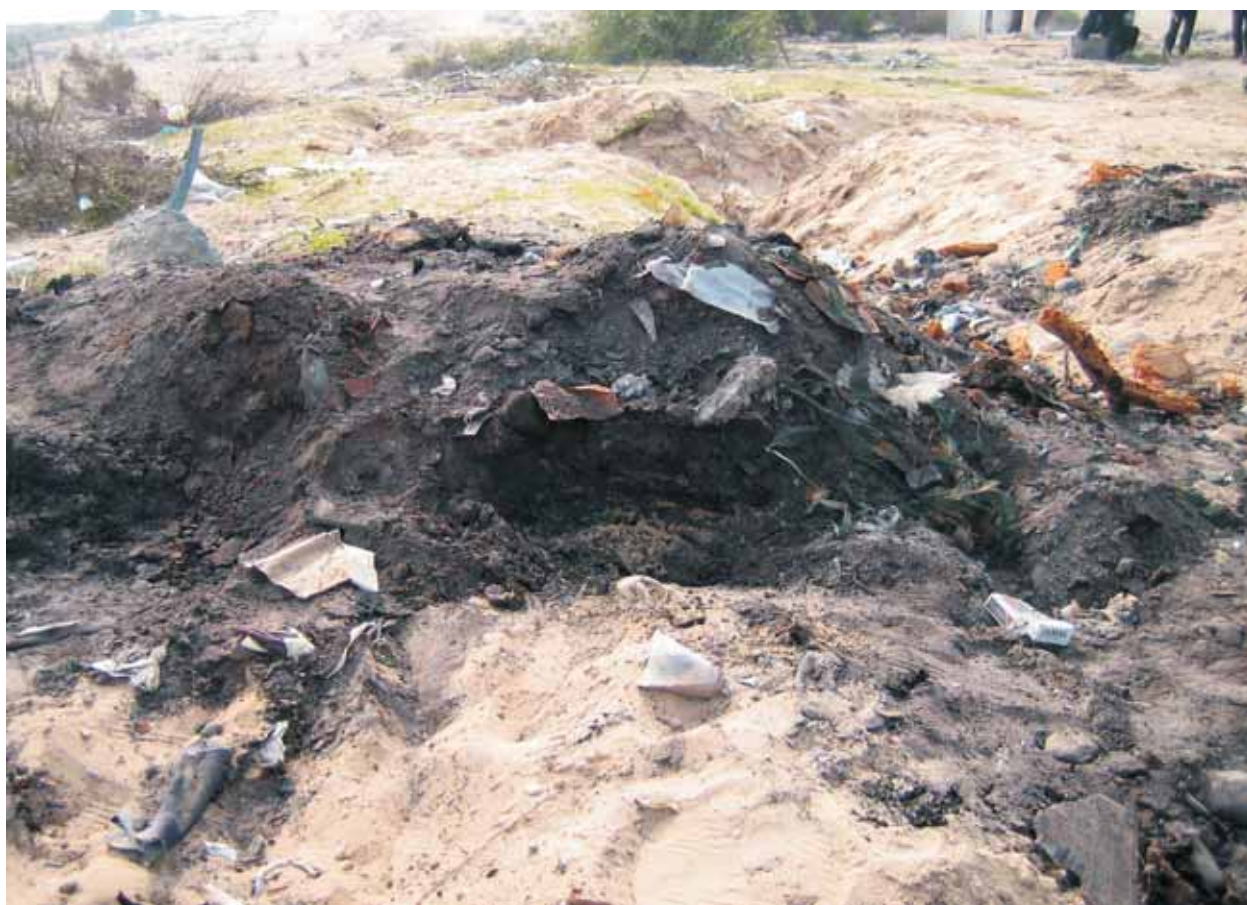
Contaminant	Location	Screening Standard	Soil threshold value mg/kg (screening criteria)	Concentration (mg/kg)
Copper	B	Dutch	96	618
Zinc	B	Dutch	350	900

*A mound of burned material at location B in Rafiah Yam*

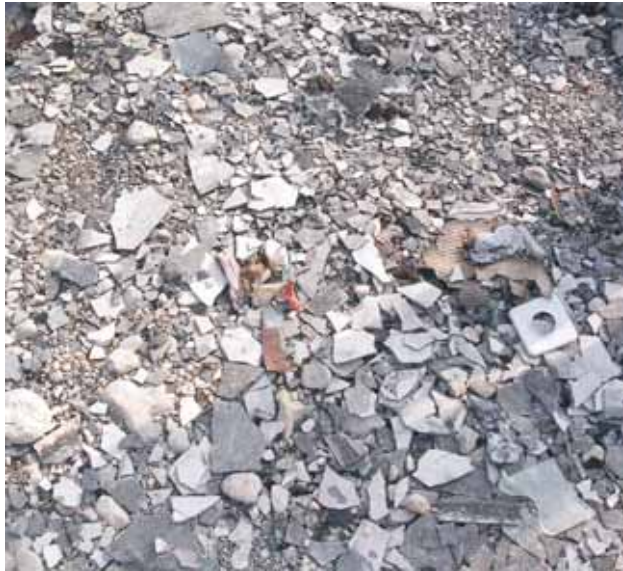
**Sample number:** 1/asb/001  
**Date sampled:** 13/12/05  
**Analysis result:** Chrysotile  
(white asbestos)  
**Location:** 31 18 46-96 N  
34 13 52-07 E

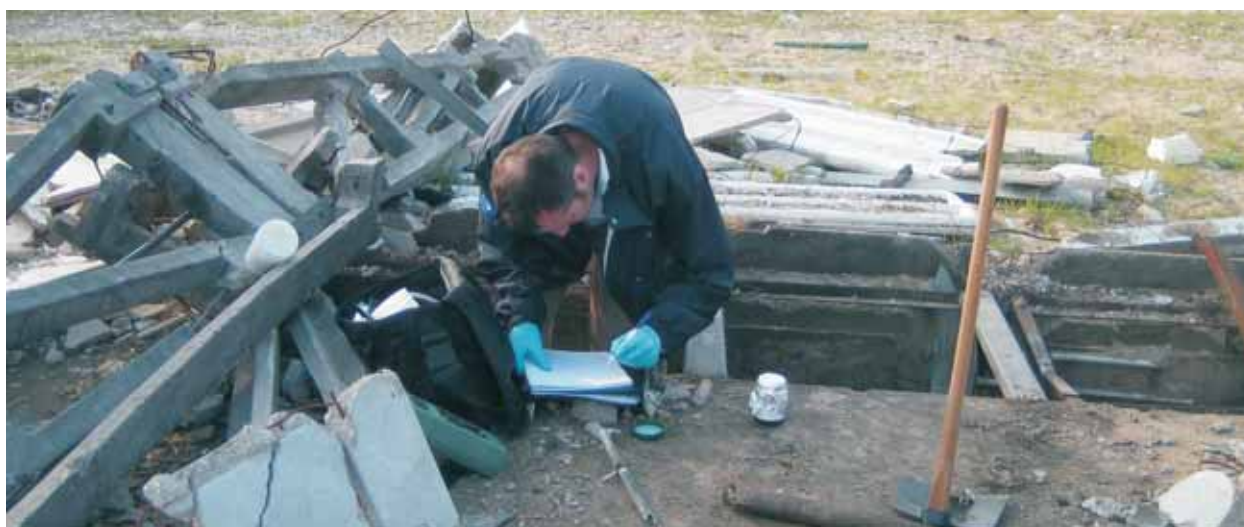
*Sampling for hydrocarbons and PCBs in the Slav settlement*

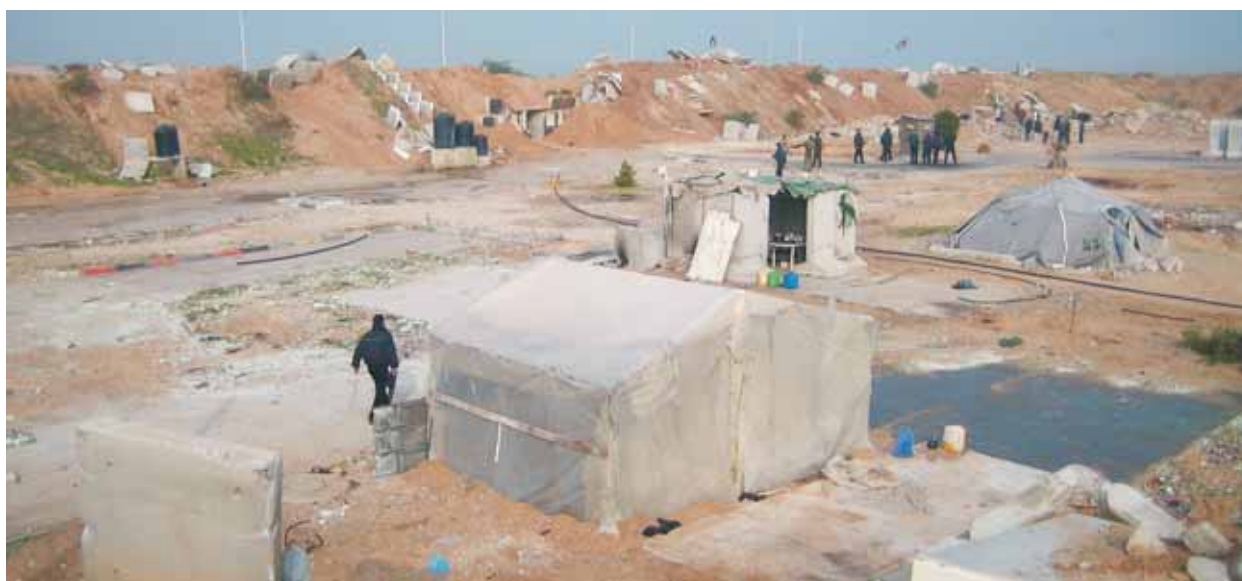
*A view of the former Israeli military post in the Slav settlement*

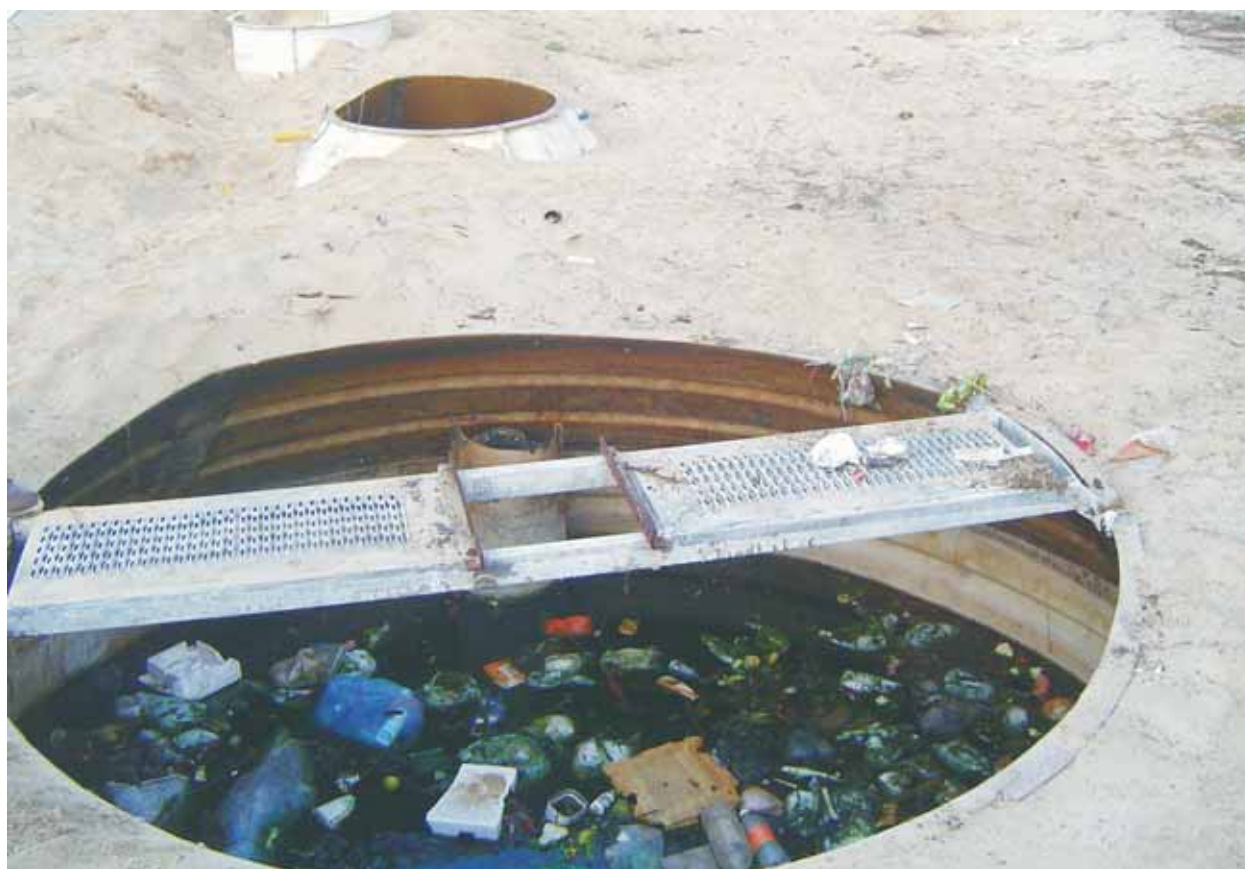
*Concrete pit containing accumulated water in the Slav settlement*

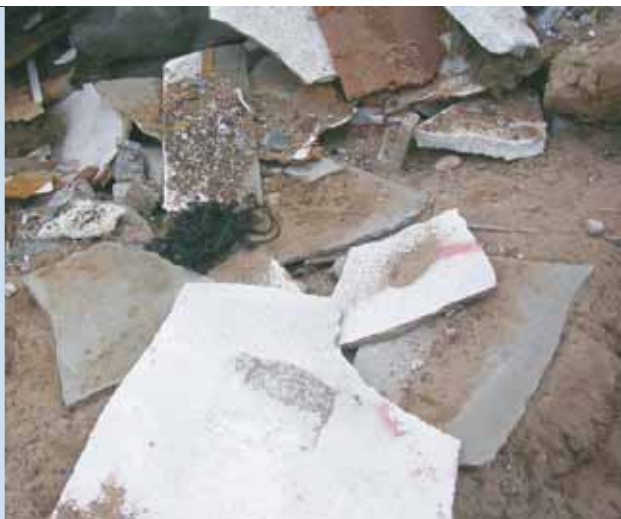
**Sample number:** 2/asb/002  
**Date sampled:** 13/12/05  
**Analysis result:** Chrysotile  
(white asbestos)  
**Location:** 31 19 18-93 N  
34 14 19-59 E

**Notes:**  
Small amounts of asbestos cement debris were noted in the area.

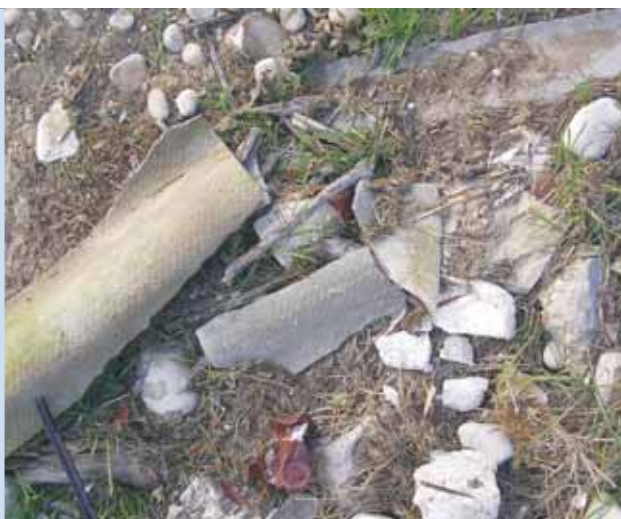
**Sample number:** 2/asb/003  
**Date sampled:** 13/12/05  
**Analysis result:** Chrysotile  
(white asbestos)  
**Location:** 31 18 59-56 N  
34 14 08-61 E

**Notes:**  
The former military area contained asbestos cement debris, possibly from the roof of demolished buildings.

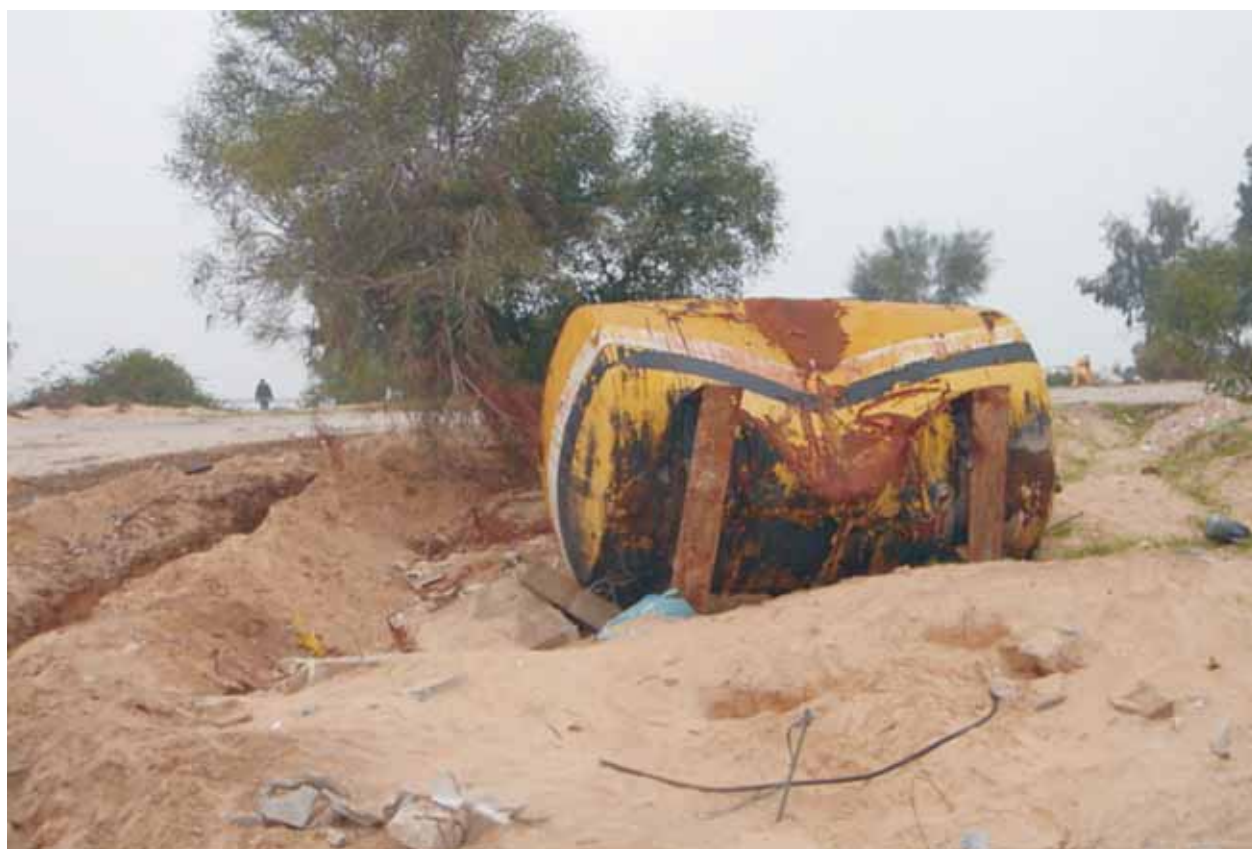
*Despite the presence of this large, obsolete fuel tank, there were no significant hazardous concerns in the Slav area*

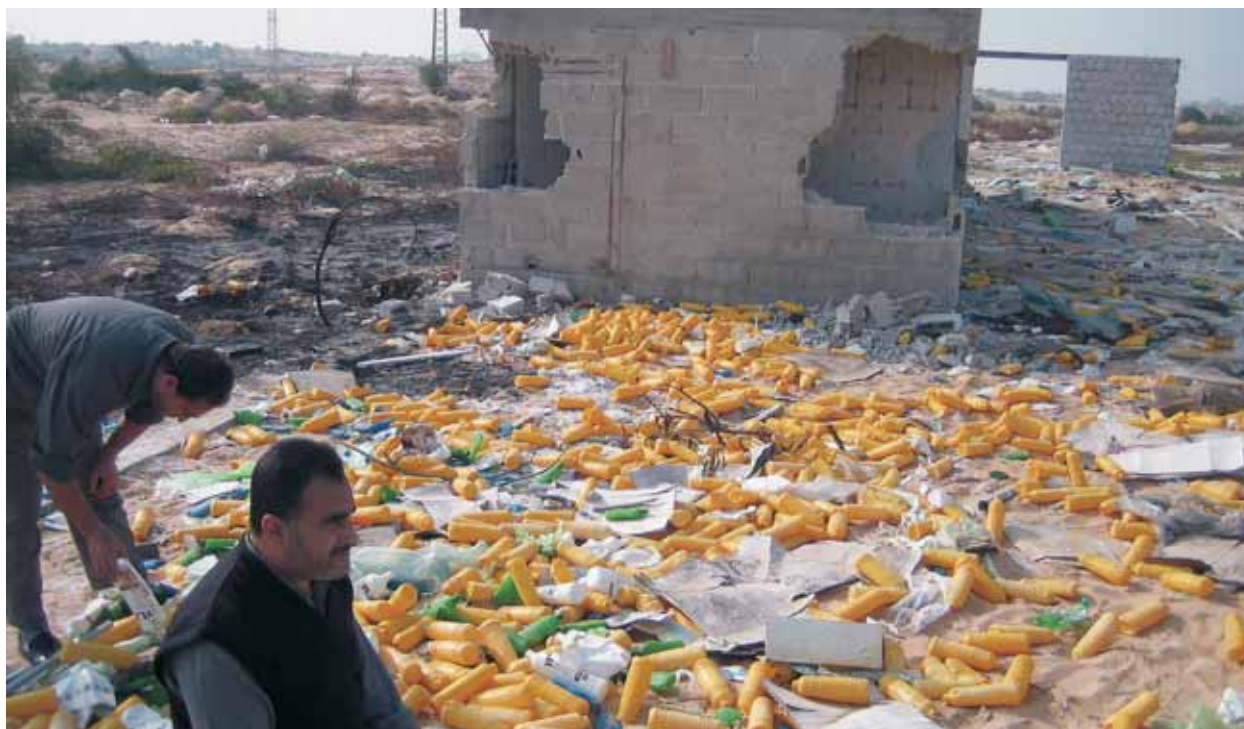
assessment, a preliminary assessment suggested possible use as some form of disinfectant or cleaner, such as bleaches. An area immediately adjacent to the discarded bottles showed the effects of burning. It was estimated that the affected areas consisted of 25m<sup>2</sup> of discarded bottles and raw products with some 30m<sup>2</sup> for the burned area. Shallow excavations showed that the contamination extended to a depth of 0.2m.

A view of the Bnei Atsmon site where industrial waste had been discarded.

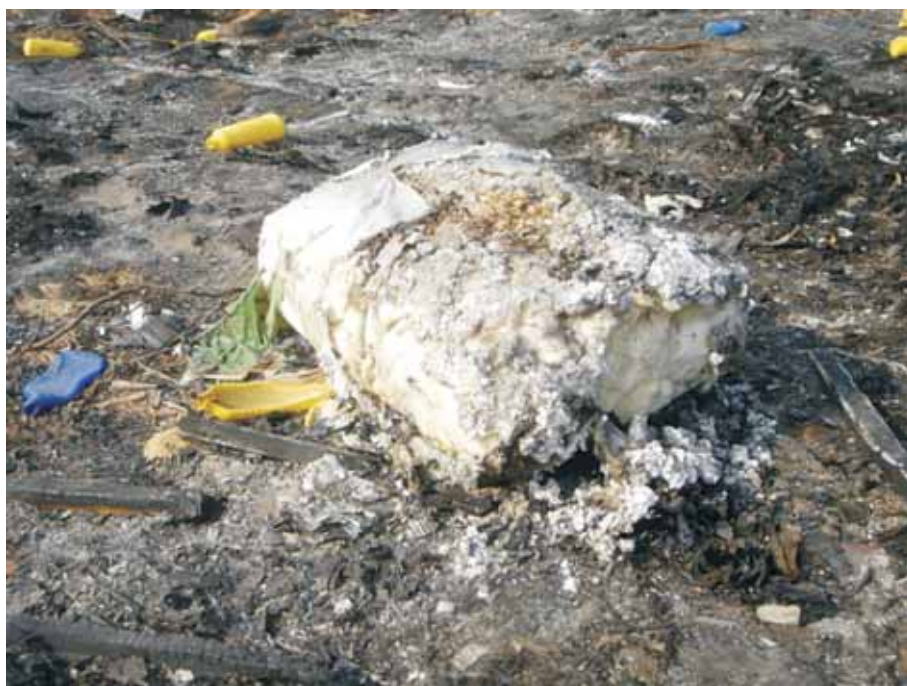
*An example of industrial waste discarded in the Bnei Atsmon site*

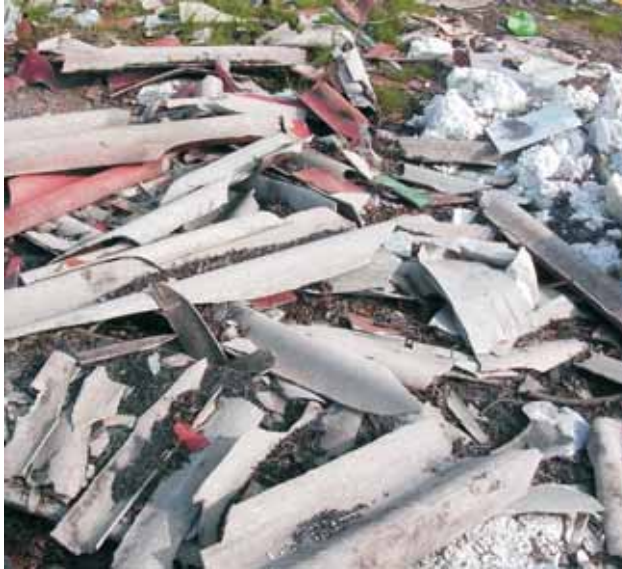
**Sample number:** 3/asb/001  
**Date sampled:** 13/12/05  
**Analysis result:** Chrysotile  
(white asbestos)  
**Location:** 31 19 29-57 N  
34 15 02-20 E

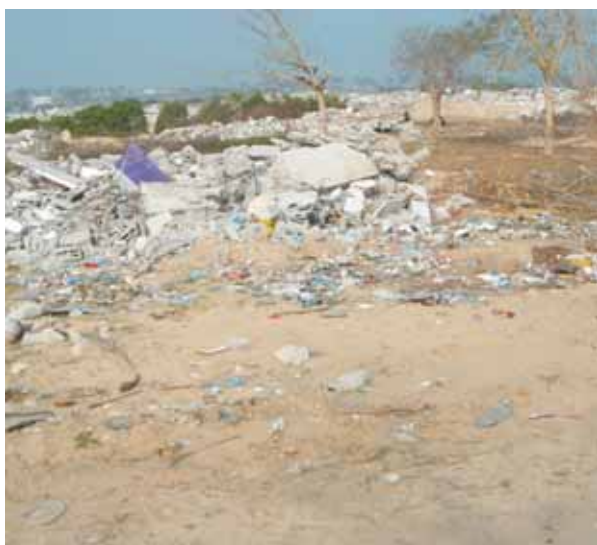
Part of the Pe'at Sade settlement showing largely inert waste

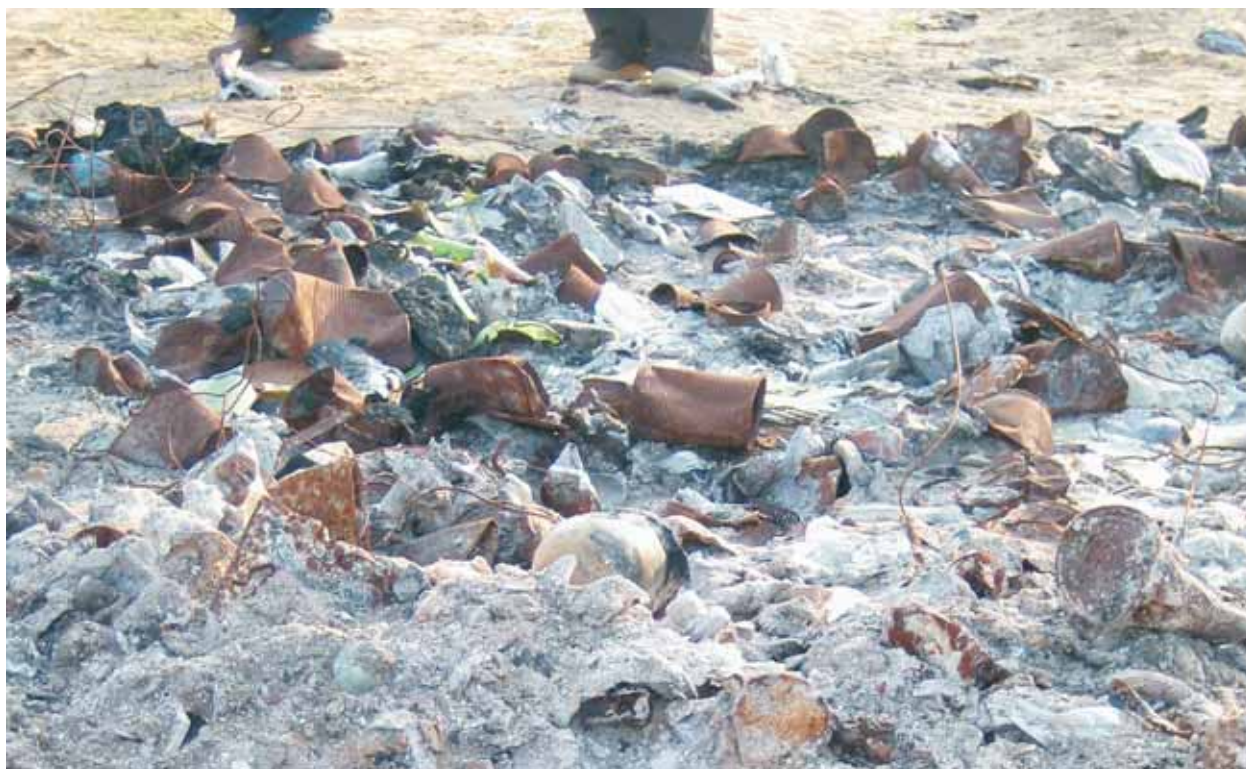
*The waste disposal site in Karem Atsama*

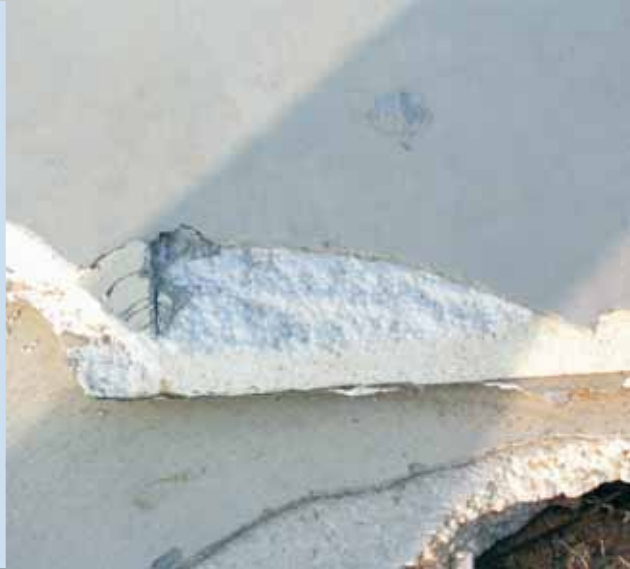
**Sample number:** 5/asb/001  
**Date sampled:** 13/12/05  
**Analysis result:** Chrysotile  
(white asbestos)  
**Location:** 31 19 08-61 N  
34 16 03-78 E

**Notes:**  
Asbestos cement had been used in a building board sandwich with polystyrene, possibly for use in an industrial refrigeration building.

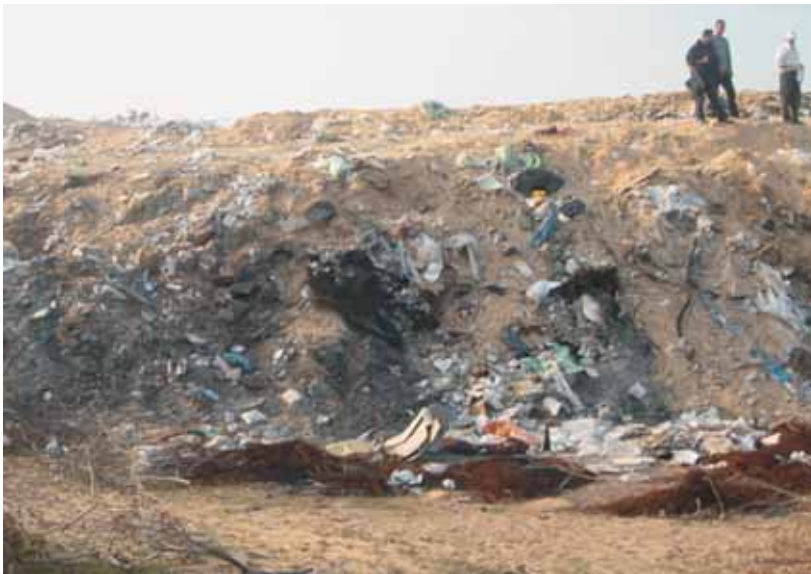
*A view of the exposed  
tipping face  
at Karem Atsama*

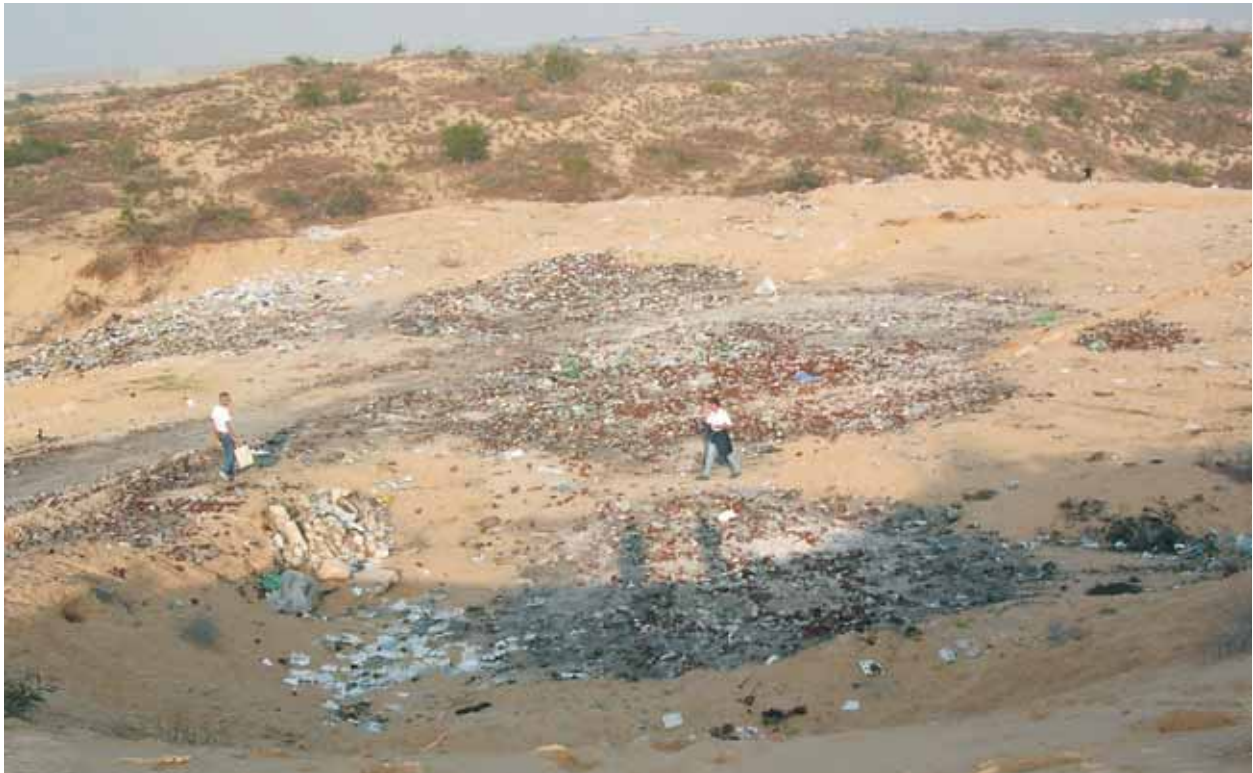
*Bird's eye view of the Karem Atsama waste disposal site*

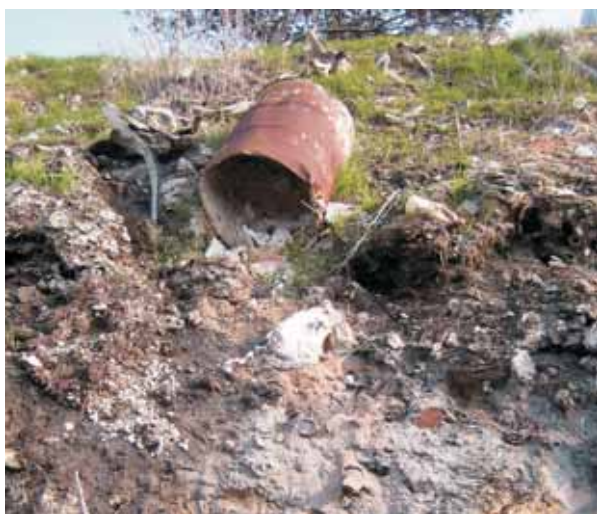
It is possible that the depression into which the material had been deposited may be a wadi feature and, as such, has the potential to channel water. It was difficult to estimate the full volume of the material dumped. However, it is thought unlikely to be in excess of 100m<sup>3</sup>.

Dumped waste material at the Bendolakh settlement

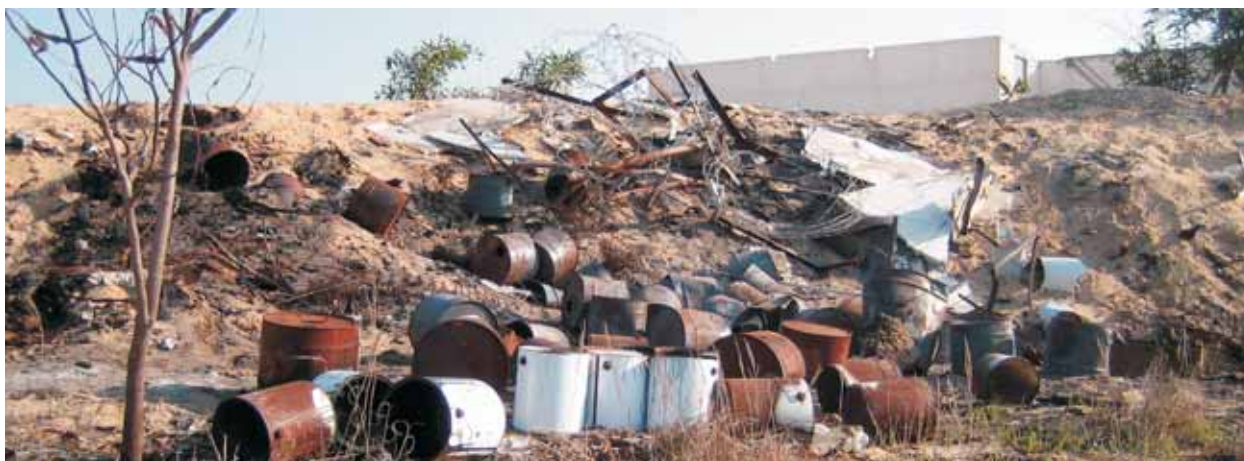
*Dumped waste at Gan Or. Although unsightly, contamination was minimal*

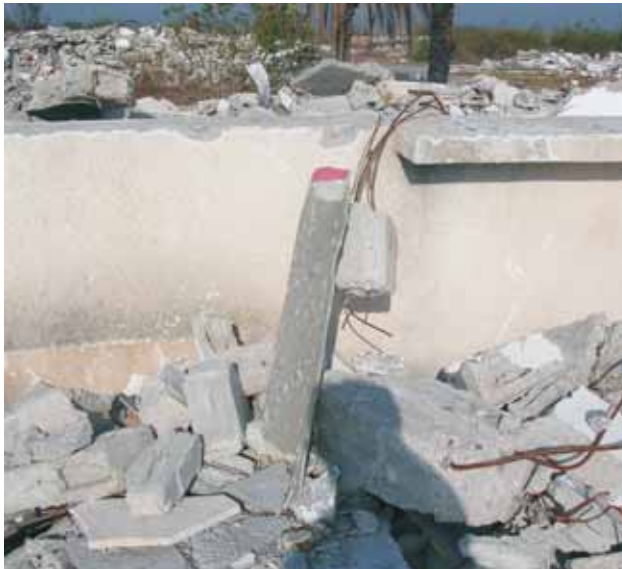
**Sample number:** /  
**Date sampled:** 13/12/05  
**Analysis result:** Assumed Chrysotile (white asbestos)  
**Location:** 31 20 13-23 N  
 34 15 32-77 E

**Notes:**  
 One of the buildings had been partly demolished and it was possible to identify asbestos cement debris within the building rubble.

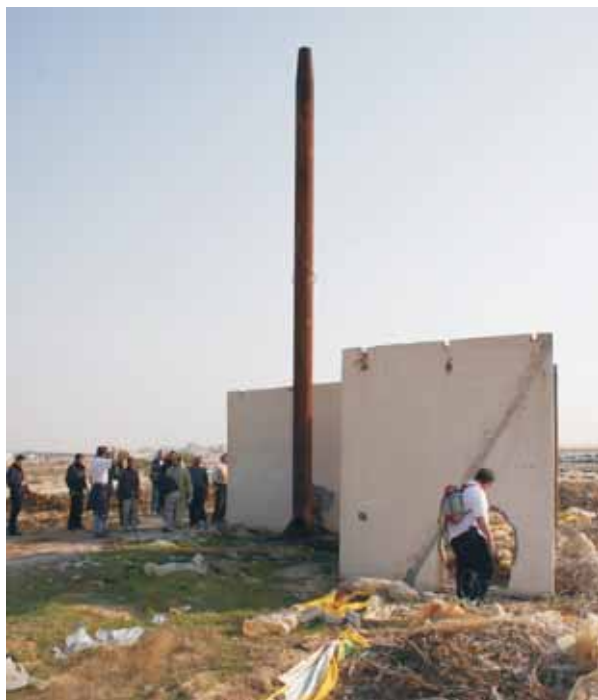
A view of the chimney to a unit in Gadid. Sampling illustrated elevated concentrations of pH and Nickel

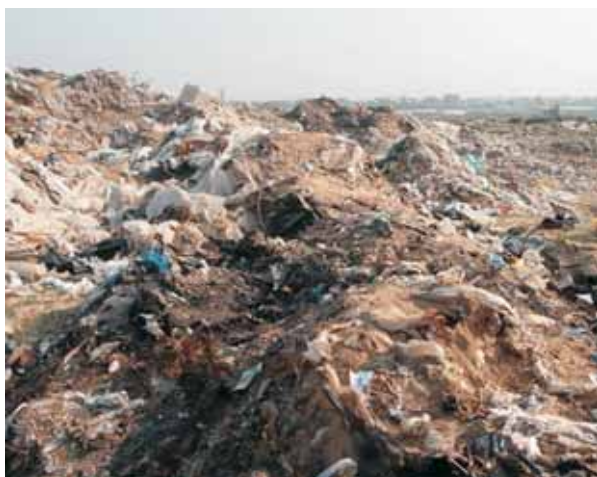
*A section of the waste disposal site in Gadid*

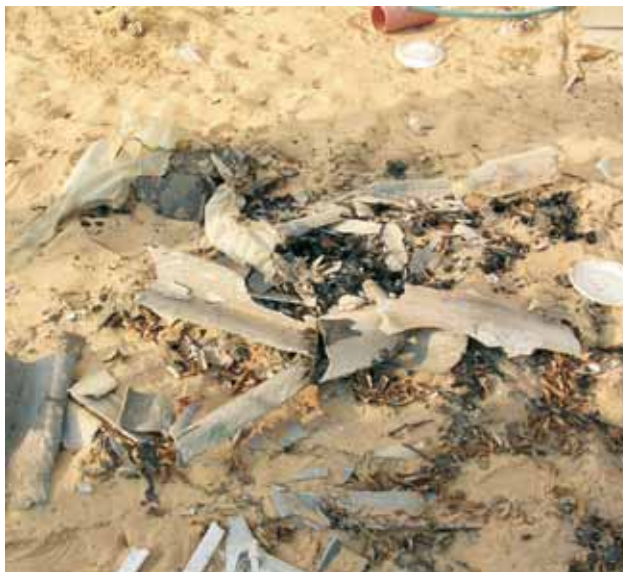
**Sample number:** 9/asb/001  
**Date sampled:** 15/12/05  
**Analysis result:** Chrysotile (white asbestos)  
**Location:** 34 67 92-17 N  
 62 11 60-37 E  
**Notes:** Further examples of asbestos cement debris.

1. Prior to the disposal and reuse of the demolition waste, asbestos should be identified and sorted out.
2. The material identified as ash (Location C), should be collected and transported to a central storage area for further treatment and disposal.

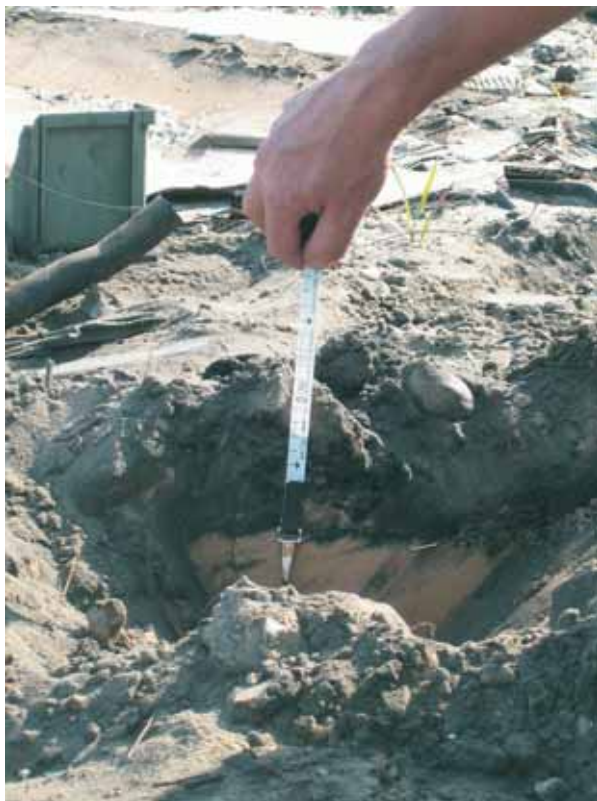
*The maximum depth of the impacted "burned" zone at location A was 10 centimeters*

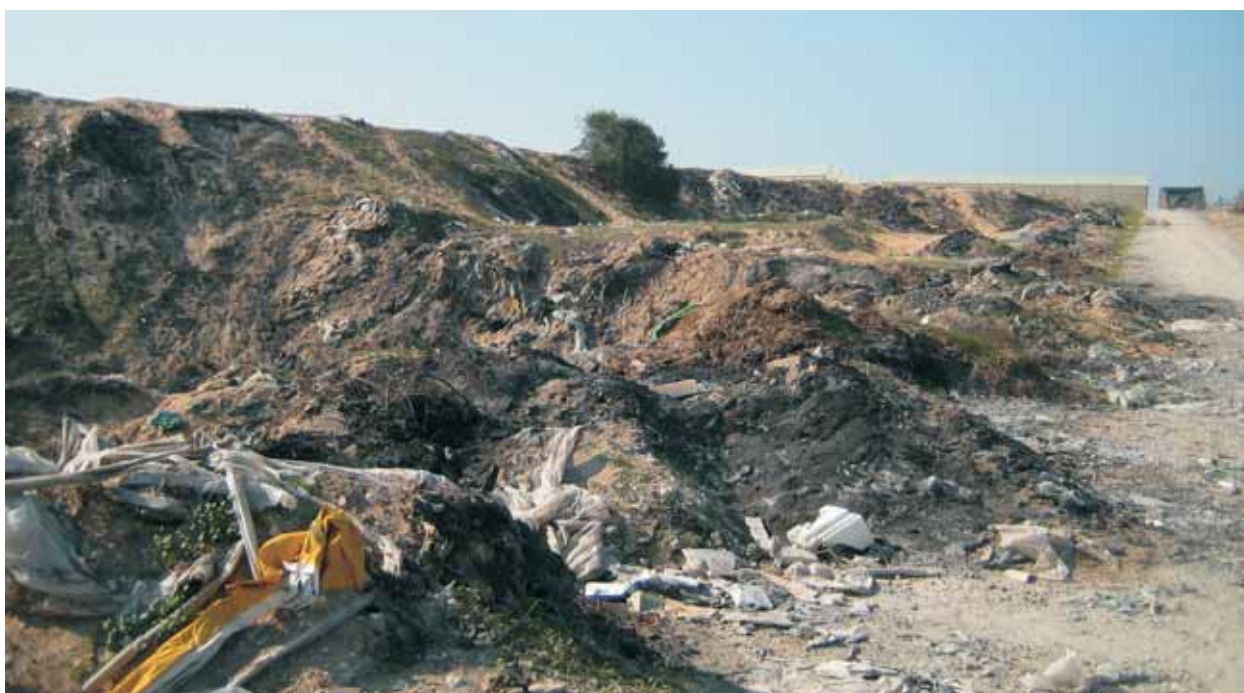
*Large area of some 500 m<sup>2</sup> impacted by waste materials, at location B in Nieve Dkalim*

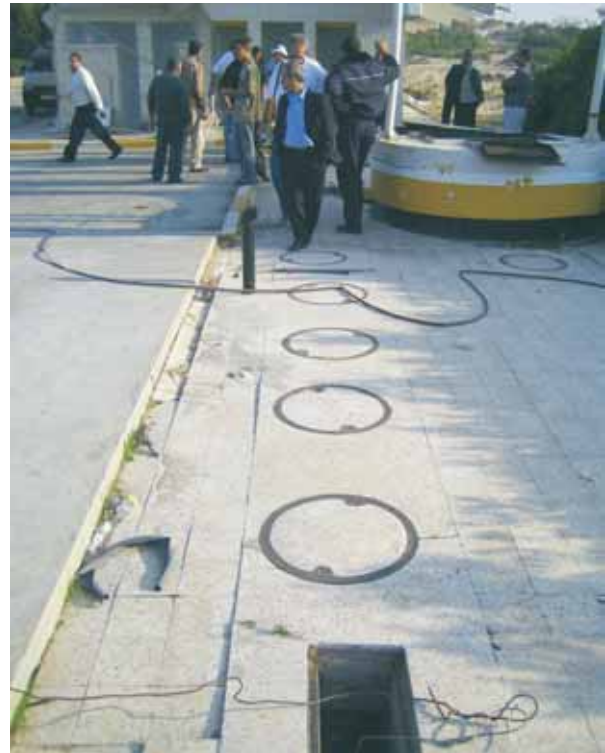
This is the site of the former petrol filling station, although much of the infrastructure including the fuel tanks remains. The site does not show any obvious evidence of contamination and there is no evidence of surface staining or any noticeable fuel odours indicating potential spillages (other than those emanating from the tanks themselves).

A conventional three-stage interceptor is present to the rear of the kiosk, which is partially water-filled and no observations of petroleum products were noted floating on the water. The discharge point of the interceptor could not be located. However, vegetation close to the boundary was in good condition suggesting that any surface discharge was of a quality sufficient not to impact on the growth of the plants.

*The site of the former petrol filling station in Nieve Dkalim*

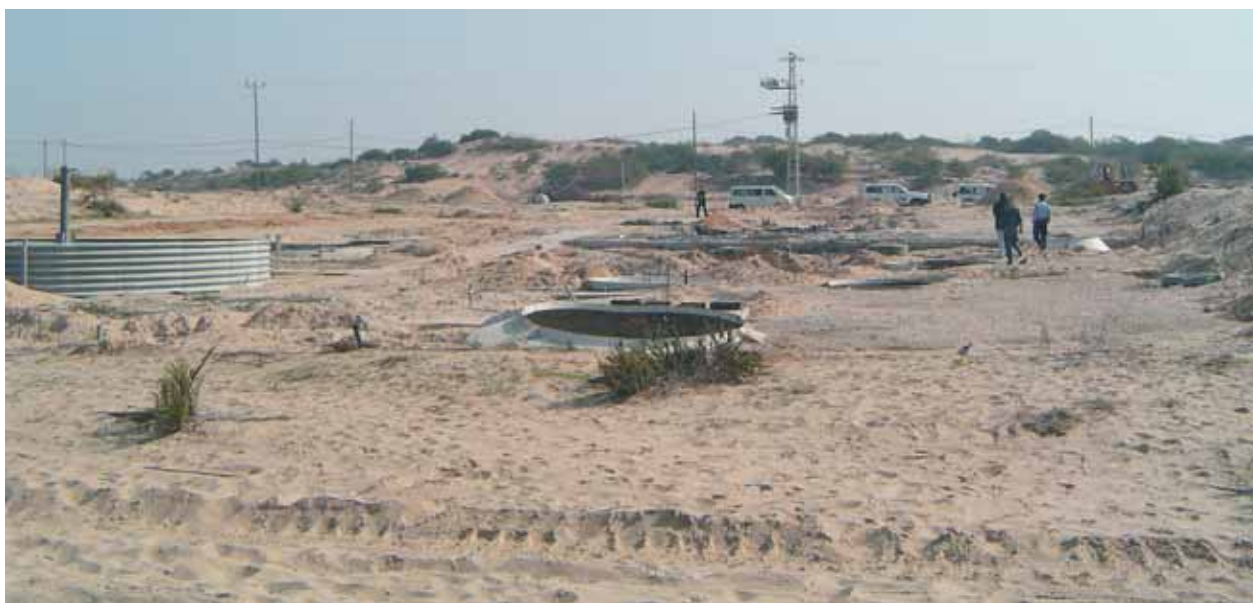
*The derelict sewage treatment plant in Nieve Dkalim*

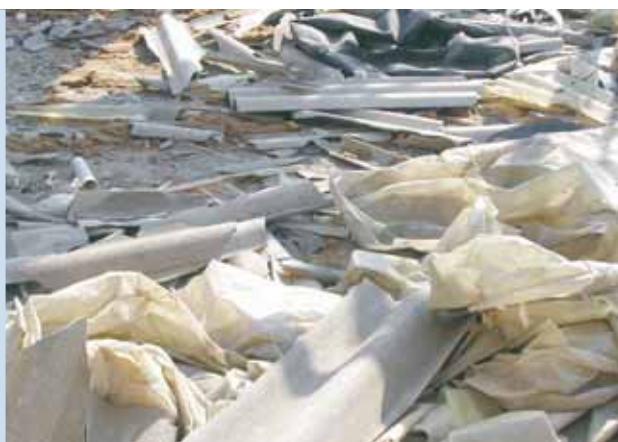
**Sample number:** 10/asb/001  
**Date sampled:** 14/12/05  
**Analysis result:** Chrysotile (white asbestos)  
**Location:** 31 21 09-97 N  
 34 16 59-98 E

**Notes:**  
 Significant amounts of asbestos cement debris were noted in the area. This was probably from the roof and walls of the original buildings.

1. Prior to the disposal and reuse of the demolition waste, asbestos should be identified and sorted out. In particular, additional efforts should be made to identify the source of the asbestos insulation board.
2. Existing buildings should be thoroughly inspected for the presence of asbestos and their condition prior to rehabilitation.
3. Repeat sampling and analyses of the water wells should be carried out after proper cleaning of the pump and purging of the wells, to identify the source of the hydrocarbons observed.
4. A decision should be taken on whether to continue with the waste disposal site. If it is to be continued, then an operational plan should be developed.
5. During the resettlement phase, consideration should be given to possible land uses for the waste disposal area.

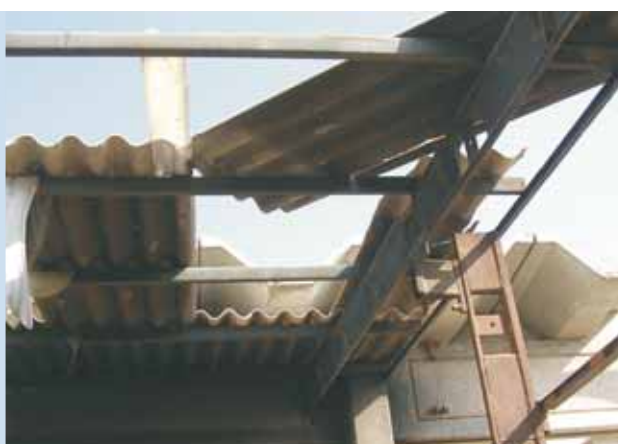
**Sample number:** /  
**Date sampled:** 14/12/05  
**Analysis result:** Assumed Chrysotile (white asbestos)  
**Location:** 31 21 09-97 N  
 34 16 59-98 E

**Notes:**  
 Asbestos cement sheeting was noted in a poor state of repair still forming the roof of some of the buildings.

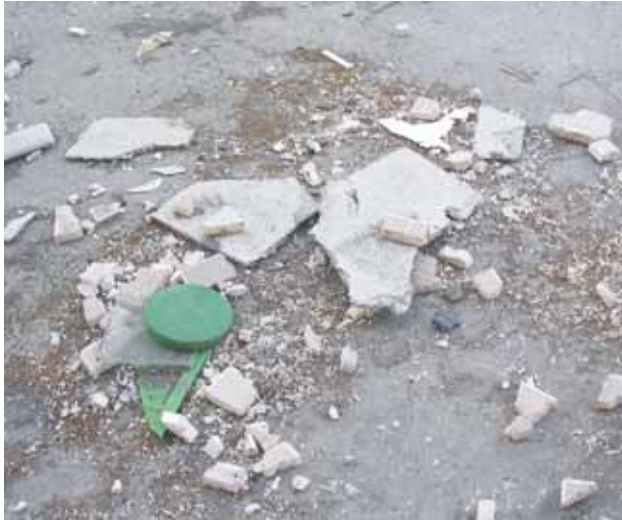
**Sample number:** 10/asb/002  
**Date sampled:** 14/12/05  
**Analysis result:** Amosite  
(brown asbestos)  
**Location:** 31 21 10-06 N  
34 17 01-40 E

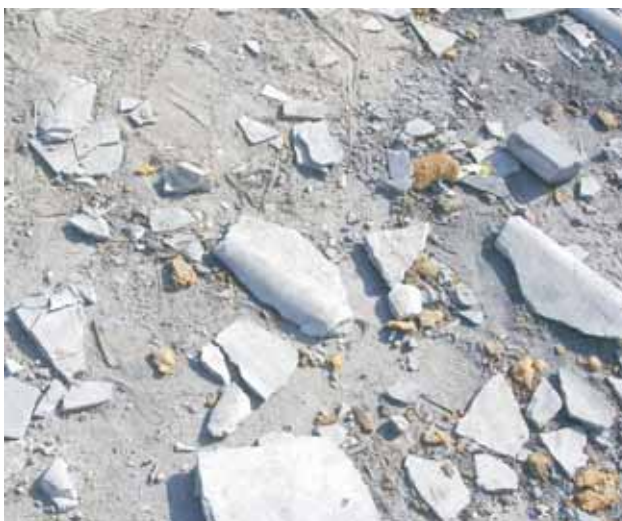
**Sample number:** /  
**Date sampled:** 13412/05  
**Analysis result:** Assumed Chrysotile  
(white asbestos)  
**Location:** 31 21 10-15 N  
34 17 01-46 E

**Notes:**  
Asbestos cement debris was noted in the former waste disposal area.

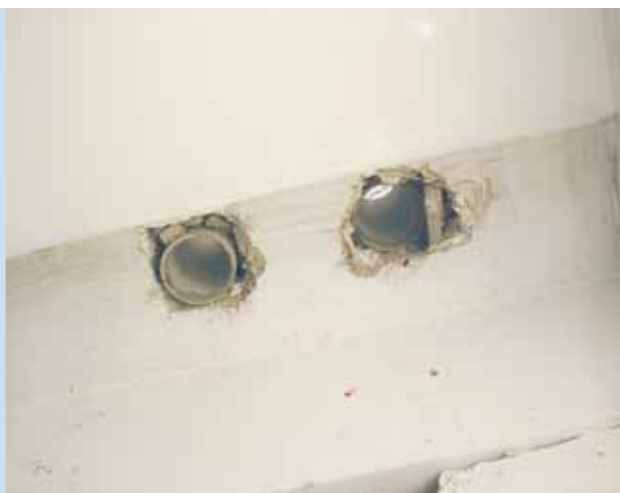
**Sample number:** /  
**Date sampled:** 14/12/05  
**Analysis result:** Assumed Chrysotile  
(white asbestos)  
**Location:** Nieve Dkalim  
university building

Asbestos cement pipes had been used to carry cables from the ground floor to the first floor.

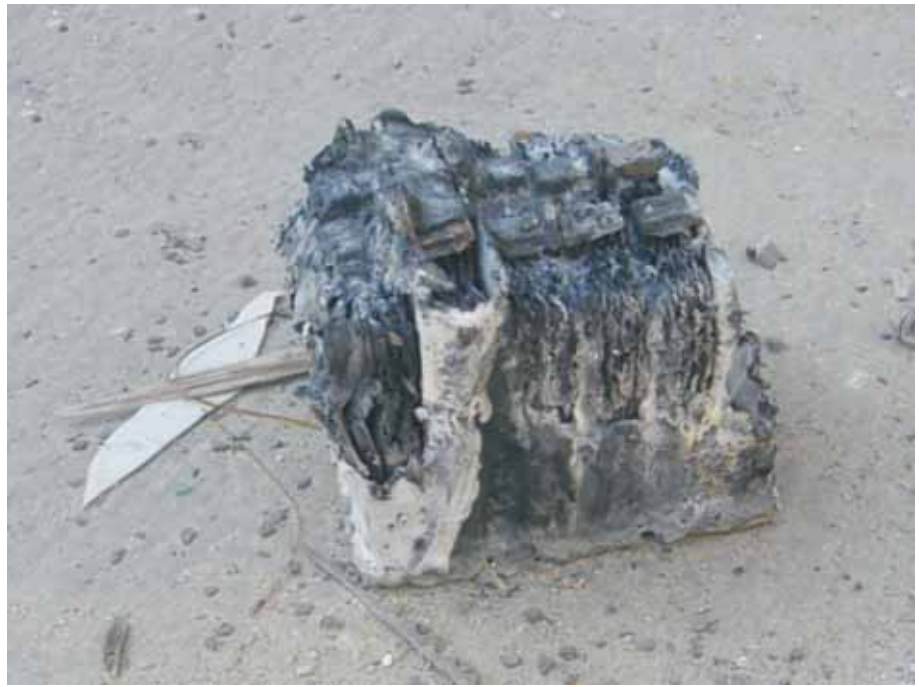
*The remains of a burned lead-acid battery at Nieve Dkalim*
