# Environmental Assessment of the Areas Disengaged by Israel in the Gaza Strip

United Nations Environment Programme

*First published in February 2006 by the United Nations Environment Programme.  
© 2006, United Nations Environment Programme.*

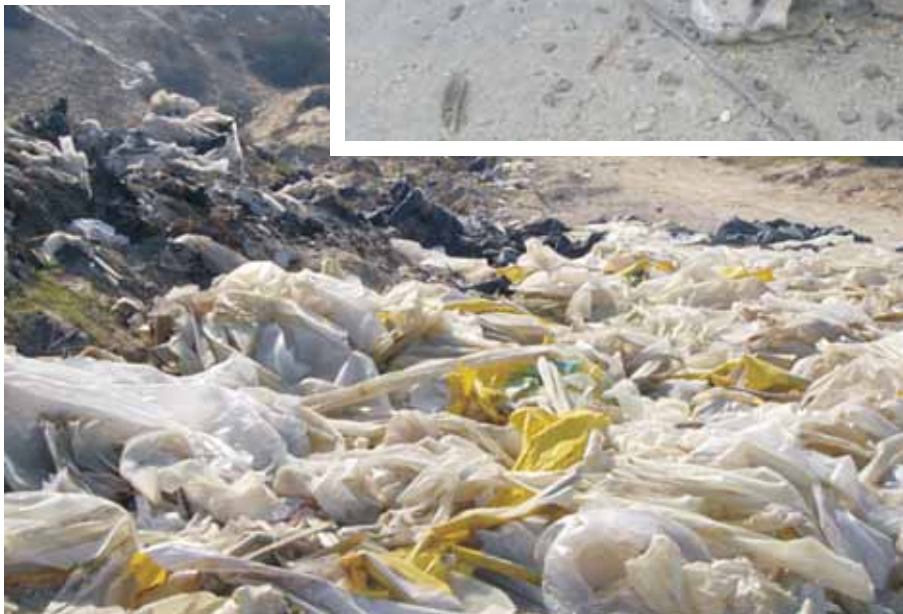
*Part of Nieve Dkalim's waste disposal site showing plastic material*

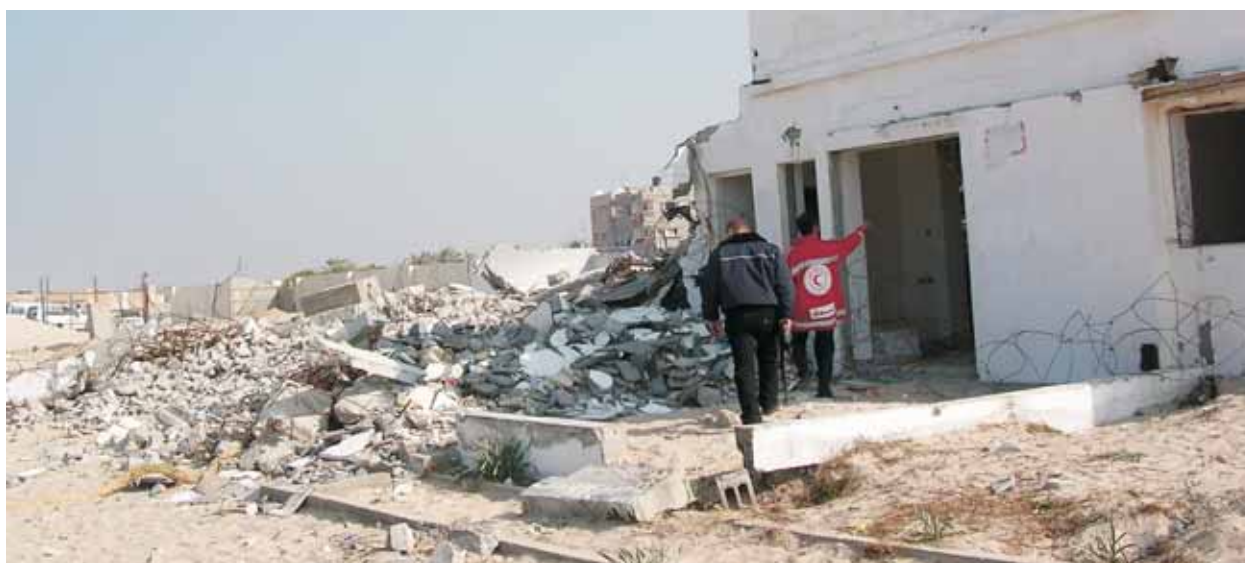
A building on the beach in Kfar Yam had been partly demolished

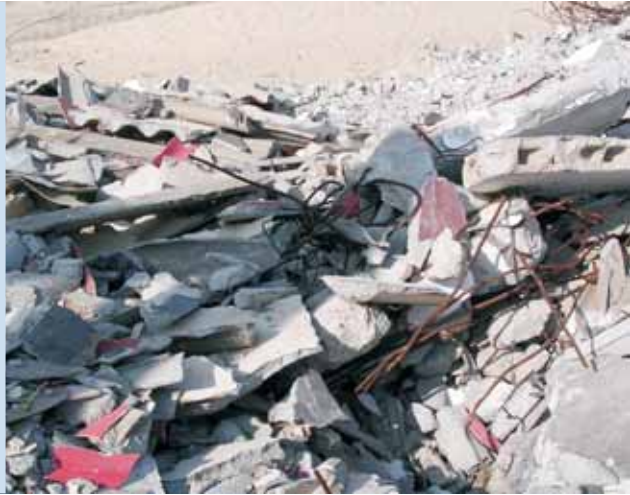
**Sample number:** 11/asb/001  
**Date sampled:** 15/12/05  
**Analysis result:** Chrysotile  
(white asbestos)  
**Location:** 34 70 03-46 N  
62 03 08-20 E

**Notes:**  
Asbestos cement debris was found to be mixed  
in the general building rubble.

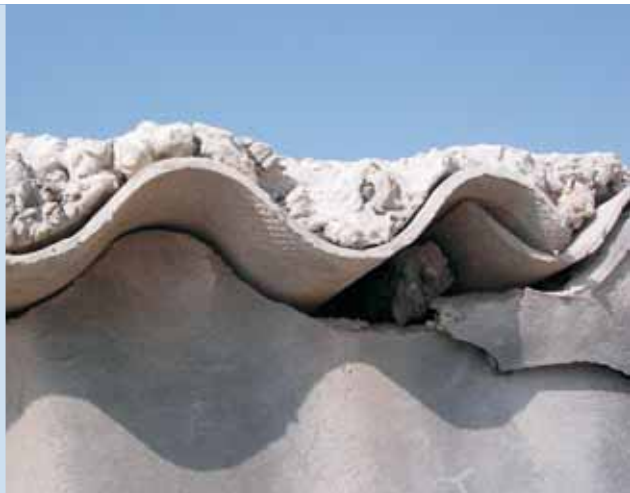
**Sample number:** /  
**Date sampled:** 15/12/05  
**Analysis result:** Assumed Chrysotile  
(white asbestos)  
**Location:** Kfar Yam beach

**Notes:**  
One part of the building had an asbestos cement  
roof still in situ. This had been used as shuttering  
for concrete.

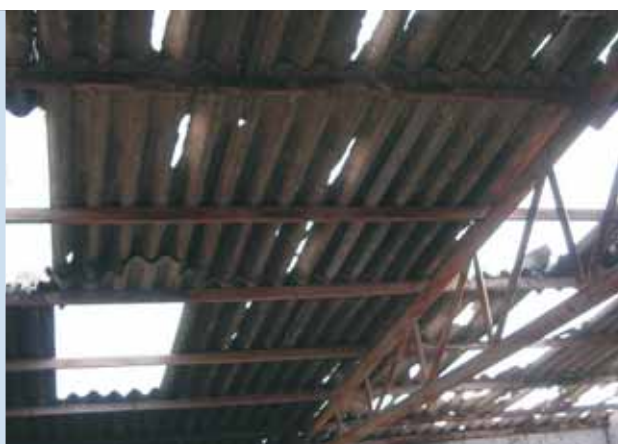
**Sample number:** /  
**Date sampled:** 15/12/05  
**Analysis result:** Assumed Chrysotile (white asbestos)  
**Location:** GPS not available  
**Notes:** Asbestos cement sheeting outside and to the rear of the building.

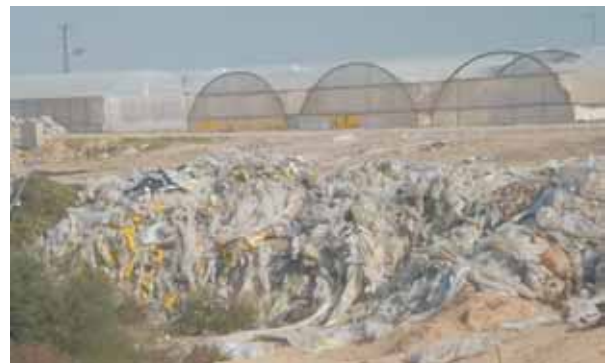
*A section of Ganei Tal's greenhouses showing plastic waste in the foreground*

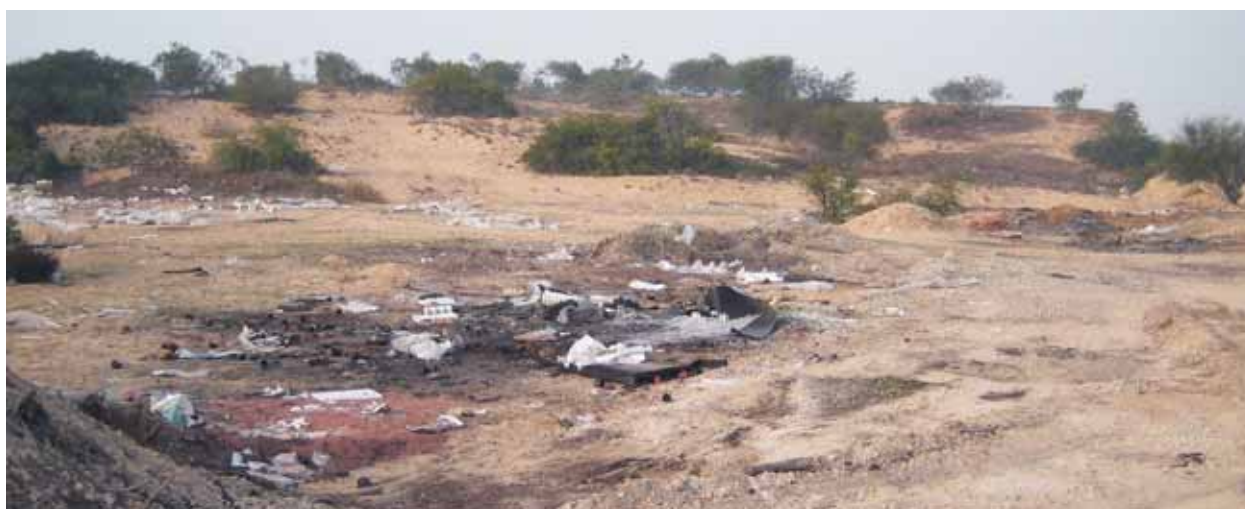
Location of soil sample collection at Katif

The sample was recovered from an area of the site characterized by a distinctive black staining, produced as the result of burning and forming a hard crust to the surface. Excavations indicated that this extended no more than 0.2m and was accompanied by a slight hydrocarbon odour, for which a VOC reading of 20ppm was recorded (against a background of 13ppm). The total area of impact was no larger than 25m<sup>2</sup>.

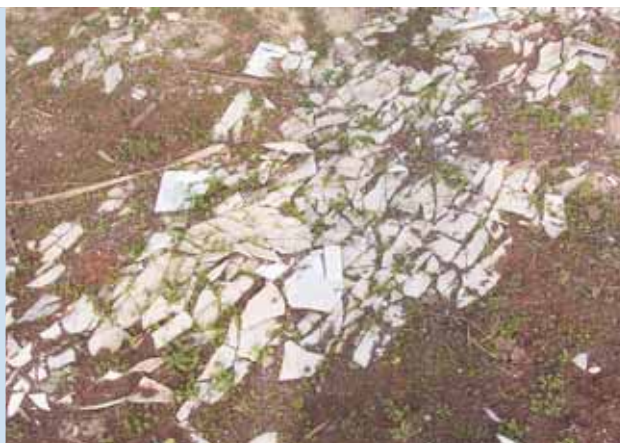
**Sample number:** /  
**Date sampled:** 12/12/05  
**Analysis result:** Assumed Chrysotile  
(white asbestos)  
**Location:** GPS not available  
**Notes:**  
A former garage that had been subject to fire damage was noted on the site. The roof appeared to have been constructed of asbestos cement.

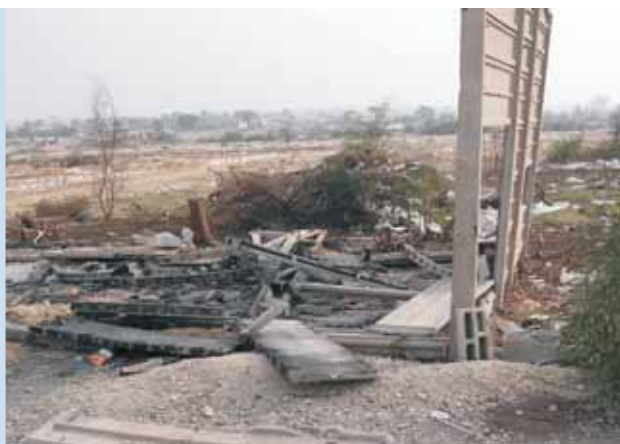
**Sample number:** /  
**Date sampled:** 12/12/05  
**Analysis result:** Assumed Chrysotile  
(white asbestos)  
**Location:** GPS not available  
**Notes:**  
The asbestos cement debris was widespread in this area. It was also possible to identify other areas of asbestos cement debris in this location.

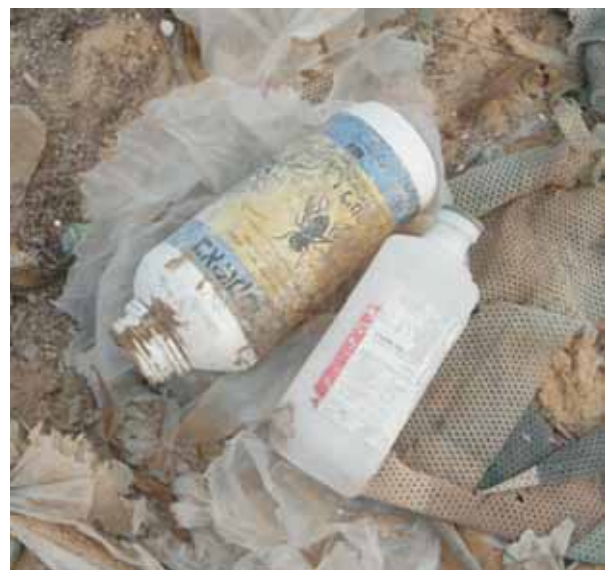
*Containers, such as those shown here, were found around the Katif site*

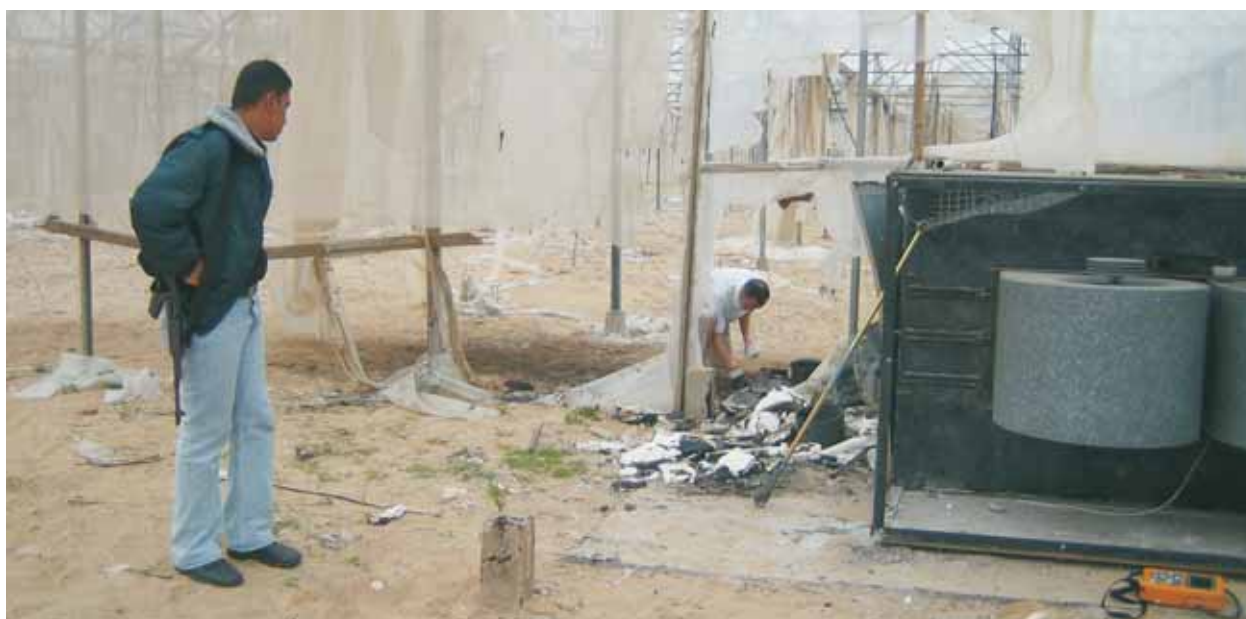
The site is located to the east of the residential centre in an area of aqua-culture tanks. Oil is visible covering an area of 5m<sup>2</sup> and appears to have been spilled from a greenhouse heating unit. The viscosity of the oil is high, limiting the extent of the spill, with a PID reading of 65ppm (against a background of 16ppm). The high viscosity and the low PID reading suggest a heavy oil, probably heating oil.

*A greenhouse heating unit with localized oil spill in the background*

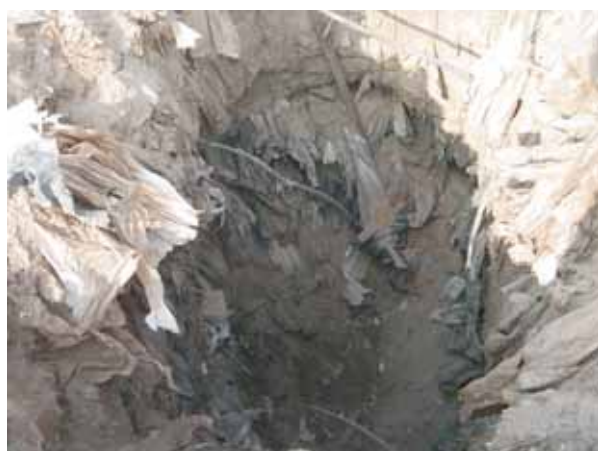
*High volumes of plastic and organic material in an excavation pit*

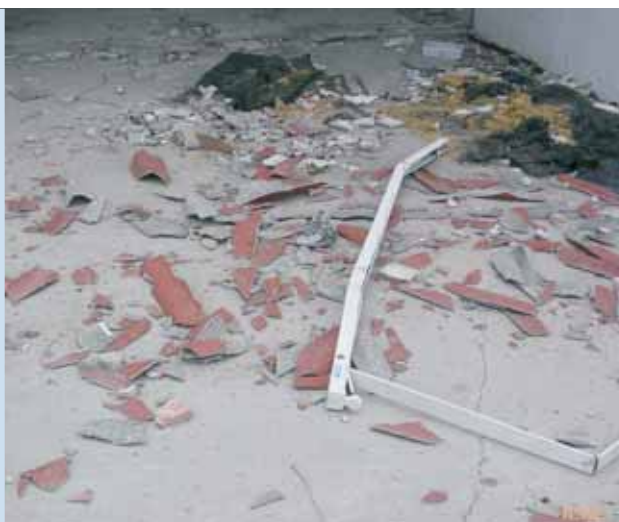
Inside the synagogue building where significant amounts of asbestos cement debris. The former roof of the synagogue appeared to have been constructed of asbestos cement sheets.

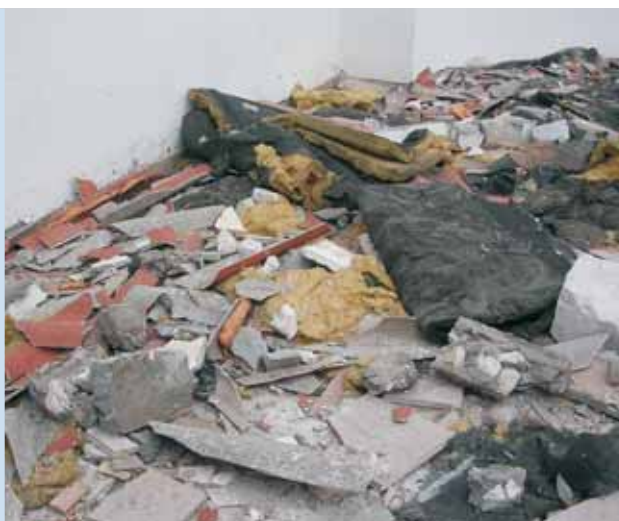
**Sample number:** /  
**Date sampled:** 12/12/05  
**Analysis result:** Chrysotile  
(white asbestos)  
**Location:** GPS not available

Inside the building the asbestos cement debris can be found mixed in with the general building rubble.

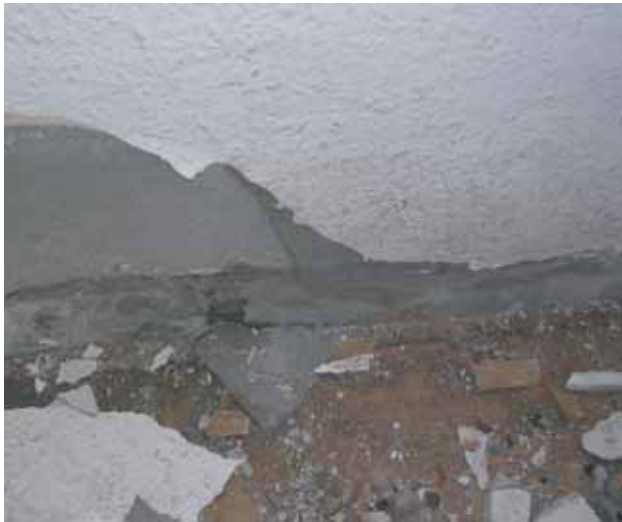
**Sample number:** 15/asb/002  
**Date sampled:** 12/12/05  
**Analysis result:** Asbestos not detected  
**Location:** GPS not available  
**Notes:** A sample of the textured coating paint from the inside of the synagogue was taken for analysis. Asbestos was not detected in the sample.

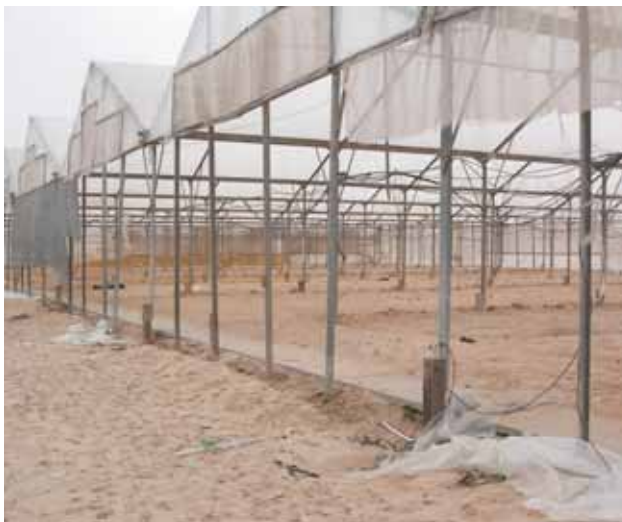
**Sample number:** /  
**Date sampled:** 12/12/05  
**Analysis result:** /  
**Location:** GPS not available  
**Notes:** Asbestos cement debris was noted in the greenhouse area.

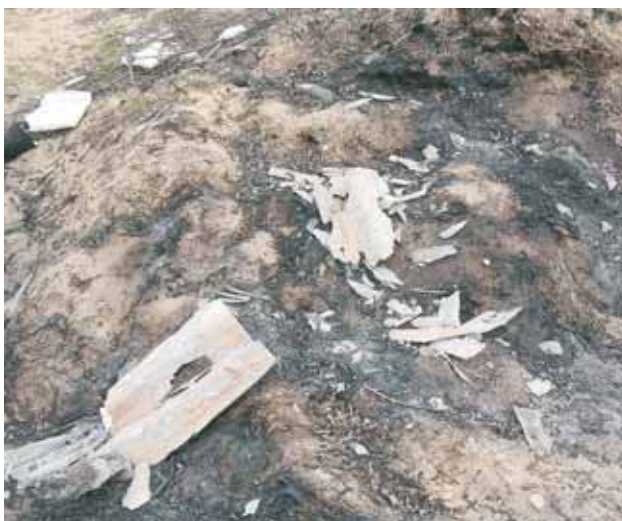
**Sample number:** 15/asb/003  
**Date sampled:** 12/12/05  
**Analysis result:** Chrysotile (white asbestos)  
**Location:** GPS not available  
**Notes:** An area of asbestos cement debris adjacent to the greenhouse area had been subject to damage by fire.

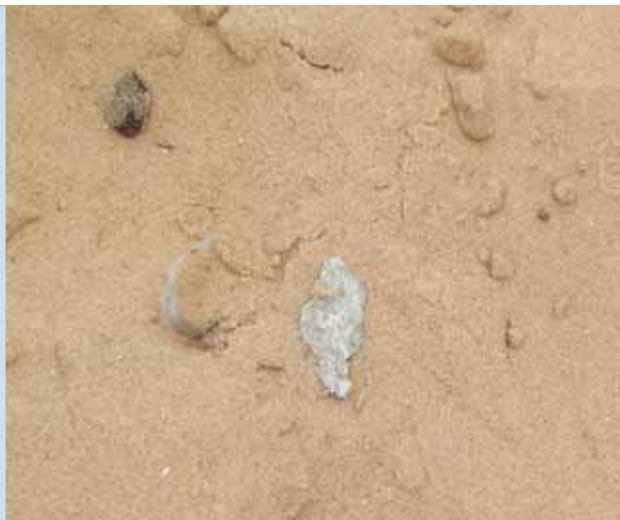
It was possible to observe asbestos cement debris approximately 5 meters down wind of the area of the above fire. A sample of the sand was taken in the area and was found not to contain asbestos.

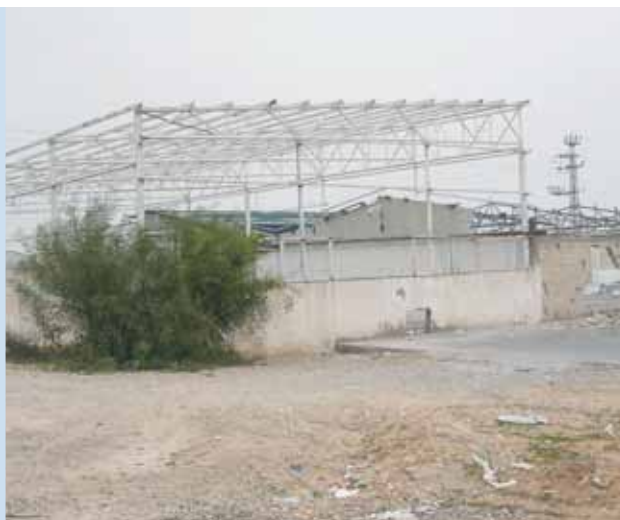
**Sample number:** /  
**Date sampled:** 12/12/05  
**Analysis result:** /  
**Location:** GPS not available

The roof and walls of the former industrial buildings appeared to have been constructed of asbestos cement. The bulk of the asbestos cement appeared to have been removed from site.

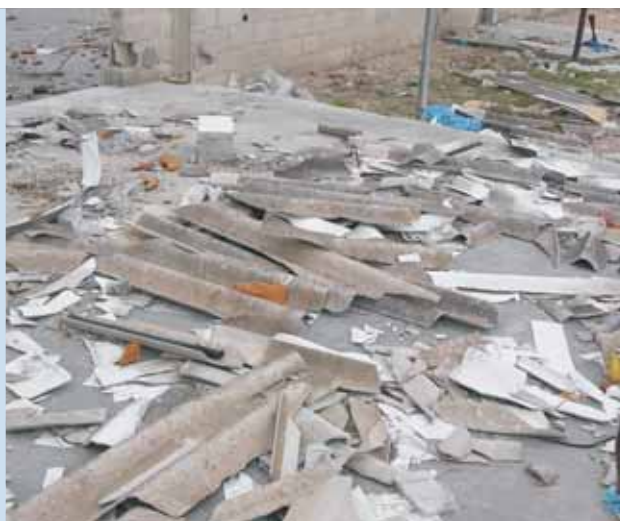
**Sample number:** 15/asb/005  
**Date sampled:** 12/12/05  
**Analysis result:** Chrysotile  
(white asbestos)  
**Location:** GPS not available

Significant amounts of asbestos cement debris where noted in the above industrial area.

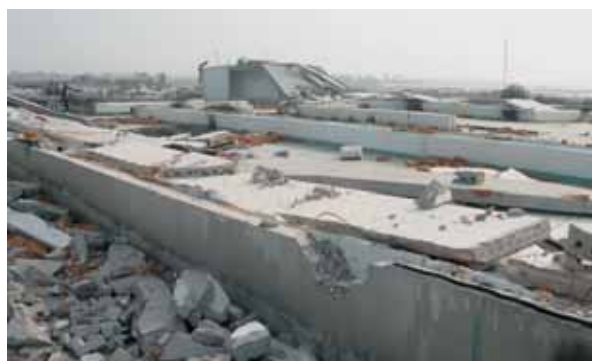
*The primary problem in Kfar Darom is rubble removal*

- 1 Prior to the handling of the demolition debris final inspection should be undertaken to verify if asbestos debris is present.
- 2 Soil should be evacuated from Location A and moved to a central location for storage and treatment.

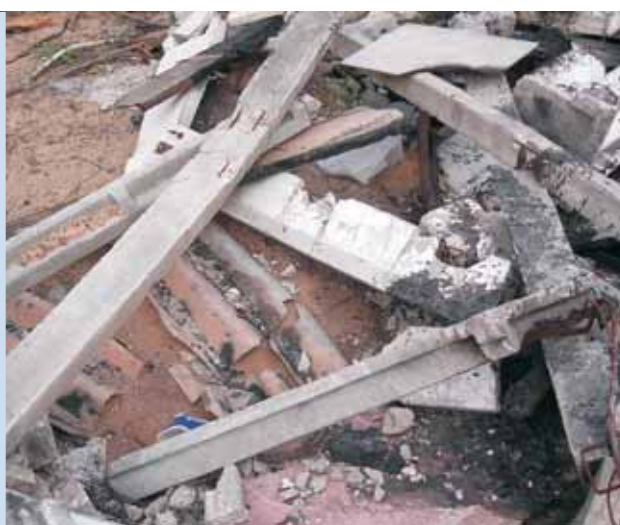
**Sample number:** 18/asb/001  
**Date sampled:** 15/12/05  
**Analysis result:** Chrysotile  
 (white asbestos)  
**Location:** GPS not available  
**Notes:**  
 Asbestos cement debris was noted in several locations around the greenhouse area.

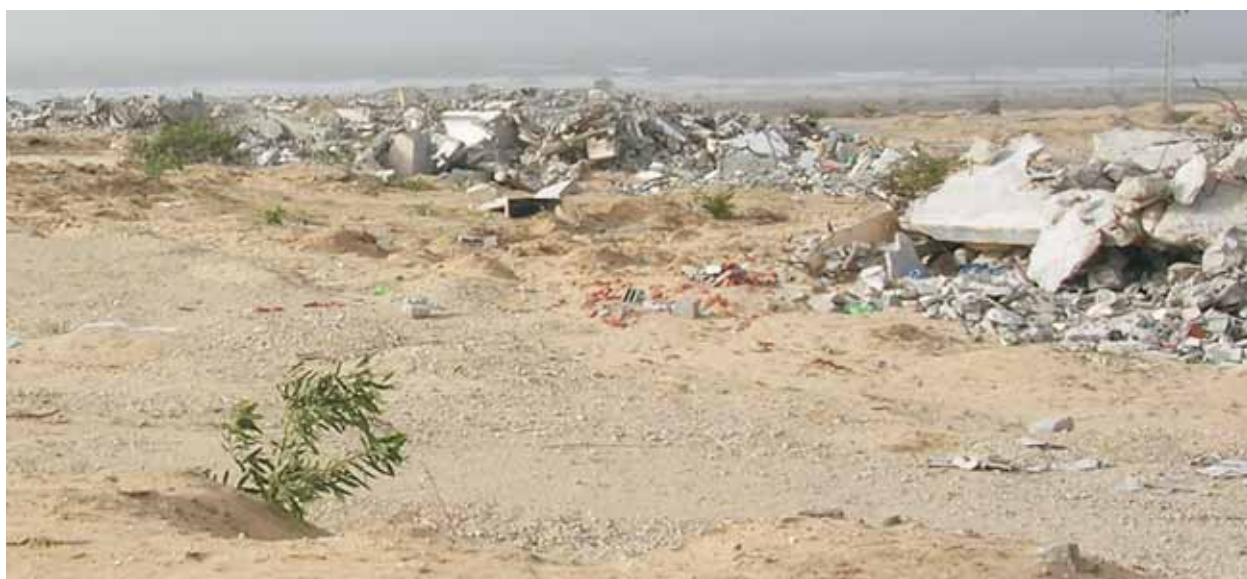
*Rubble removal is the primary problem in Dugit*

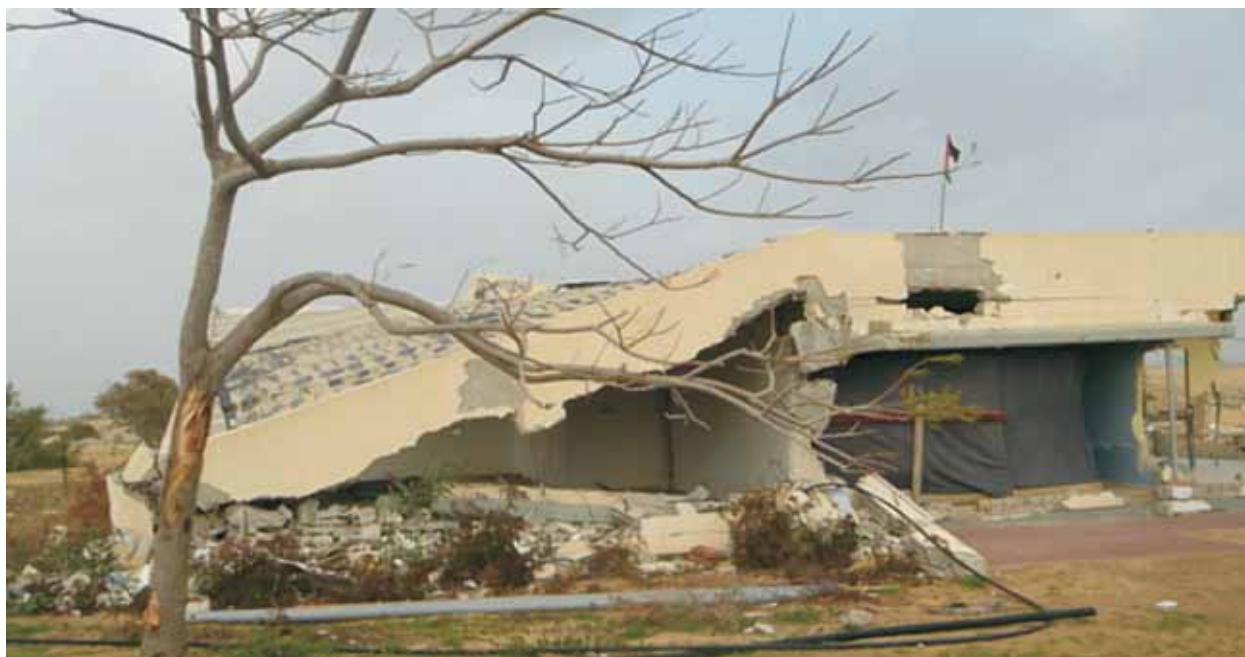
*As with the other small settlements, the main issue was rubble*

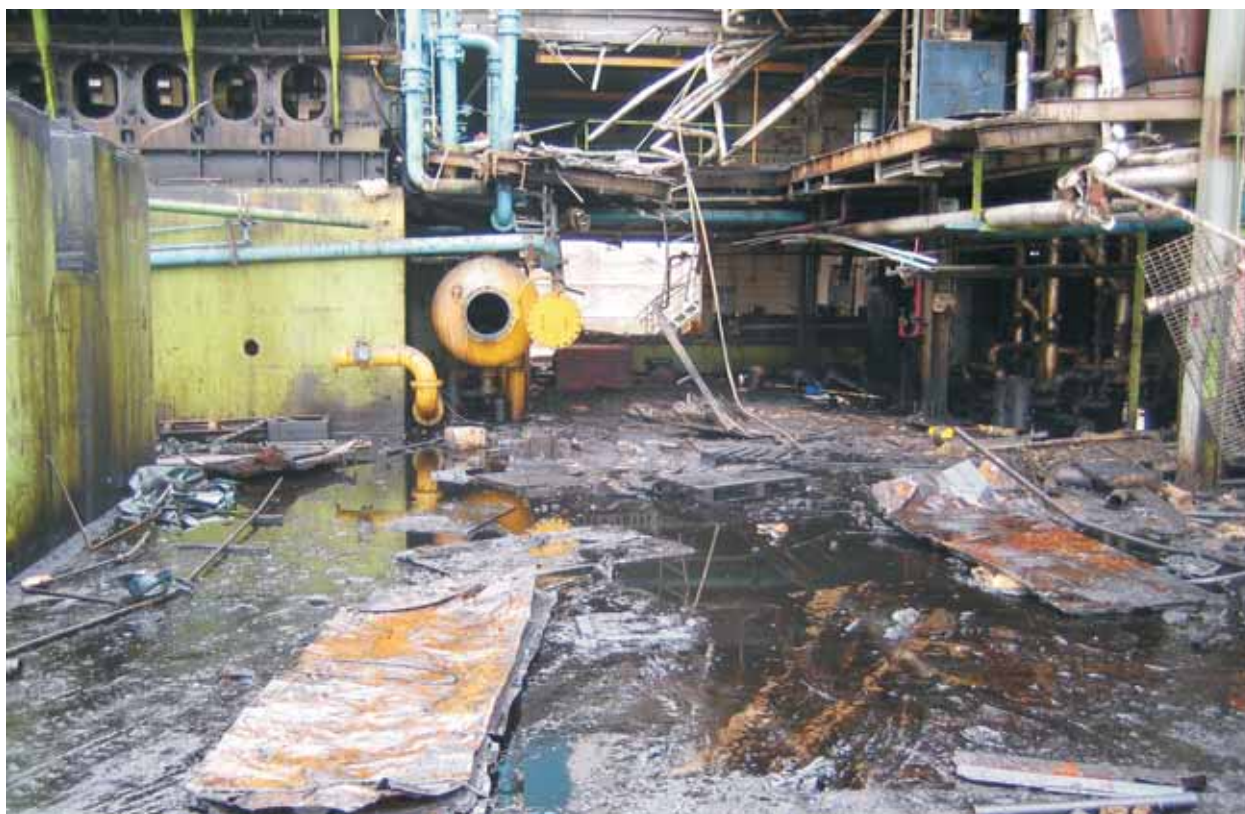
*Spilled oils on location in Erez Industrial Estate*

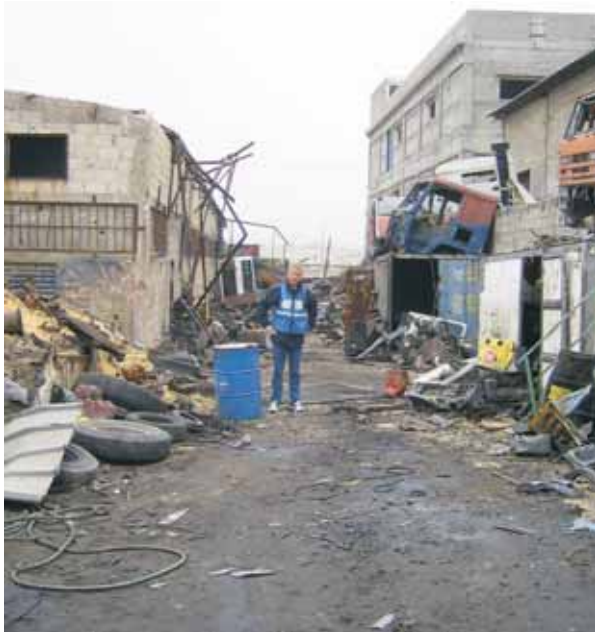
*A compound, on location in Erez, used for breaking down motor vehicles*

This was a small to medium-sized compound of an approximate area of 3,000m<sup>2</sup> used for the breaking of motor vehicles with resulting piles of various engine and body parts. A building covers about half of the compound and it was not possible to view inside. There was no impermeable cover to the ground surface and mobile contaminants could migrate directly into the subsurface. The surface was clearly stained with oils and lubricants.

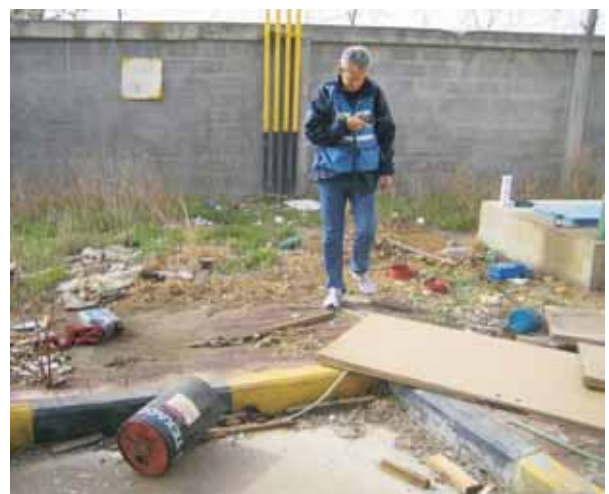
A petrol station located on the southeastern corner of the estate. This was a large facility and clearly served a number of vehicle types with three conventional car pump islands and two large vehicle pump islands. The former were served by five underground storage tanks (coloured green, grey, red, white and blue) themselves filled through offset pipes. The larger vehicle pumps were serviced from three tanks located to the south of the service area, where hydrocarbon staining and odours were identified covering a small area of about 10m<sup>2</sup> but extending to 0.5m. PID readings of 300ppm were recorded from 0.1m and 190ppm from 0.5m (background readings of 14ppm for both depths).

Hydrocarbon staining was also noted over an area of the forecourt close to the five tanks. However, this appeared to be only surface staining and contained by the concrete, which was of high integrity.

There was no indication of any petrol interceptor unit and there was no Arco drainage within the entrance/exit ramps. It is possible that the surface water run-off from the petrol station entered into drainage servicing the whole estate and that a series of interceptors or possibly even a primary treatment unit exists elsewhere in the estate.

*A petrol station located on the southeastern corner of Erez*

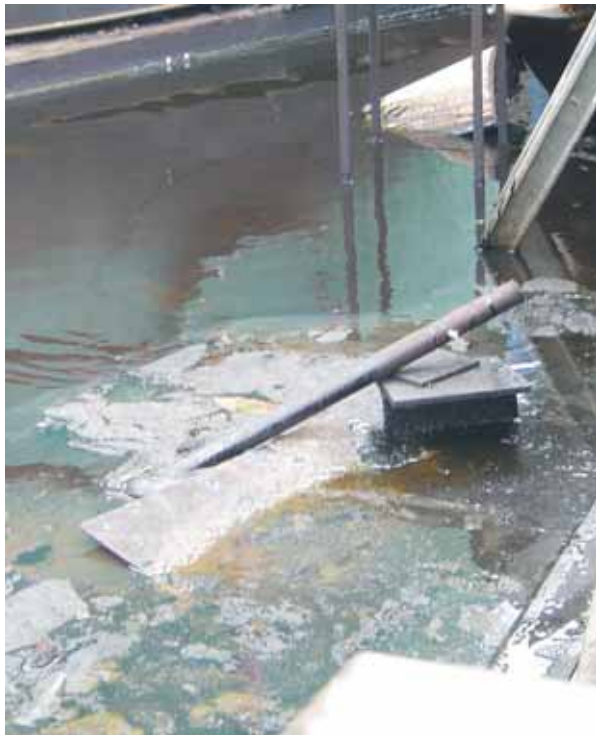
*Spilled oil inside cemented isolation structure*

Two diesel storage tanks were seen inside the industrial area and leakage was noted inside the cemented isolation structure. A water sample was collected from the cemented tank.

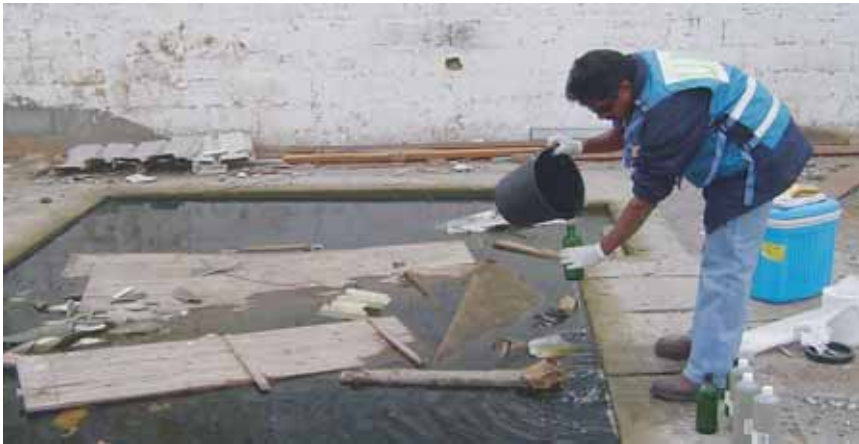
This was an unknown factory inside which were two subsurface storage tanks, full of stagnant water. These storage tanks are 7m long, 4m wide and 1m deep and they appear to be of good integrity (i.e. not leaking). The water sample was taken from the polluted water based on visual analysis.

*Taking a water sample from an industrial unit in Erez*

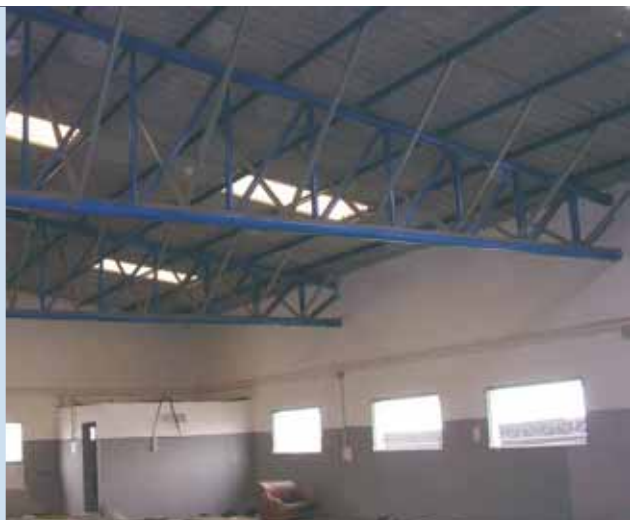
**Sample number:** Erez/asb/001  
**Date sampled:** 16/12/05  
**Analysis result:** Chrysotile (white asbestos)  
**Location:** 31 33 23-37 N  
 34 32 13-48 E  
**Notes:**  
 In a number of locations the asbestos sheets had been dropped on to the floor of the buildings.

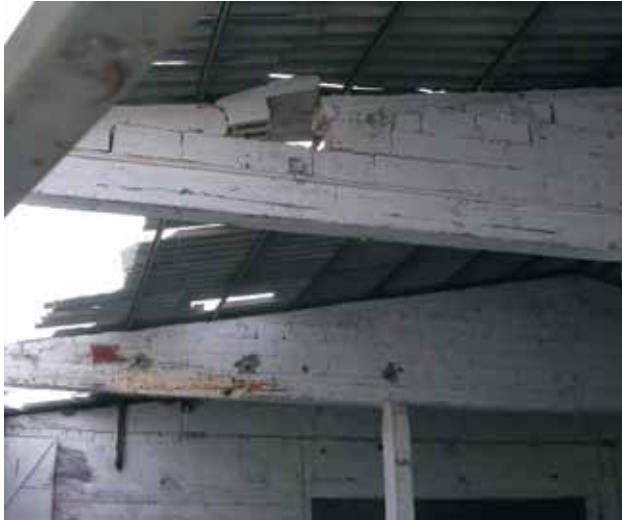
**Sample number:** /  
**Date sampled:** 16/12/05  
**Analysis result:** Assumed Chrysotile (white asbestos)  
**Location:** GPS not available  
**Notes:** Damaged asbestos cement sheets were still fixed to some of the buildings.

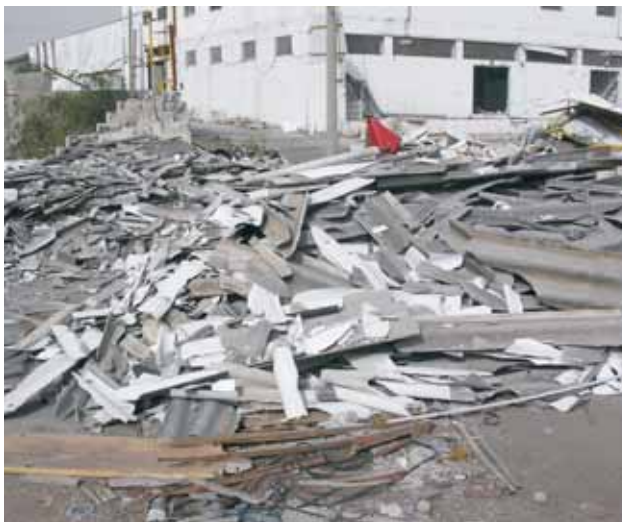
**Sample number:** /  
**Date sampled:** 16/12/05  
**Analysis result:** Assumed Chrysotile (white asbestos)  
**Location:** GPS not available  
**Notes:** Large stockpiles of asbestos cement were noted in one location.

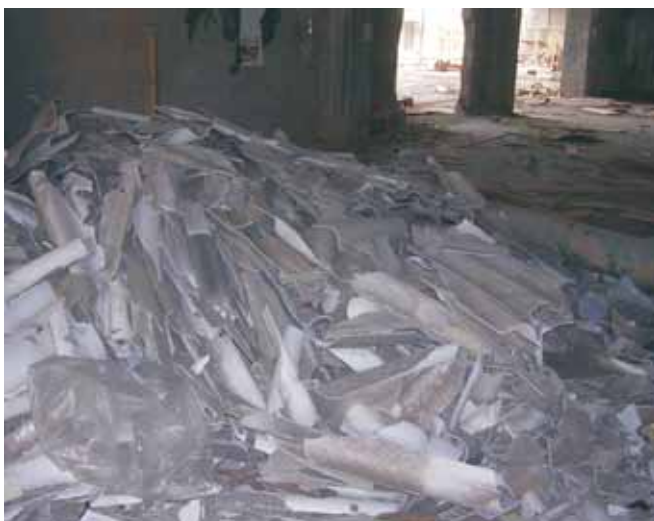
**Sample number:** /  
**Date sampled:** 16/12/05  
**Analysis result:** Assumed Chrysotile (white asbestos)  
**Location:** GPS not available  
**Notes:** A significant amount of asbestos cement had been stored in this industrial unit.

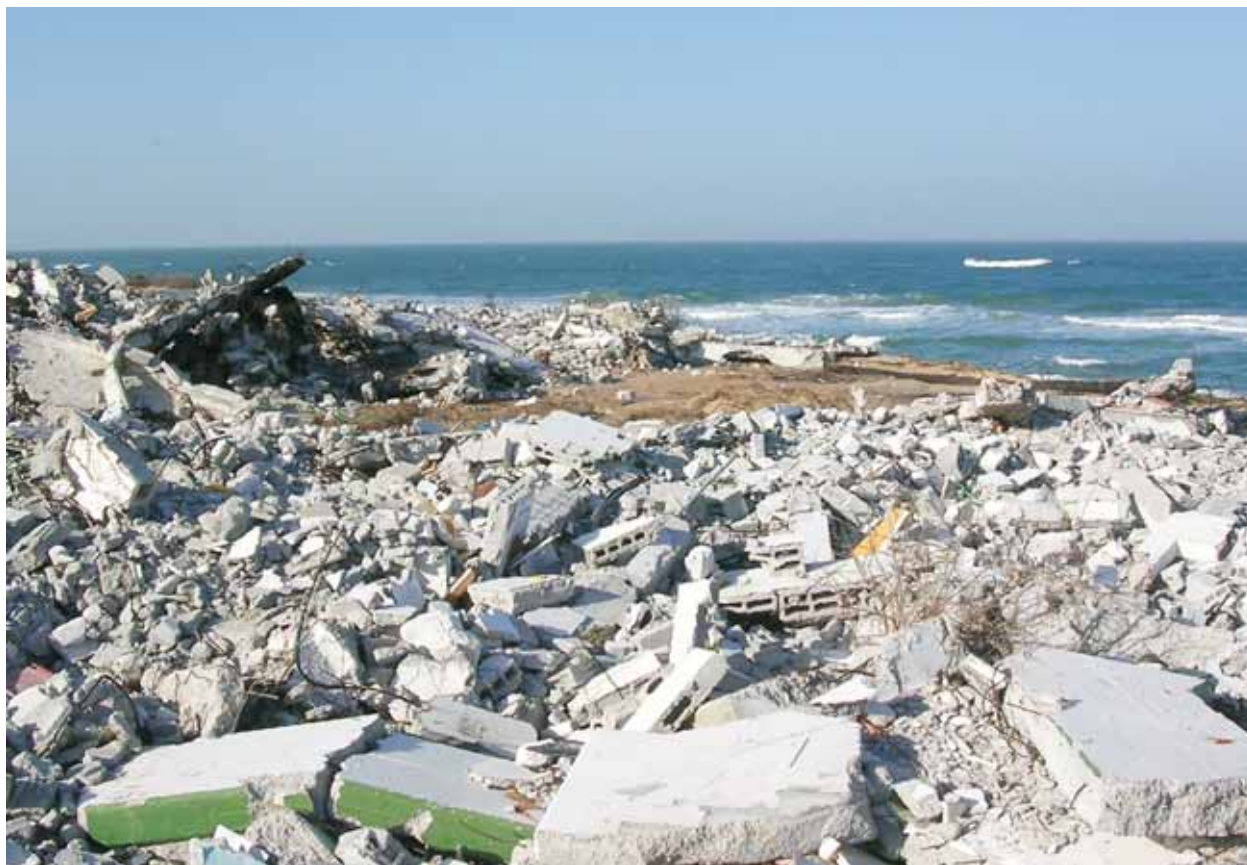
*Rubble at Gaza Beaches site*
