Environmental Baseline Study for the Proposed Expansion of the UNSOA Logistics Base

Mombasa, Kenya, 2010

ENVIRONMENTAL BASELINE STUDY FOR THE PROPOSED EXPANSION OF THE UNSOA LOGISTICS BASE, MOMBASA, KENYA 2010

ENVIRONMENTAL SAMPLING FOR ENVIRONMENTAL BASELINE STUDY (EBS)

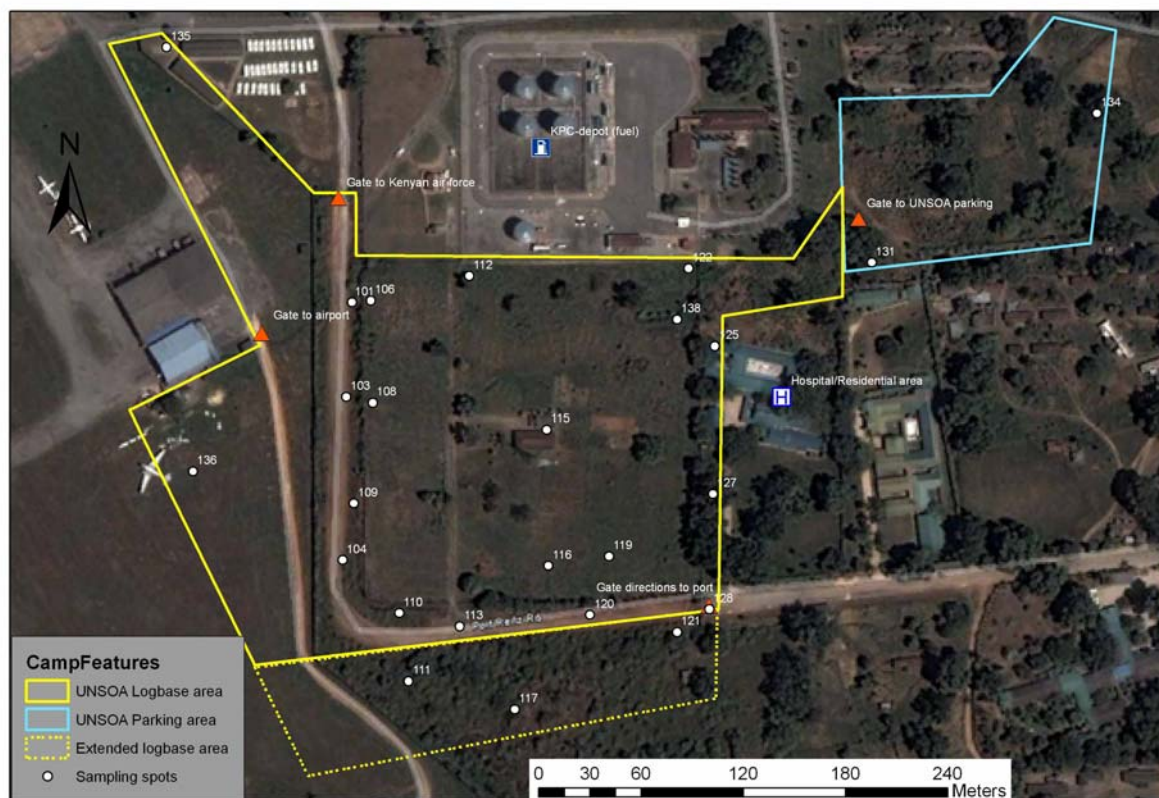
Figure 3. Sampling spots at the new proposed area at the air field.

A total of 28 samples were taken at 25 sites. Samples 119, 116 and 110 were taken at two depths. These locations are according to information received earlier possible sites for future fuel station, garbage collect and soak pit, see Figure 3.

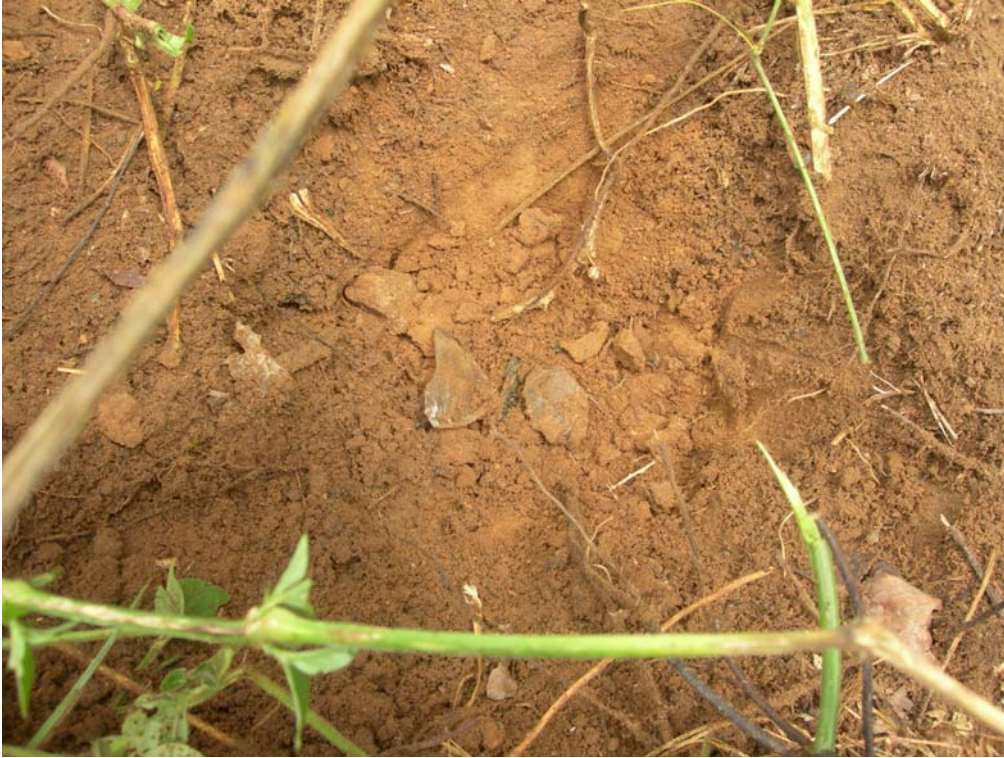
Figure 5. Sampling spot 111 at airport site. Shards of glass and porcelain were found at approximately 10-15 cm.

At two locations signs were found indicating that these have been dump sites: at spot 128, near the eastern gate organic debris like branches, grass etc has been dumped. At spot number 111 shards of porcelain and glass were found approximately 10-15 cm below the surface (Figure 5).

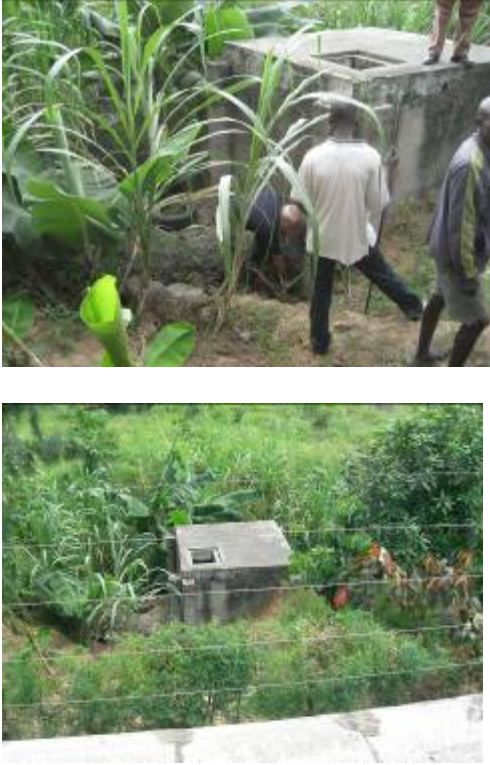
| Spot No | Photo | Comments: 2010-08-25—26, 26-28 degrees C, sunny, partly cloudy, wind speed appr 2-3 m/s (south) |
|---|---|---|
| 1 | | <p>Utside wall, close to guard tower in north western corner</p> <p>Sample at 0-10 cm</p> <p>PID reading: 0,0 (in bag at hotel)</p> |

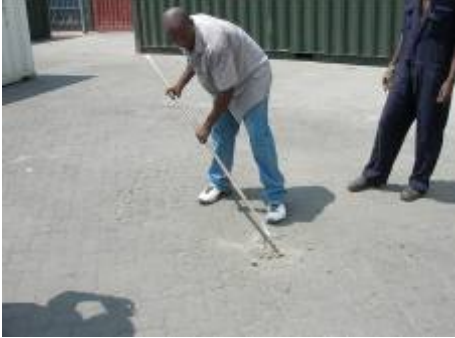
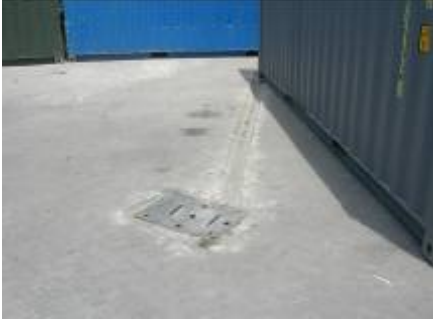
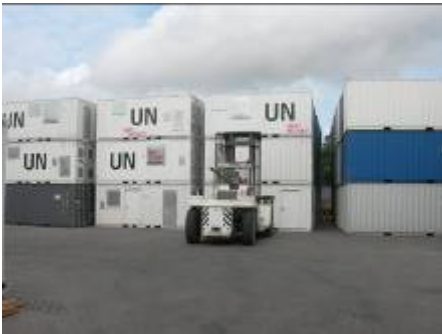
| <p>4 and 4B</p> | | <p>Sampling at two depths</p> <p>4A: At 0-10 cm PID reading (in bag at site): 2,2 ppm</p> <p>PID reading (in pit) at: - 25 cm – 0,4 ppm - 40 cm – 0,0 ppm</p> <p>4B: Sample at 50 cm</p> <p>PID reading (in bag at site): 0,6-1 ppm Original soil (i.e. no filling material)</p> |

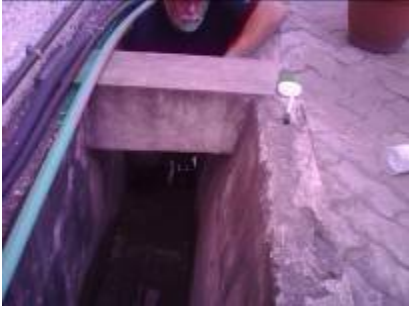
| 5 | | <p>On the western side of wall Wet sediment Drainage from trench on the opposite side of the wall (sample 6)</p> |

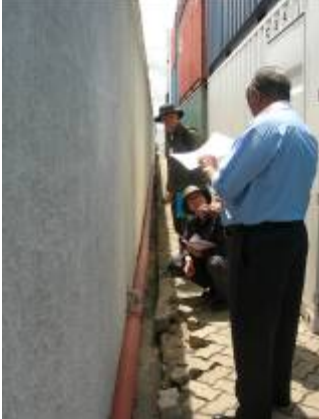
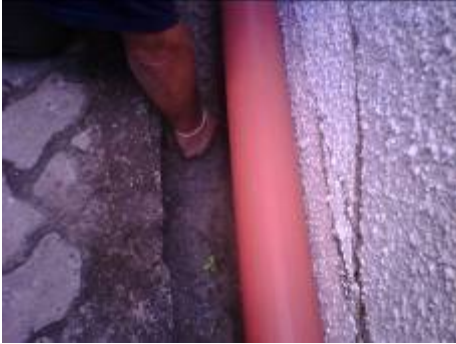
| 6 | | <p>On the eastern side of wall Dry sediment Drainage to trench on the opposite side of the wall (sample 5)</p> |

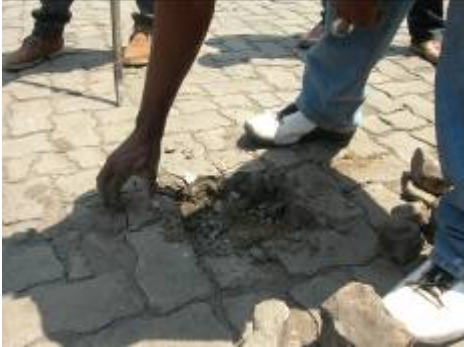
| 7 | | <p>Sample at 0-10 cm Directly under bricks PID reading (in bag on site):. 0,9 ppm PID reading (in pit) at: - 30 cm: 0,0 ppm (maram – filling material)</p> |

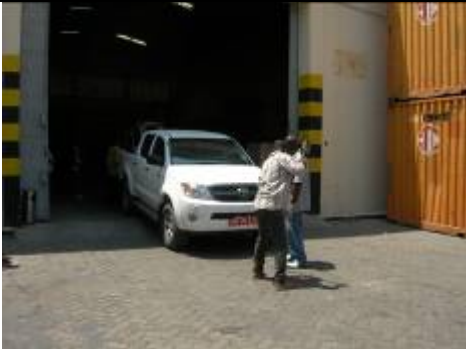
At one location (sampling spot 8B) the soil sample showed levels close to threshold values; however not exceeding them. This sampling spot was just outside the entrance to Warehouse 1 where e.g. electronics, furniture, and detergents are and have been stored. There was a strong odour and visible leakage of detergents inside this building.

| 8 | | <p>At entrance to warehouse 1 (detergents)</p> <p>Sample at two depths</p> <p>8A: Sample at 0-10 cm (directly under bricks)</p> <p>PID reading (in bag on site) 0,4 ppm</p> <p>PID reading (in pit) at : - 20 cm 0,0 ppm</p> <p>8B: Sample at 33 cm Filling material - maram PID reading (on bag on site): - 0,3 ppm</p> |

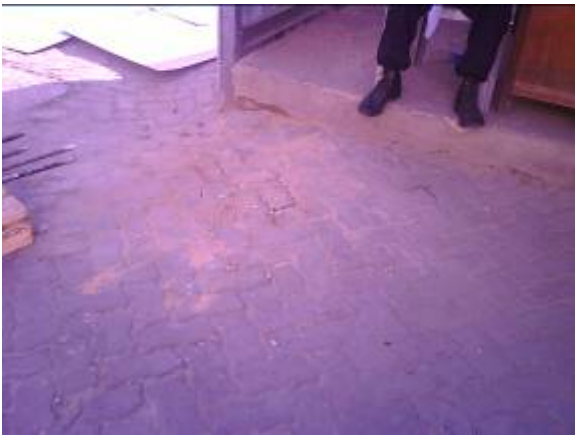
| 9 | | <p>Old fuel station (now guard shed)</p> <p>Sampling at two depths:</p> <p>9A: At 30 cm – filling material PID reading (in bag at hotel): 2,3 ppm</p> <p>9B: At 40 cm Original soil PID reading (in bag at hotel): 2,3 ppm</p> |

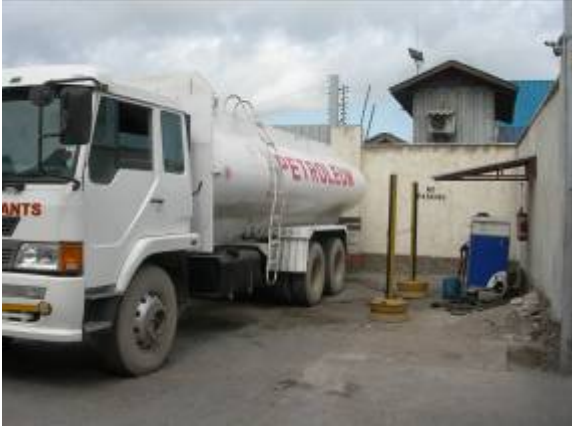
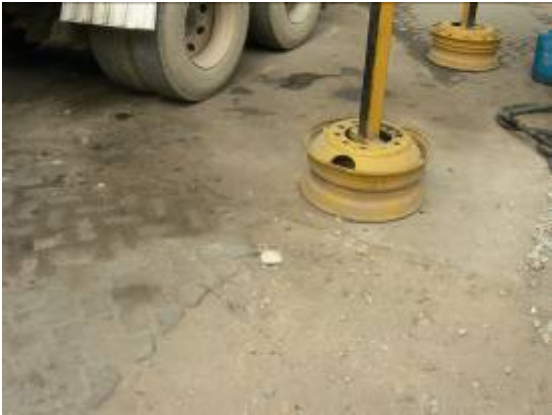
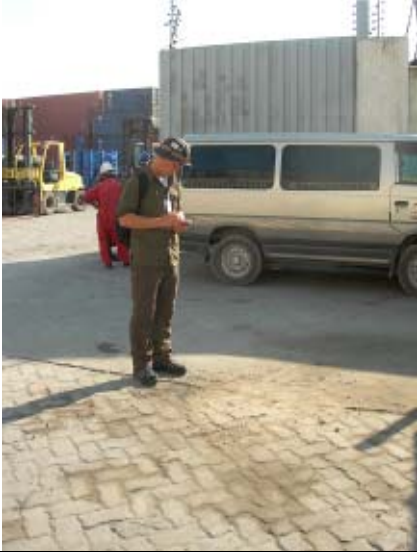
| <p>10</p> | | <p>Current fuel station</p> <p>Sampling at 50 cm Filling material Strong odour of oil</p> <p>PID reading (in bag at hotel): 3,0 ppm</p> |

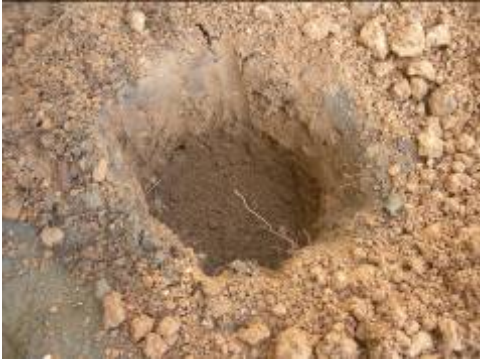
| <p>11</p> | | <p>Car wash area</p> <p>Sampling at three depths</p> <p>Sample taken close to wall och soil surface (no bricks)</p> <p>11A: 0-5 cm PID reading (in bag at hotel) 2,4 ppm</p> |

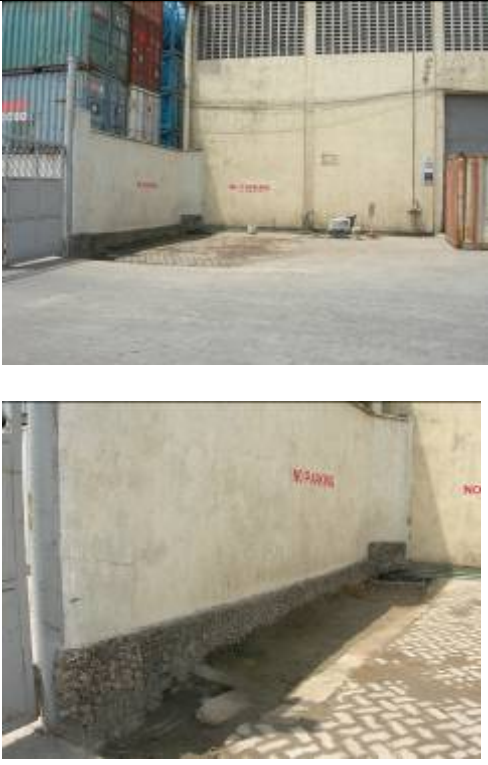
| | | <p>11B: Sampling at 45-50 cm Filling material PID reading (in bag at hotel): 2,3 ppm</p> <p>11C: Sampling at 60 cm Original (?) soil, lack (silt, clay) PID reading (in bag at hotel) 2,1 ppm</p> |

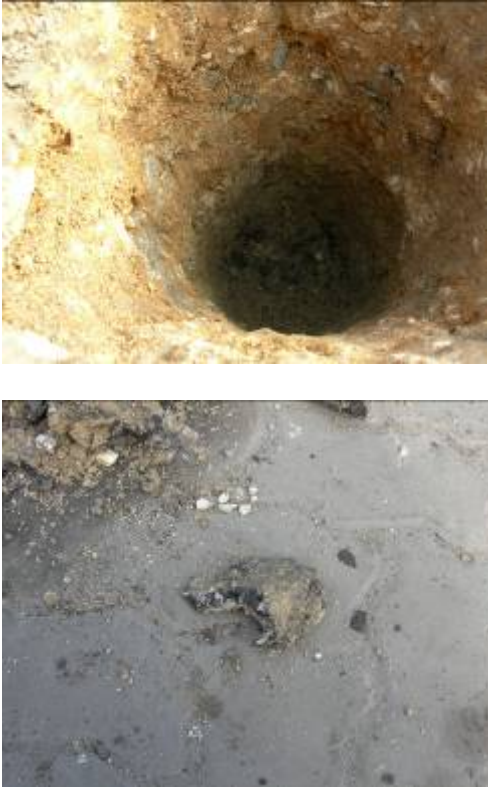
| <p>12</p> | | <p>Old chem. site Sampling at three depths</p> <p>12A: Sampling at 0-30 cm Filling material PID reading (in bag at hotel): 2,3 ppm</p> <p>12B: Sampling at appr. 60 cm Tar or bitumen pieces (impermeable layer?) Smells of asphalt, bitumen, tar PID reading (in bag at hotel): 2,3 ppm</p> <p>12C: Sampling at 70-80 cm Smells of chemicals, rubber PID reading (in bag at hotel): 2,2 ppm</p> |

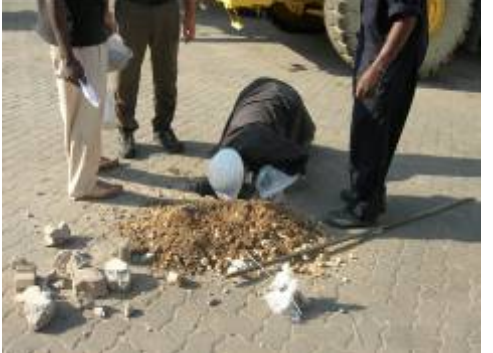
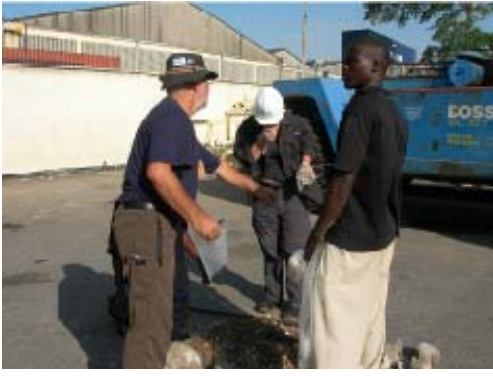
| <p>13</p> | | <p>Sample at three depths:</p> <p>13A: 0-30 cm Smells of clay and POL PID reading (in bag at hotel): 2,1 ppm</p> <p>13B: 60 cm (tar/asphalt/bitumen) Smells of oil/arphalt PID reading (in bag at hotel) 2,0 ppm</p> <p>13C: 70 cm Luktar unket Original (?) soil</p> |

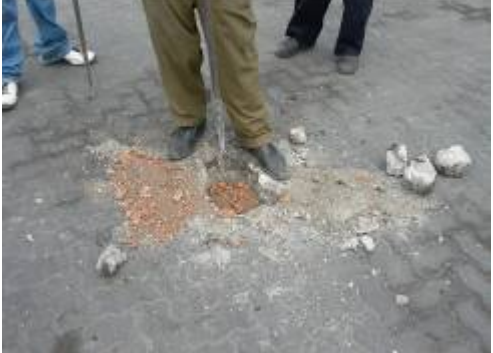
| <p>14</p> | | <p>Sample at 0-10 cm Top soil (directly under bricks) PID reading (in bag on site): 1,5-1,6 ppm</p> <p>PID reading (in pit) at 22 cm: 0,3 ppm</p> |

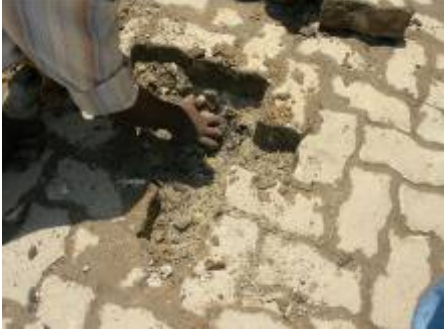
| 17 | | | <p>Outside truck assembly garage (non UN garage)</p> <p>Sampling at two sites</p> <p>17: Top soil, directly under bricks 0-10 cm PID reading (in bag on site): 0,3 ppm</p> <p>PID reading (in pit) at 15-20 cm: 0,0 ppm</p> |

| | | <p>17B: Sampling at 34 cm Sand/filling material PID reading (in bag on site) 0,0 ppm</p> |

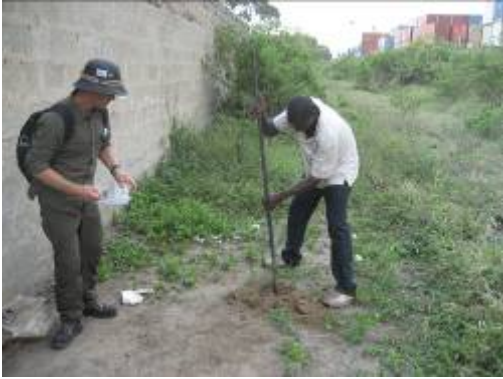
| 18 | A photograph showing two workers in an outdoor setting. One worker, wearing a dark uniform and a cap, stands on the left holding a white bag. The other worker, wearing a white shirt and dark pants, is bent over, using a long-handled tool to dig into the soil. The ground is dirt with some sparse vegetation. In the background, there is a concrete wall and some colorful buildings. | <p>Outside wall, south west of area Appr. 25 m from wall Sample at 10-20 cm PID reading 0,0-0,1 ppm (in bag at hotel)</p> |

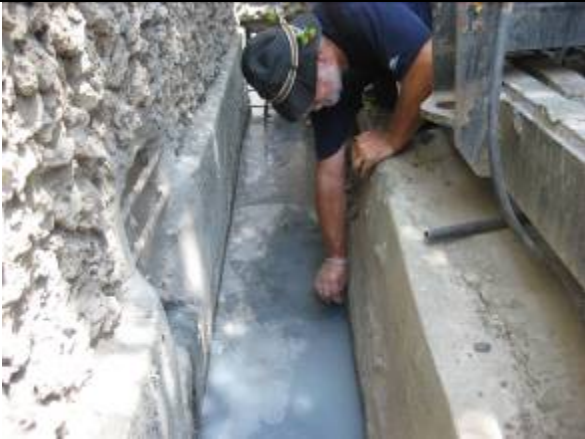
| 19 | A photograph showing a worker in a dark blue shirt and a cap, leaning over a concrete trench. The worker is using a tool to sample soil from the bottom of the trench. The trench is filled with a dark, moist substance, possibly soil or sludge. The background shows a rough, light-colored wall. | |

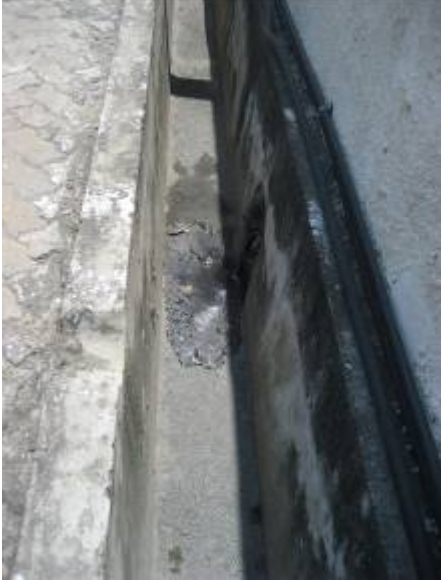
| 22 | | Picture 1. Between sample point 21 and 22, leakage of tar/asphalt to drainage – tätskiktet från kemplattan? |
