**ENVIRONMENTAL AUDIT
OF THE SITES AFFECTED
BY THE DUMPING OF
TOXIC WASTES FROM THE
“PROBO KOALA”**

UN  
environment

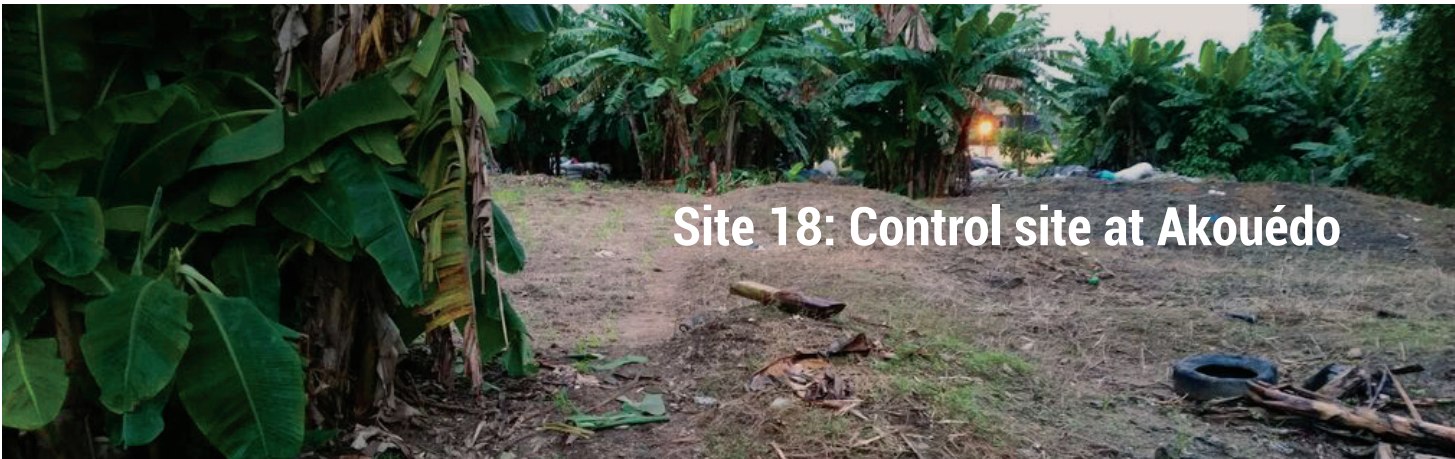
Site 18: Control site at Akouédo

- Site 18 – Control site at Akouédo:** This control site is located within the municipal waste disposal site’s perimeter walls, near the entrance gate and weighbridge, in an area that was not impacted by the Probo Koala toxic wastes dumping of 2006. Situated in a part of the waste disposal site that had not received any significant volume of new waste in recent years, it was selected to serve as a

control site illustrating prevailing conditions in an environment that was significantly contaminated from long-term routine disposal of urban solid wastes as well as industrial wastes. One surface (0-20 cm) soil sample was collected on this site. It was not possible to collect a deeper sample as the ground underfoot was still comprised essentially of undegraded waste materials.

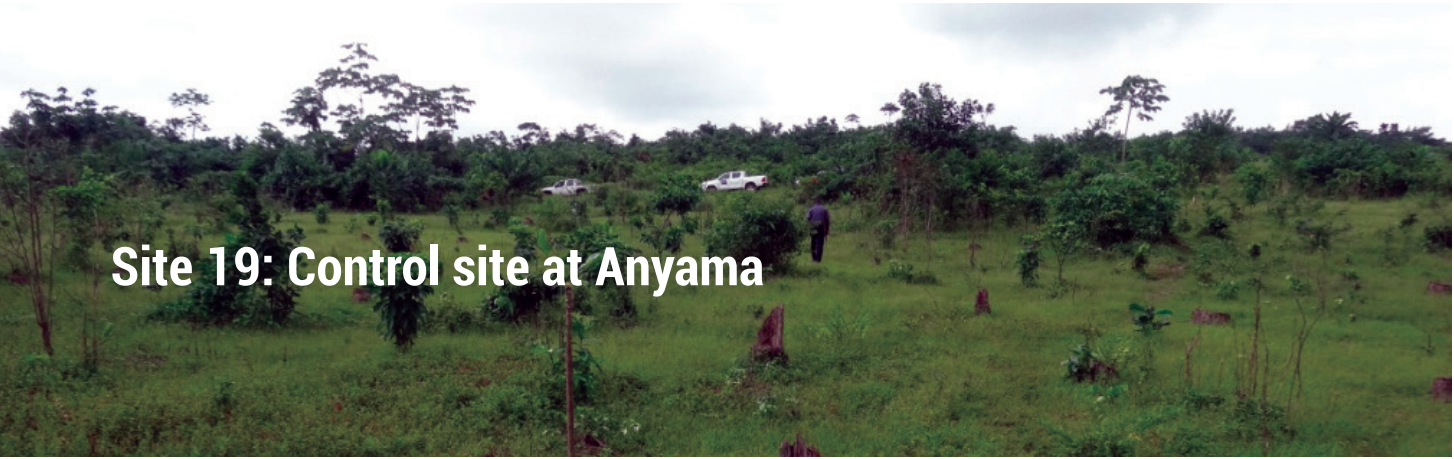
Site 19: Control site at Anyama

- Site 19 – Control site at Anyama:** This control site is located near the town of Anyama, 15 km to the north of Abidjan, in a rural area of grassland, forest and small agricultural plots. It is accessible by vehicle but located some 320 m from the Abobo highway coming from Abidjan. Considered to be completely non-impacted by the Probo Koala wastes, this site was selected to serve as a control

site illustrating the prevailing environmental conditions within a rural setting that was expected to have similar soil characteristics as Abidjan, but not to be severely impacted by urban activities or waste disposal. One surface (0-20 cm) and one 1 m-depth soil sample were collected from within the control site, as well as one sample of groundwater and one sample of air.

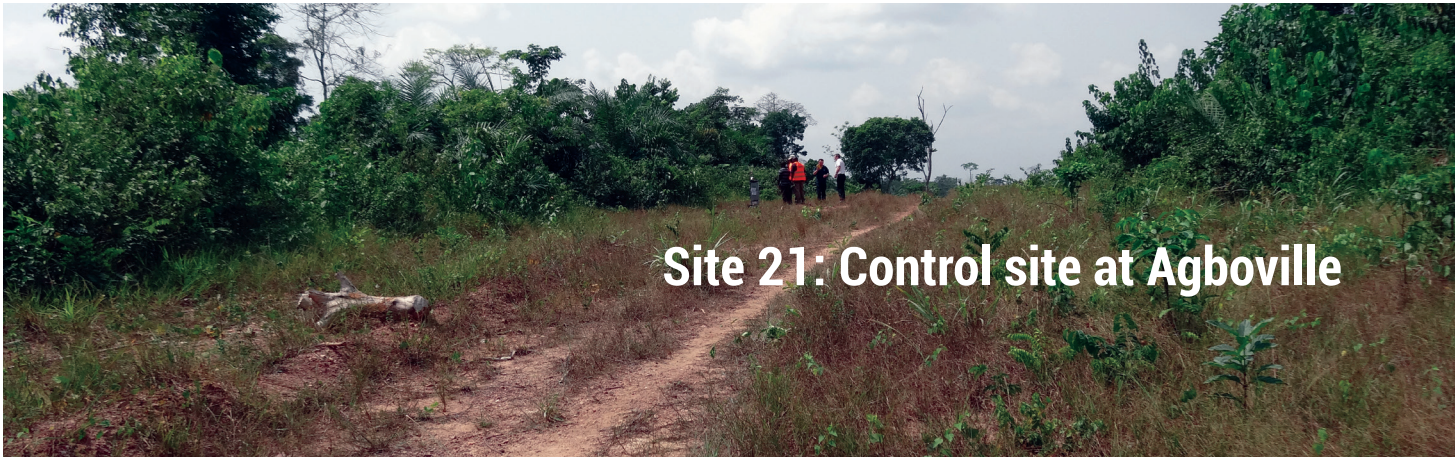
Site 21: Control site at Agboville

- Site 21 – Control site at Agboville:** This control site is located some 65 km from Abidjan, near the town of Agboville. It is located within a forested area interspersed with small agricultural plots. Approximately one kilometer from the main road, it is accessible by vehicle along a small dirt track. Considered to be completely non-impacted by the Probo Koala wastes, this site was selected to serve as a control site illustrating the prevailing environmental conditions within a rural setting, with a specific focus on air quality, as the Anyama site (Site 19) was close enough to Abidjan to potentially be impacted by the urban air pollutants of the city and the main road

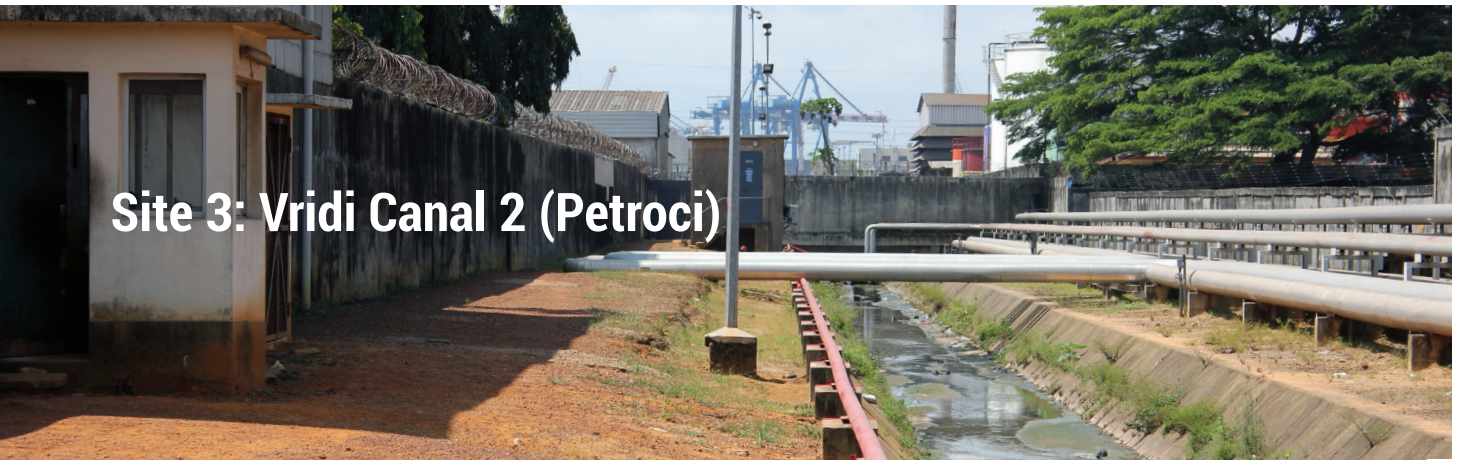
Site 3: Vridi Canal 2 (Petroci)

The site is located along the same road as Site 2, within the Vridi Canal industrial zone, on grounds owned by the Ivorian national oil company, Petroci. The site of interest represents the location at which the pipe connected to the drain into which Probo Koala wastes were dumped at Site 2 intersects with a concreted canal flowing to the lagoon. The pipework and canal were reportedly remediated by Trédi in 2006-2007, and continue to carry drainage to the lagoon.

Given that the canal is concreted, no further action is needed on this site to remediate the impacts of the 2006 toxic waste dumping from the Probo Koala.

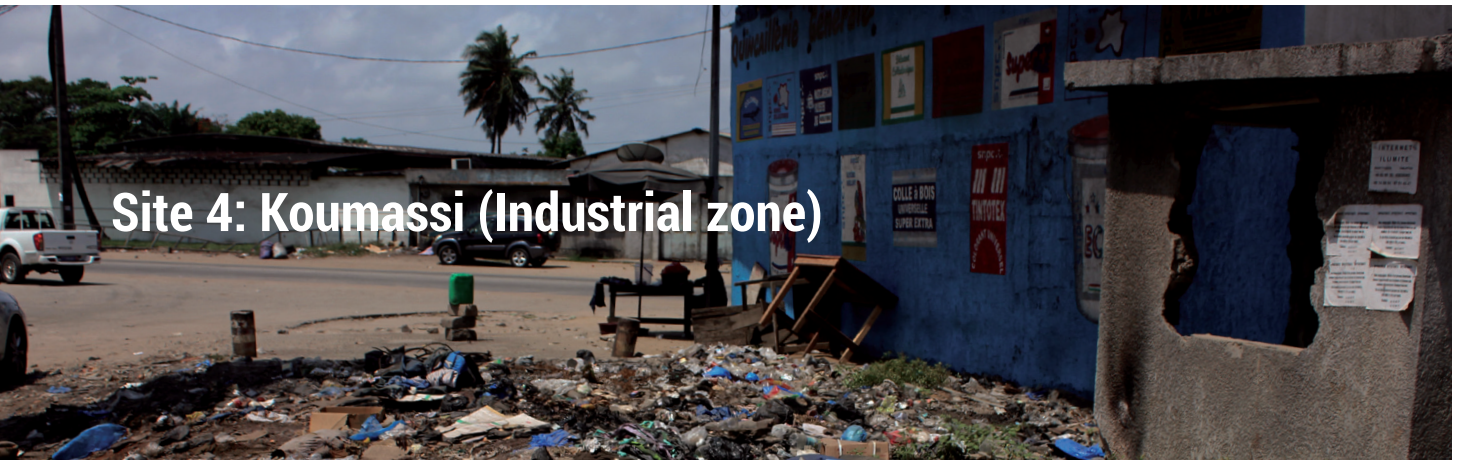
Site 4: Koumassi (Industrial zone)

This site is located in the industrial zone of Koumassi, an area in the south of Abidjan. It is reported that wastes from the Probo Koala were dumped into an open roadside drain running alongside buildings used for commercial purposes. The original concrete drain and surrounding soil were removed and remediated by Trédi in 2006-2007, and the resulting void backfilled with material excavated from elsewhere. The original drain was replaced by a buried drainage pipe. Finally, the site was re-surfaced in conjunction with the removal of an obsolete

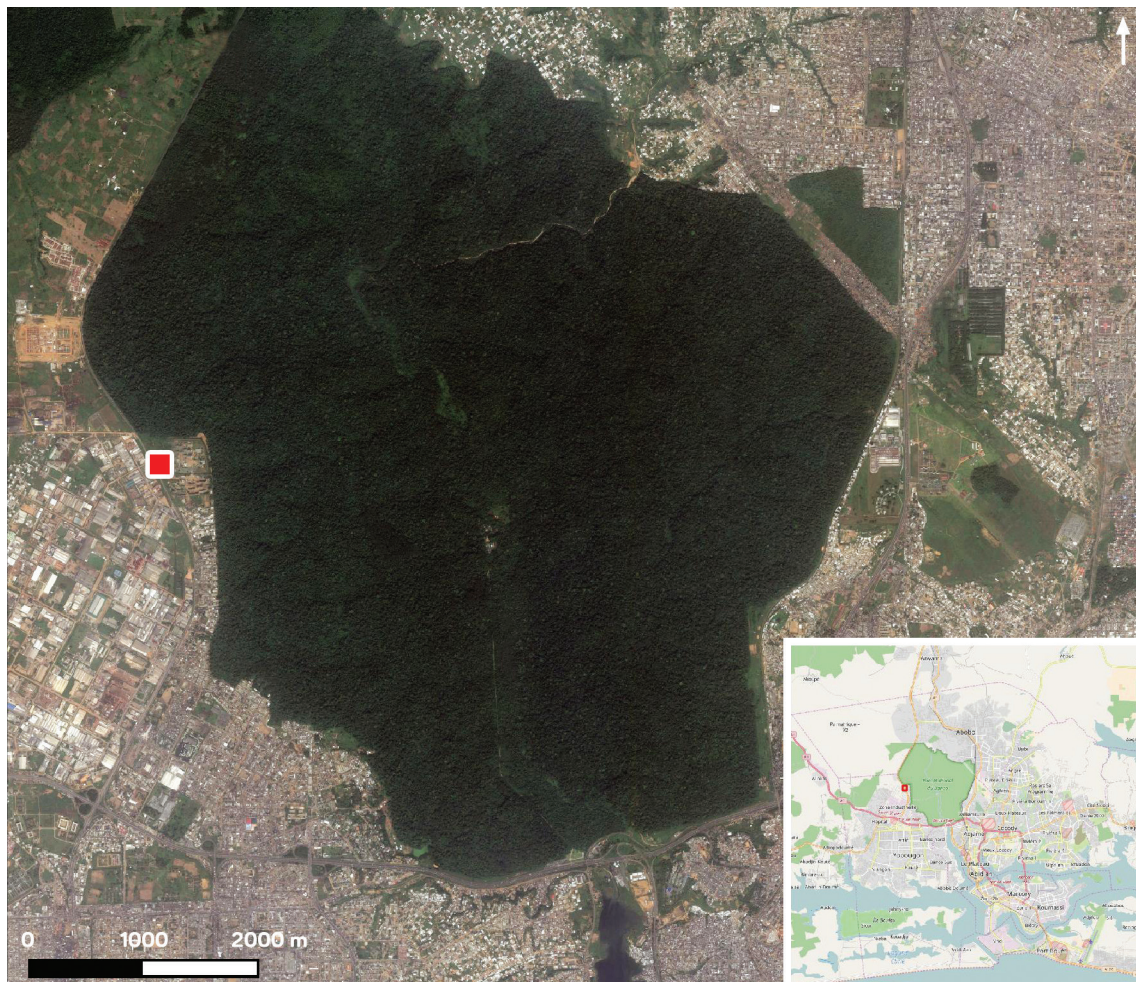
Map 9. Site 5: MACA 1

The spill location is located along a busy road in the industrial zone of Yopougon, in front of Abidjan's prison (Maison d'Arrêt et de Correction d'Abidjan, or MACA). It is reported that a truck containing wastes from the Probo Koala remained parked on the roadside for three days, during which time the wastes leaked from the vehicle and discharged into the adjacent ditch. During clean-up works undertaken by Trédi in 2006-2007, the soil within, and adjacent to, the ditch was excavated and taken off-site for treatment. The land adjacent to the ditch

- A 1 m-depth sample was taken approximately 2 m to the east of the composite soil sample location;
- A second 1 m-depth soil sample was taken from the base of an open ditch which had been excavated for the placement of cabling; and
- A third 1 m-depth soil sample was taken approximately 10 m to the north of the other soil samples.

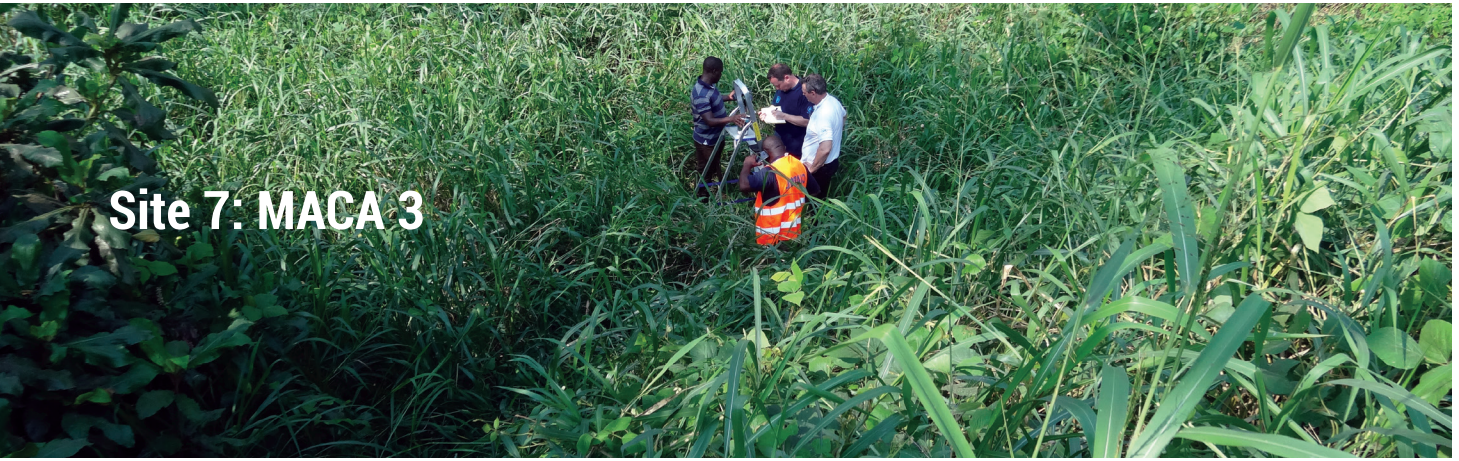
Site 7: MACA 3

Wastes from the Probo Koala are reported to have been dumped onto the roadside at this site located approximately 1 km from Site 6 (MACA 2) on the busy Yopougon-Agboville road. The liquid wastes flowed down the steep, heavily vegetated, embankment into the Banco Forest, a national park. Potentially contaminated material was excavated by Trédi for off-site treatment in 2006-2007, and the resulting void back-filled with clean soil.

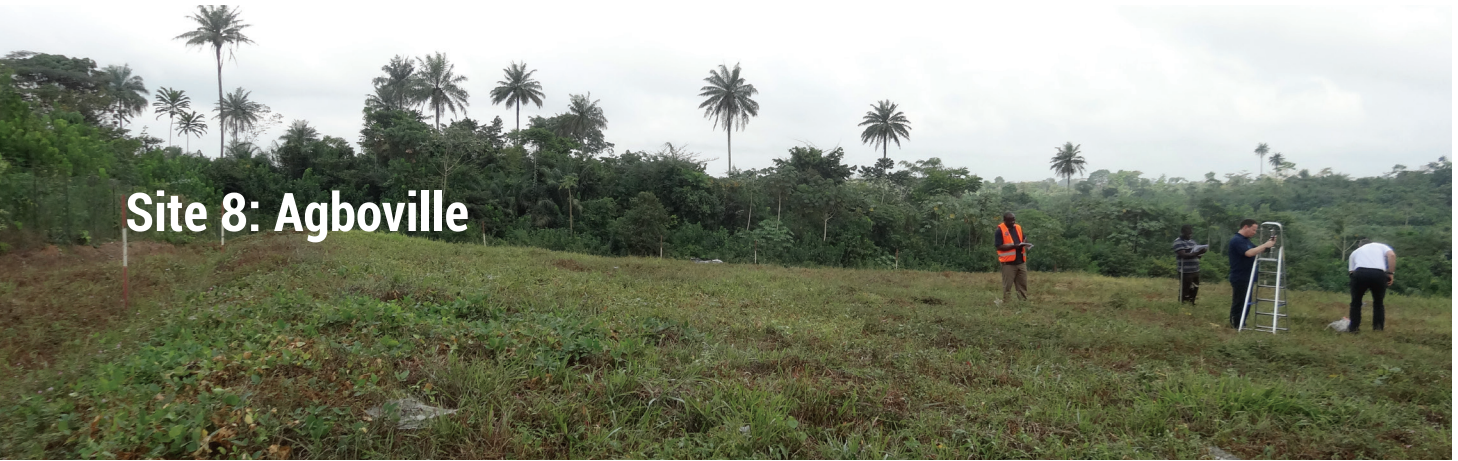
Site 8: Agboville

This site, located within the municipality of Agboville, some 61 km north of Abidjan, is not a dumping location. Rather, Site 8 has been used to treat a stockpile of dry maize that was suspected to have been contaminated through airborne pollution following the 2006 dumping event in the Vridi area. As mentioned in the section on Site 1, this maize was moved here in 2012 from the Treichville silos it was stored in for several years after the dumping.

A contract for removal, transport and treatment of the maize was signed by the Government and a company named Envipur in November 2010, and the work started in January of 2012. Site 8 was originally a remote green-field site, selected and purchased by Envipur for its considerable distance from Abidjan. The maize was placed in a single cell constructed on the site, the base of which was lined with a geomembrane. All drainage from the treatment cell is contained within concrete chambers, from where it is periodically pumped and placed in plastic tanks that are transported back to Abidjan for treatment. As part of its contracted services, Envipur has conducted

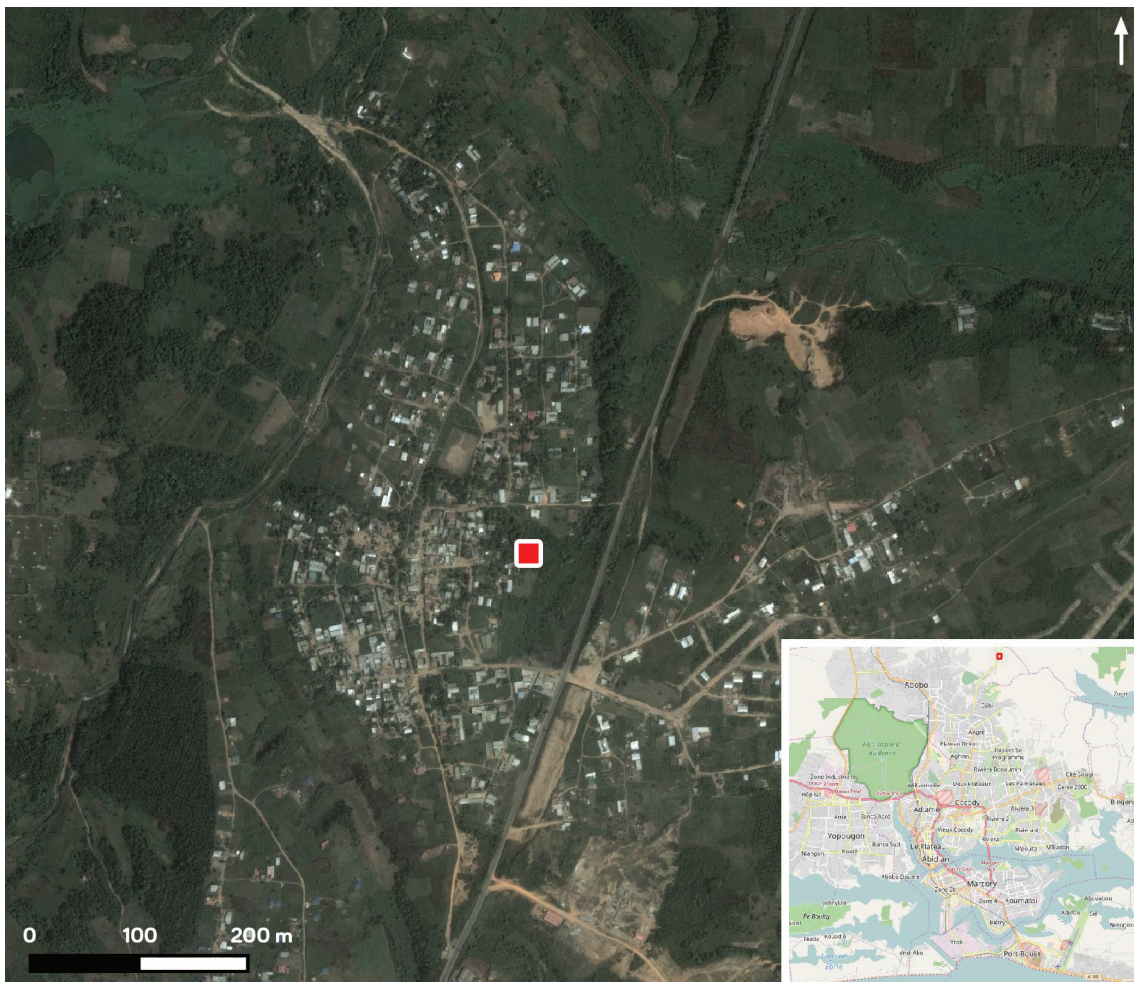
Map 13. Site 9: Alépé 1

This site is a large open area adjacent to the main road linking Abobo and Alépé, located near the village of Djibi. Wastes from the Probo Koala are reported to have been dumped down an embankment from the roadside, and to have flowed downstream across the site.

between September 2007 and March 2008 by Biogénie, then contracted directly by Trafigura; contaminated materials were stored on site in big bags. Starting in 2010, Biogénie was contracted by the Government to conduct additional and complementary clean-up, which included finalizing excavation and treating contaminated soils – from Alépé 1 and 2, as well as some other sites – using biological activation techniques. It is reported that the site was excavated down to a depth of 14 m in some locations, and that some 16,000 tons of soil were treated here. Following some delays due to the post-electoral violence in 2010-2011, the bio-remediation

process at Alépé was considered to be completed by end 2014. The treated soil was then redistributed across the site in 2015.

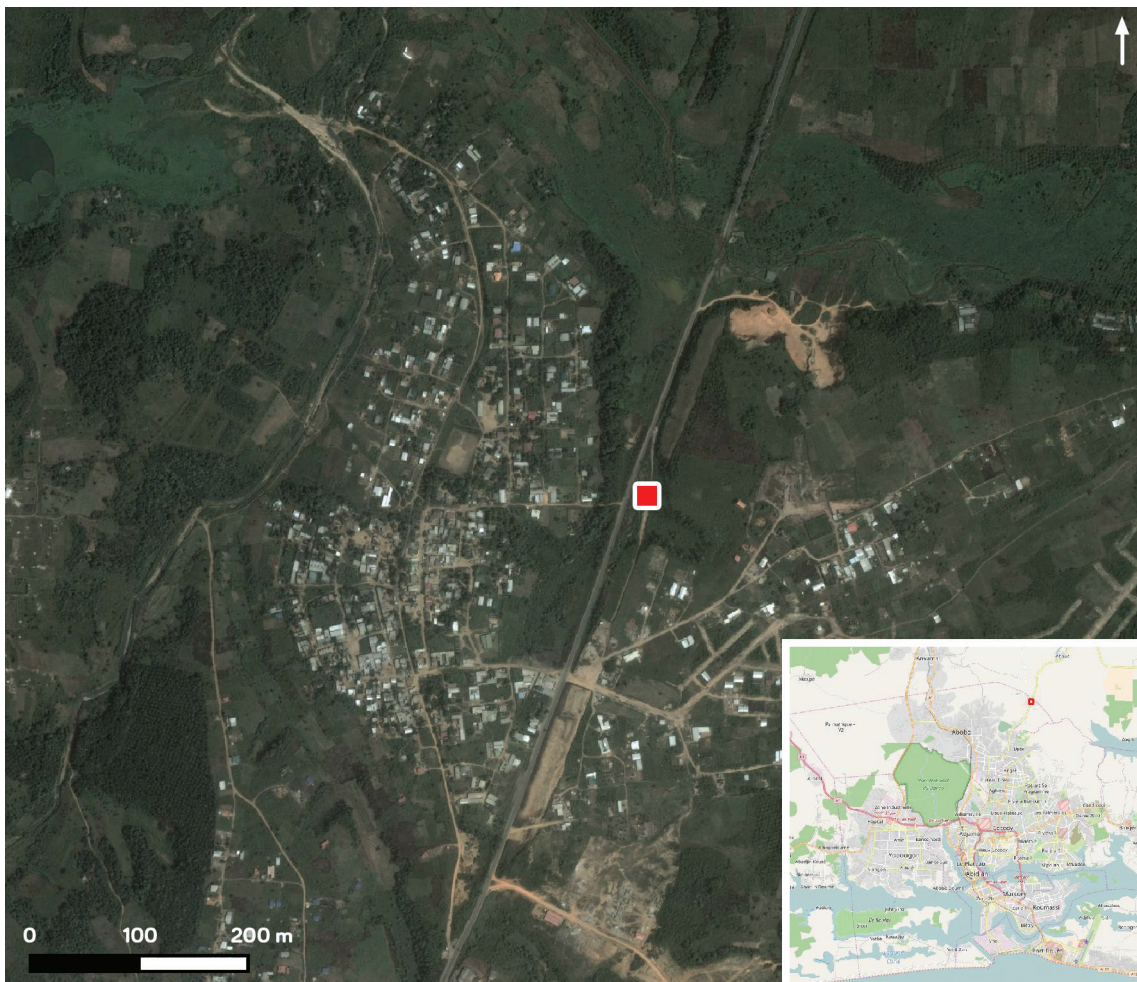
Map 14. Site 10: Alépé 2

This site is located down a steep and densely vegetated embankment on the side of the main road linking Abobo and Alépé, approximately 1 km from Site 9. Wastes from the Probo Koala are reported to have been dumped from two tanker trucks down the side of the embankment, and to have flowed along the bed of the rivulet at the bottom, eventually crossing under the road and flowing into a small pond that is thought to have been used for pisciculture.

This site was divided in two sections: the eastern side of the road, where the spill was reported to have taken place; and the western side of the road, where

the waste flowed through. The following samples were collected:

- On the eastern side of the site, one surface (0-20 cm) and one 1 m-depth soil sample were taken adjacent to the rivulet; and
- On the western side of the site, one composite surface soil sample (0-20 cm) was taken next to the small pond and one 1 m-depth soil sample was collected in an area of planted crops adjacent to the road.

The laboratory results show that the current concentrations of the contaminants of concern in soil are all below the standards set by the Government of Côte d'Ivoire for clean-up. No further action is needed on this site to remediate the impacts of the 2006 toxic waste dumping from the Probo Koala.

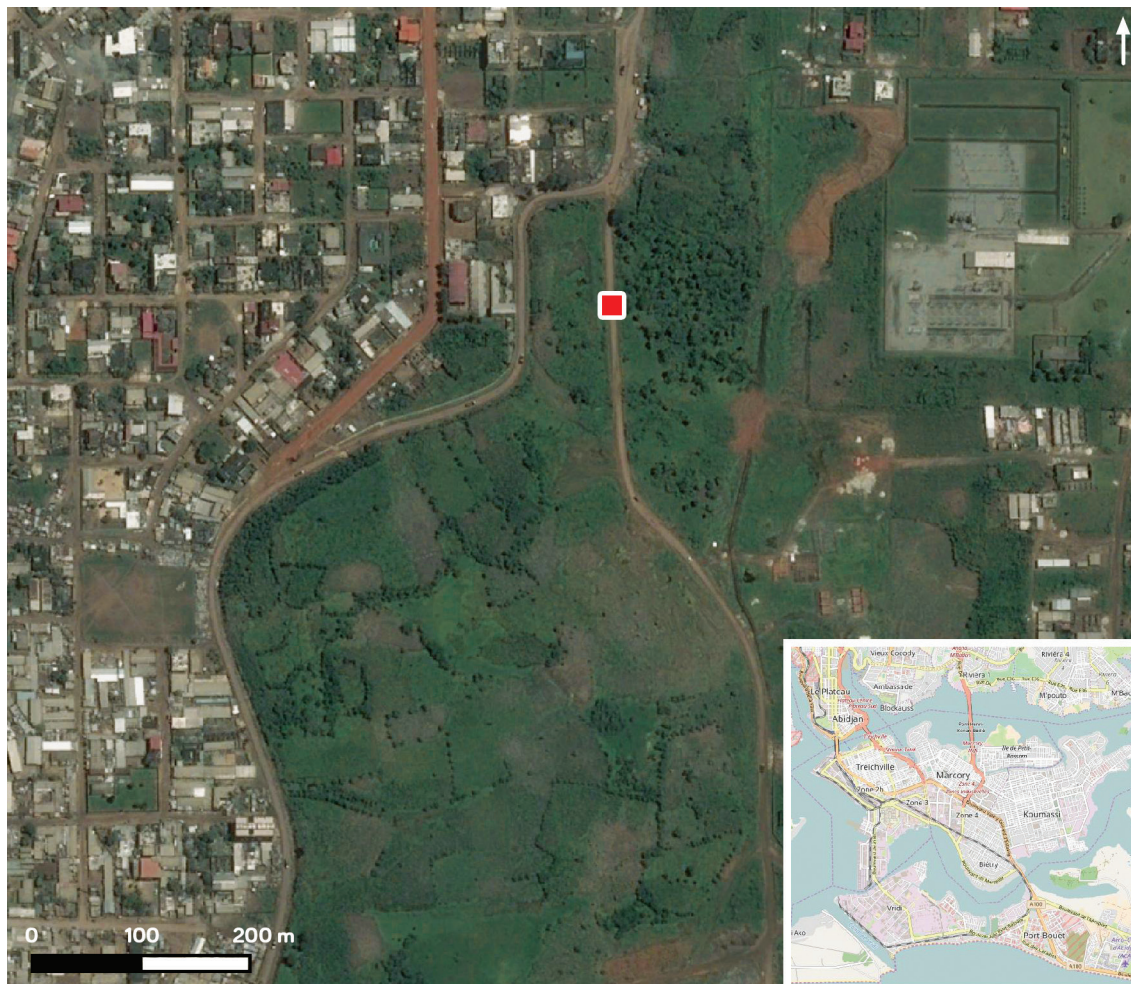
Map 15. Site 11: Akouédo 1

This spill site is located within Abidjan's municipal waste disposal site at Akouédo, in an area that is currently not actively used. Wastes from the Probo Koala are reported to have been dumped into the ditch running parallel to the dirt road that traverses the vast waste disposal grounds. During clean-up operations by Trédi in 2006-2007, contaminated materials were excavated and removed for off-site treatment, and the remaining void back-filled with clean soil. At the time of sampling, small, informal plantations of food crops, such as banana, maize,

One composite surface (0-20 cm) soil sample was taken approximately 5 m from the track, on the far side of the drainage ditch, where the soil was covered with a layer of refuse.

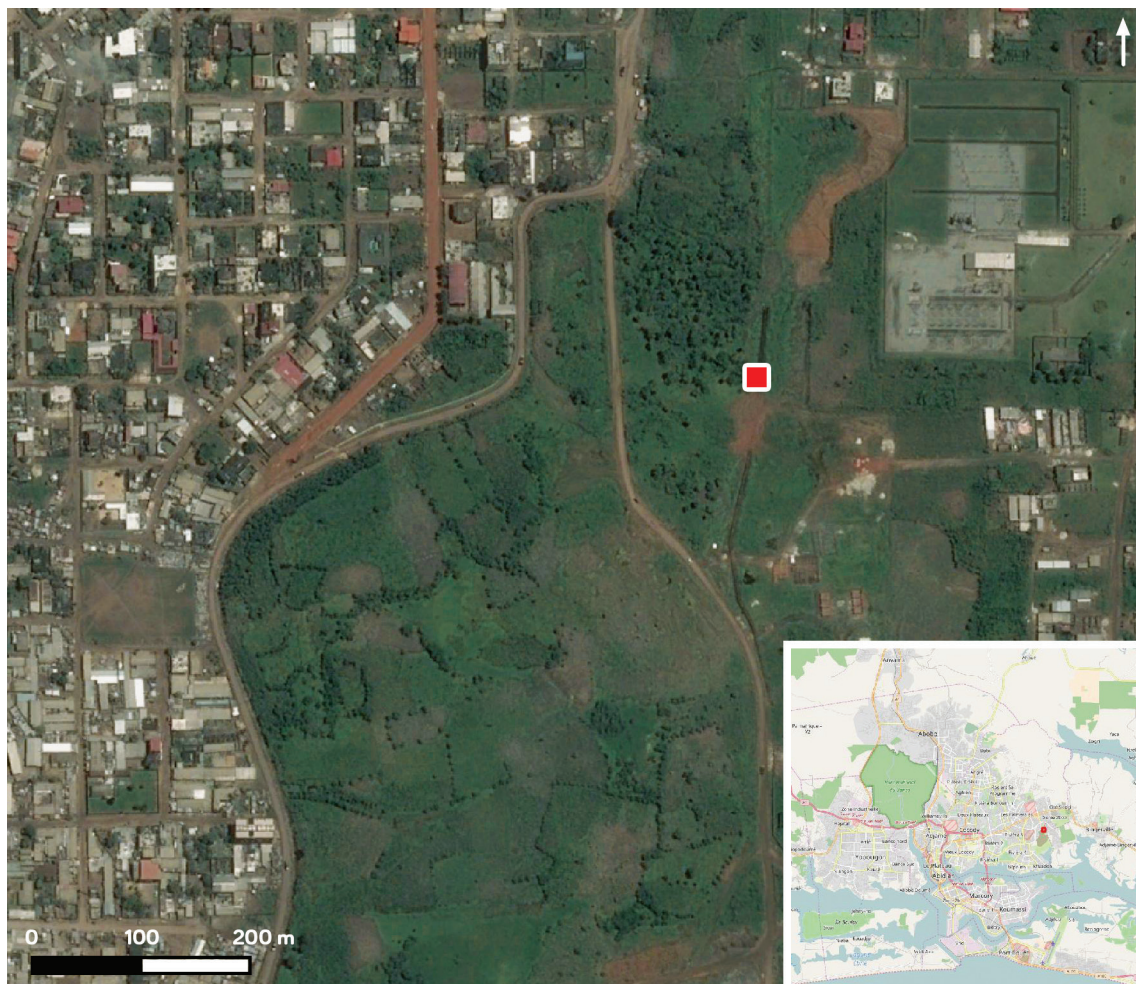
Map 17. Site 13: Akouédo 3

Two surface (0-20 cm) soil samples were taken near the concrete perimeter wall where the spilled material flowed to from Site 11 to the west.

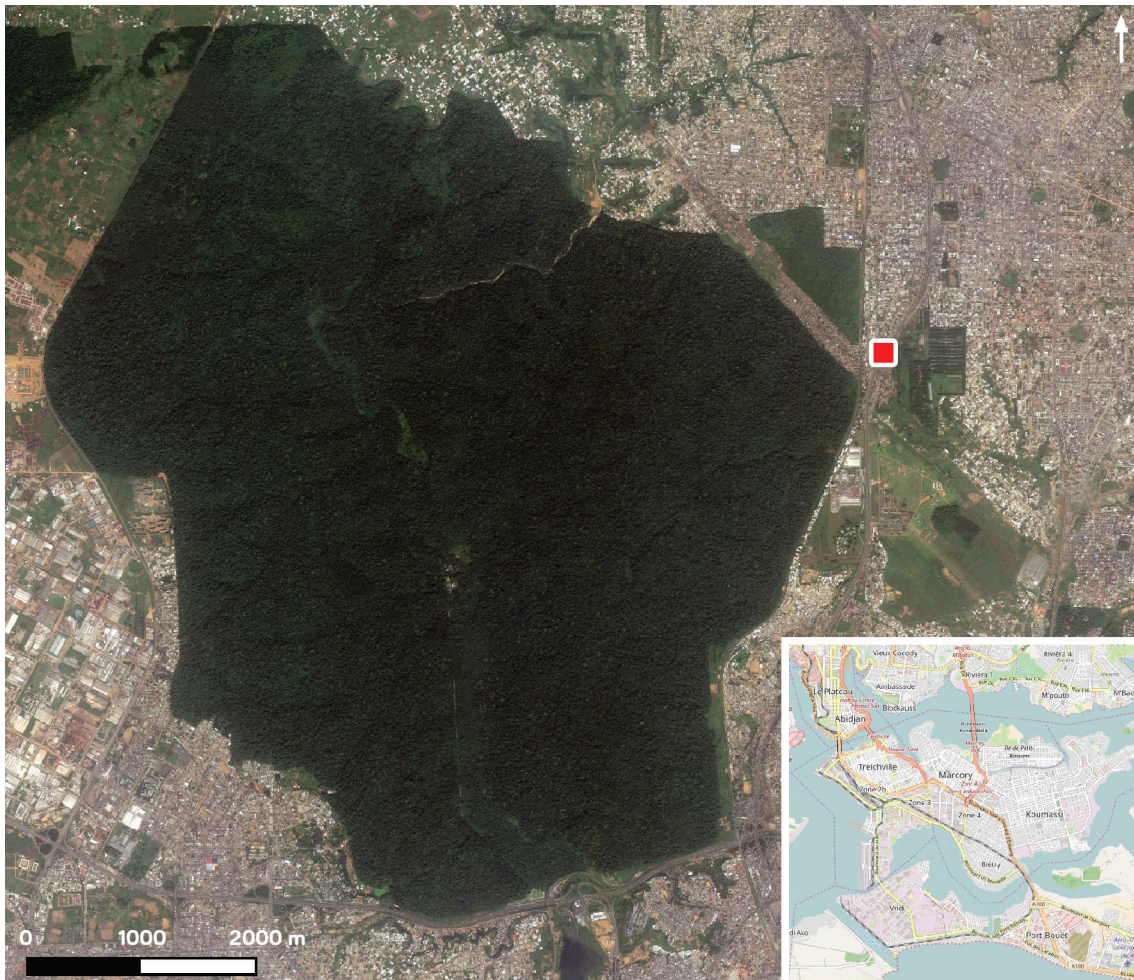
Map 18. Site 14: Coco-Service

Clean-up works undertaken by Trédi in 2006-2007 included removing and replacing the drainage structure, while the surrounding soil was excavated and treated off-site. At the time of sampling, the site was used as a tipping point for household trash, and to burn tires and other refuse. A small banana plantation could also be found on a flat area between the road and the stream below.

Two surface (0-20 cm) soil samples were taken: one at the top of the slope, at the level of the adjacent road; and the other at the bottom of the slope, near the stream.

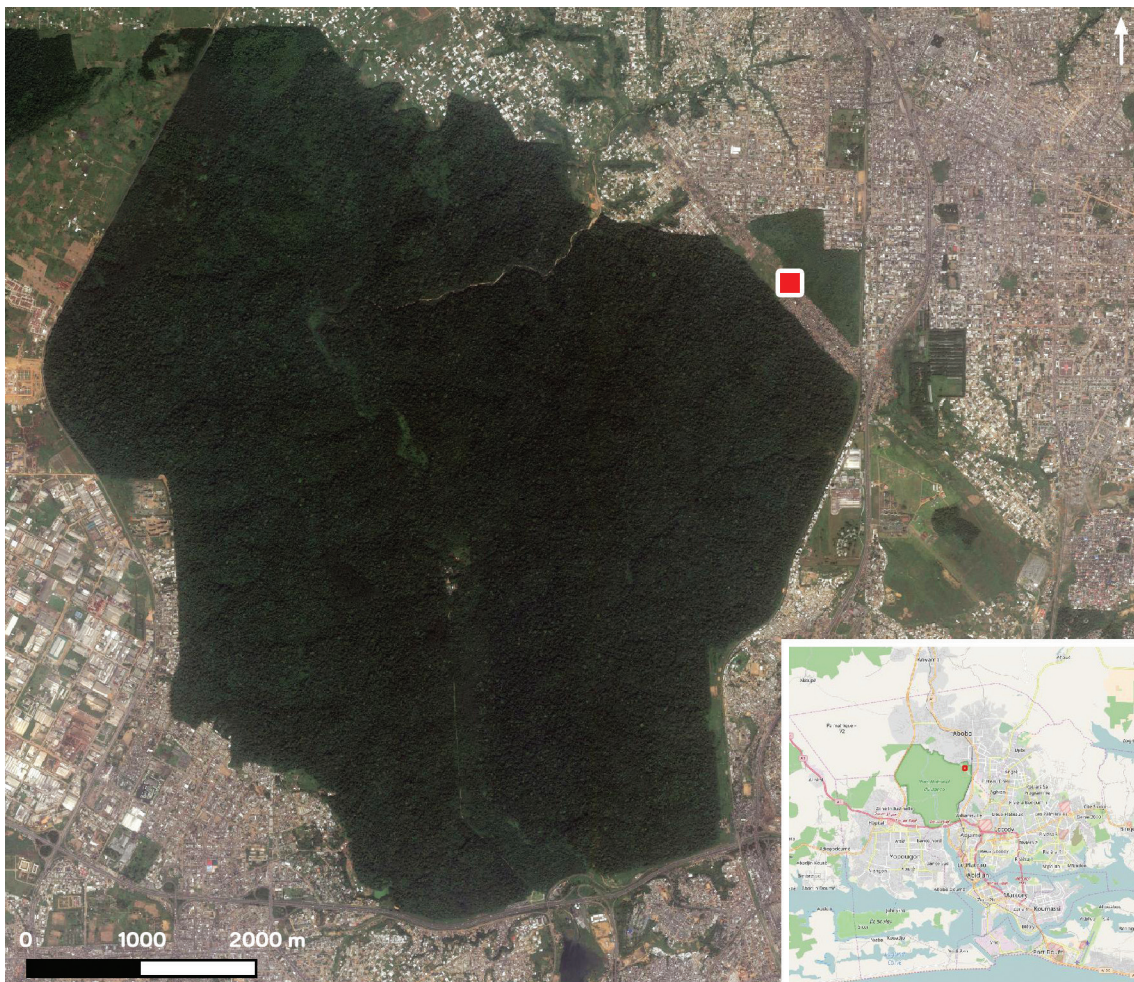
Map 19. Site 15: Abobo Sagbé

This spill site is located within a vast expanse of informal and unregulated small businesses including mechanics, spare parts dealers, auto body shops and other vehicle-related workshops located in the Abobo area, at the edge of the Banco National Park. Wastes from the Probo Koala are reported to have been dumped onto an open plot of land, which at the time was situated at a distance from the workshops, but is now surrounded by them. Clean-up works undertaken by Trédi in 2006-2007 included excavating the surrounding soil for

Two surface (0-20 cm) and two 1 m-depth soil samples were taken at the spill location.
