ENVIRONMENTAL AUDIT OF THE SITES IMPACTED BY THE “PROBO KOALA” TOXIC WASTE DUMPING IN ABIDJAN, CÔTE D’IVOIRE

SITE 2: VRIDI CANAL 1 (CAP LOGISTICS)

Site name: Vridi Canal 1 (Cap Logistics)
UN Environment site reference no: 2

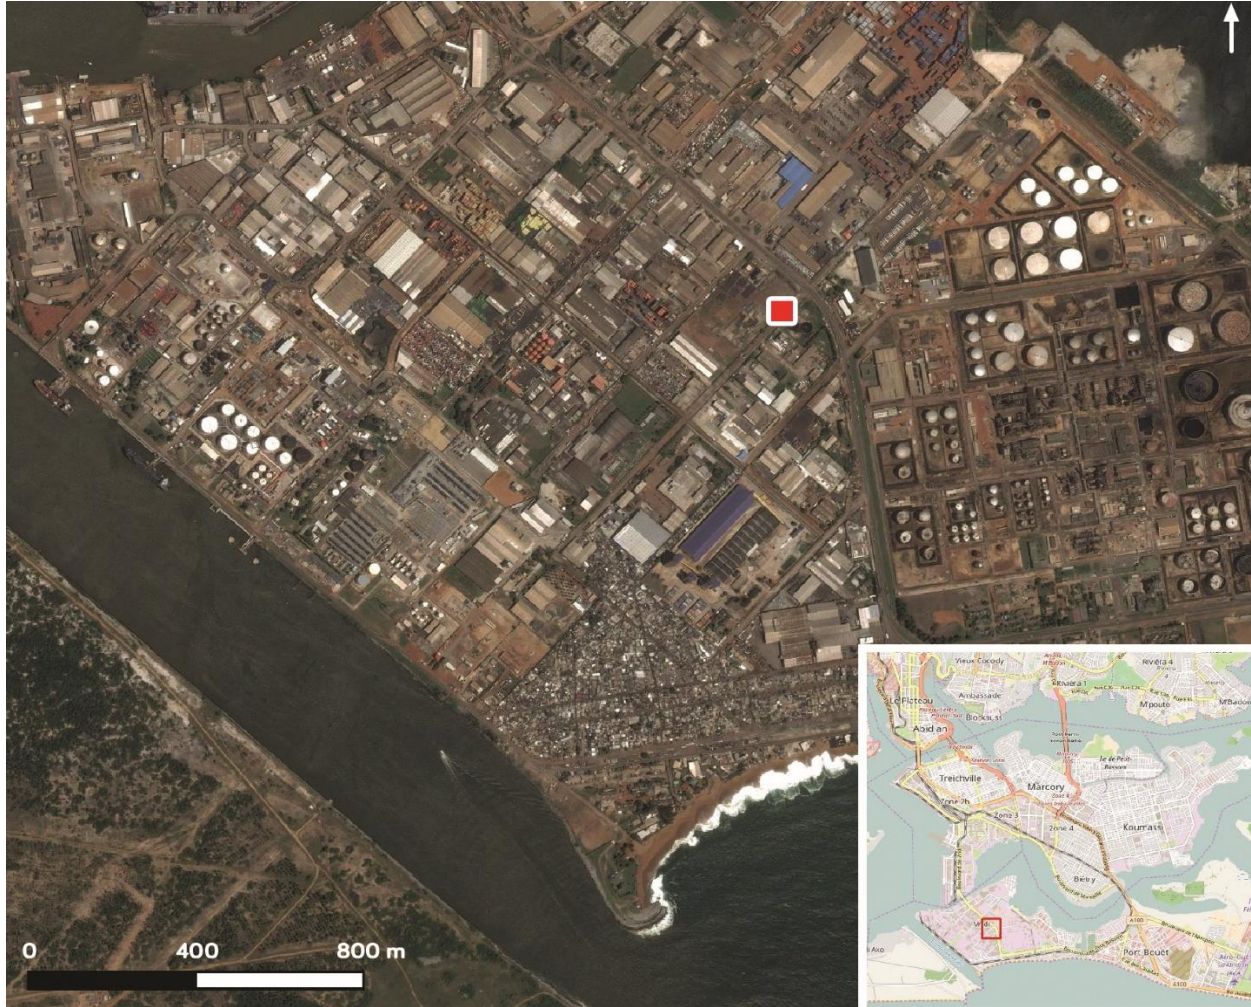
The site is located along the edge of a warehouse complex, within the large industrial zone along the Vridi Canal. Wastes from the Probo Koala were reportedly dumped into a partly open and partly culverted roadside drain, causing overflow from the drain onto the surrounding area a few meters away. In addition, some leakage is thought to have occurred as the waste flowed through the pipe, as it was not fully sealed. Clean-up efforts undertaken by Trédi in 2006-2007 included the replacement of the pipework, and the excavation of the surrounding soil. A company named EMEB-CI was contracted to carry out additional clean-up of the sites between October 2010 and June 2011, which comprised the replacement of the internal sanitation network and the cleaning of the manholes and pipes connected to the main network. There is now a high concrete-block wall along the road, separating the location where the wastes overflowed from the point where they were dumped.

Three soil samples were taken at this site: one from the existing drain and two from the overflow point on the warehouse grounds, including one surface (0-20 cm) sample and one 1 m-depth sample.

The following recommendation can be made to address these issues: while no further action is needed on this site to remediate the impacts of the 2006 toxic waste dumping from the Probo Koala, the Government should establish environmental monitoring systems for the Vridi industrial zone, based on sound environmental standards, to ensure that pollution is not draining into and further contaminating Ébrié Lagoon.

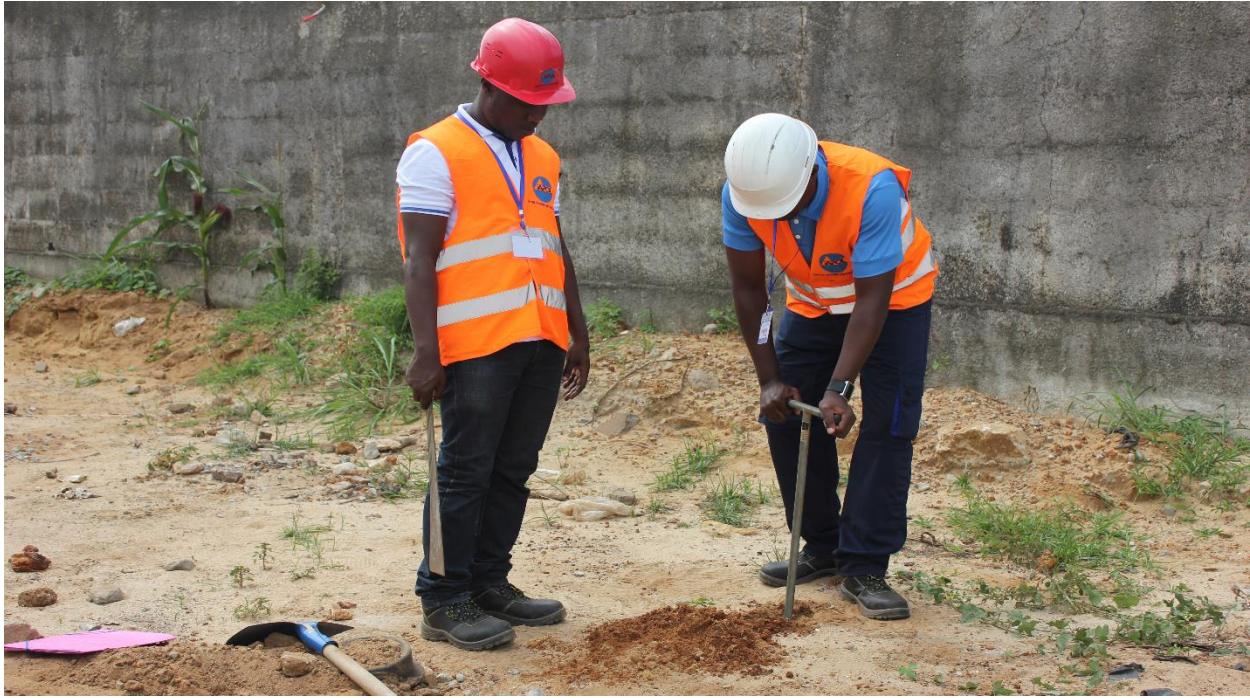
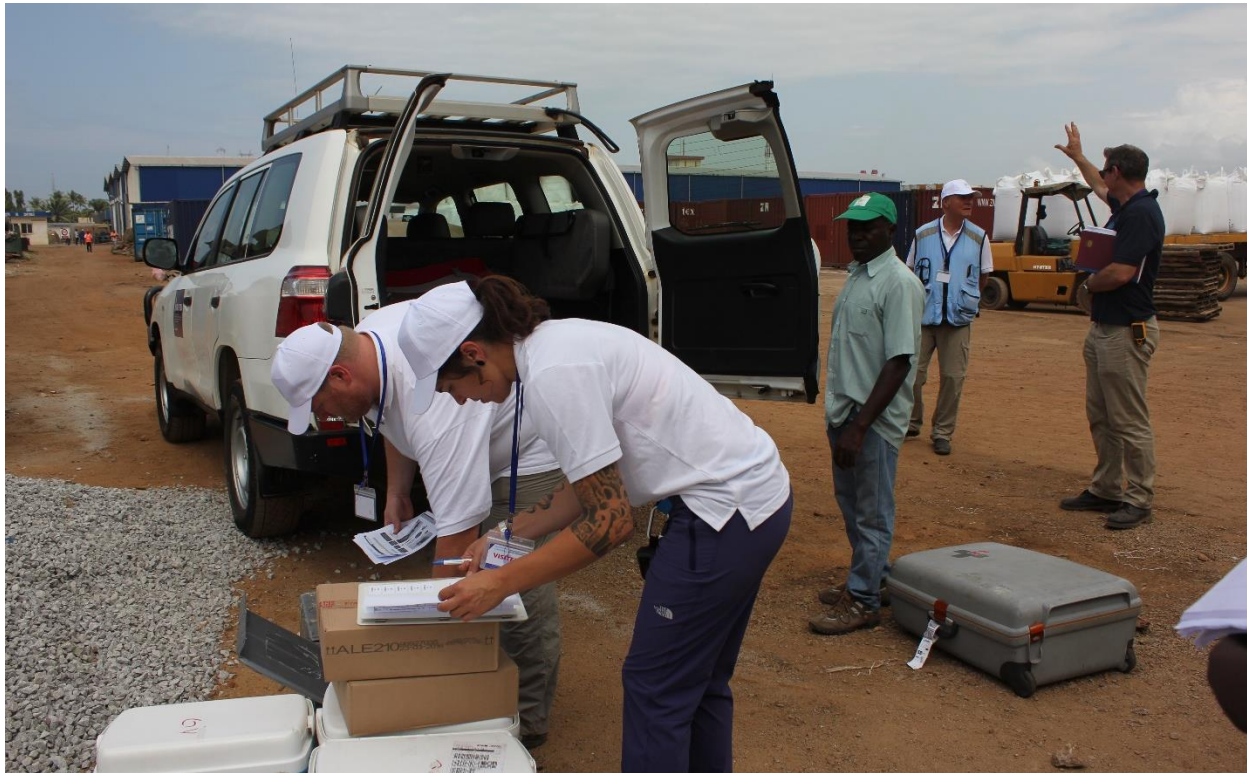
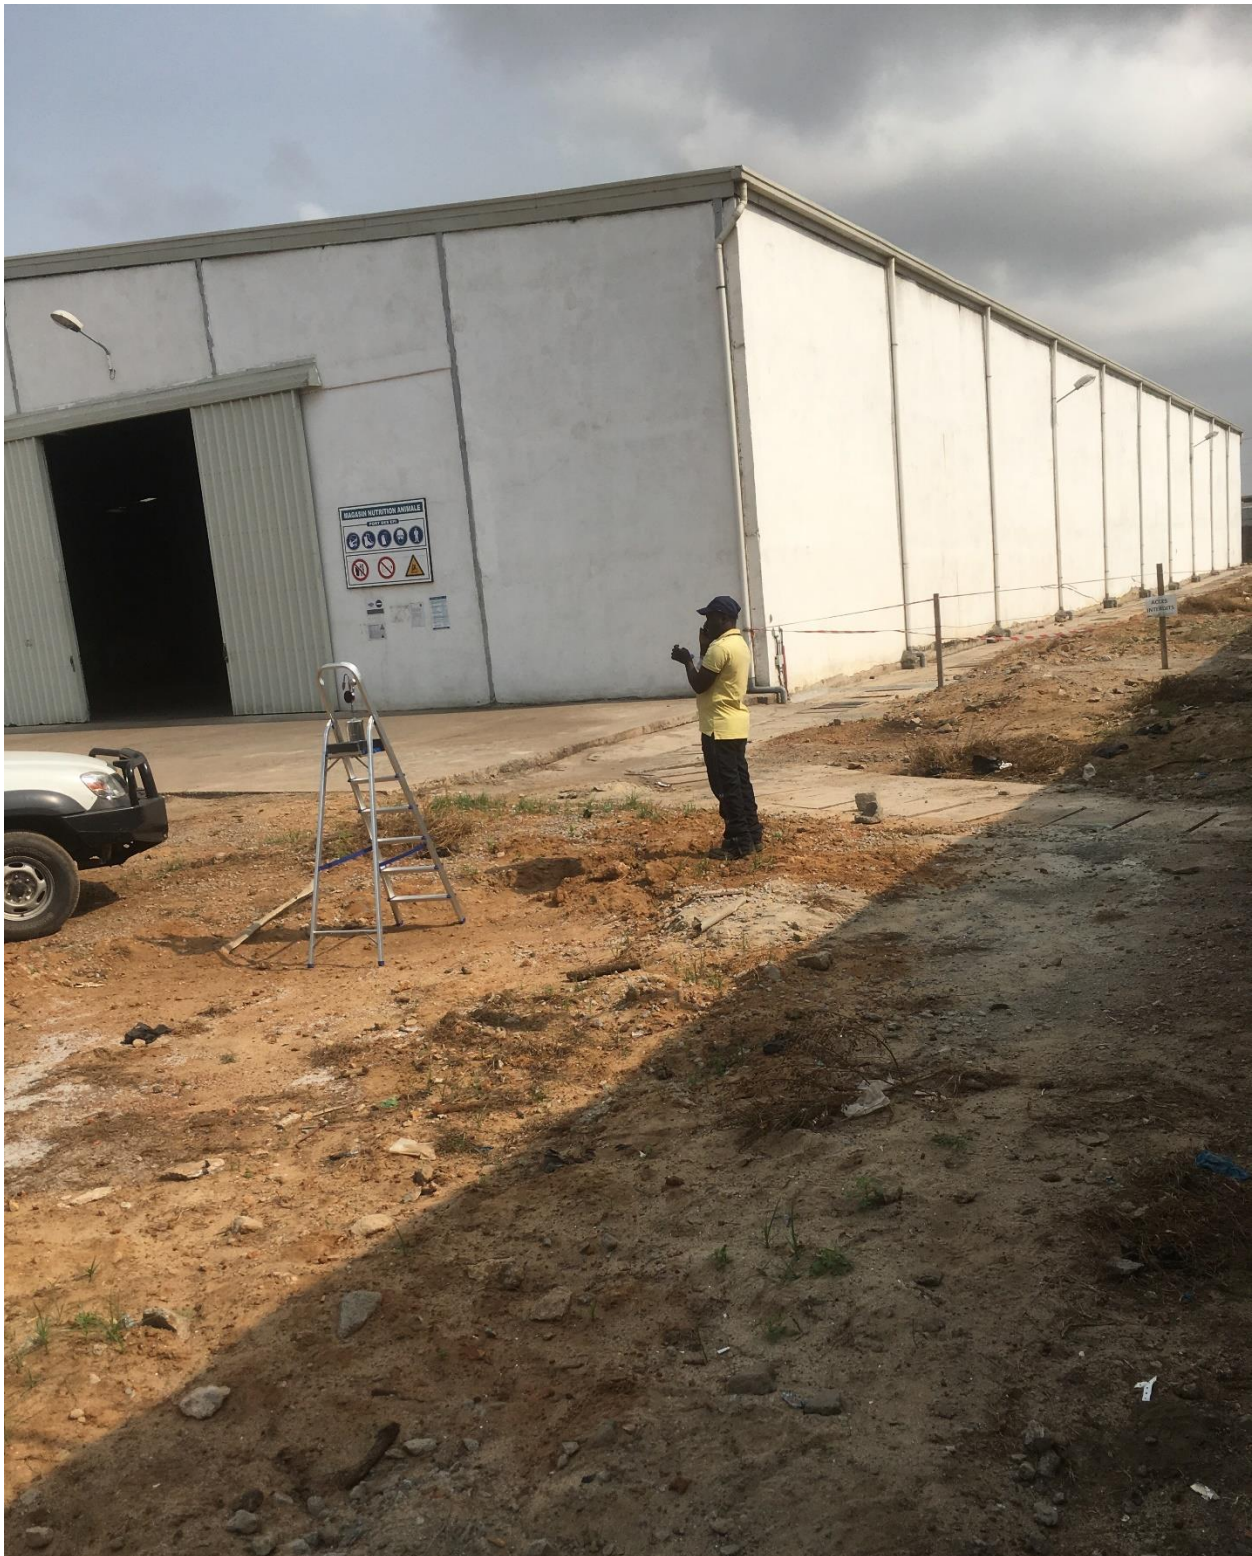
Site Photos

Surface water quality results for Site 2 show high levels of hydrocarbons, which is indicative of industrial pollution from local sources. In addition, heavy metal pollution is observed in the surface water samples, which is also to be expected in urban industrial areas.
