# Ground Contamination Assessment Report

**Military Waste Storage Site, Astana, Afghanistan**

**United Nations Environment Programme**

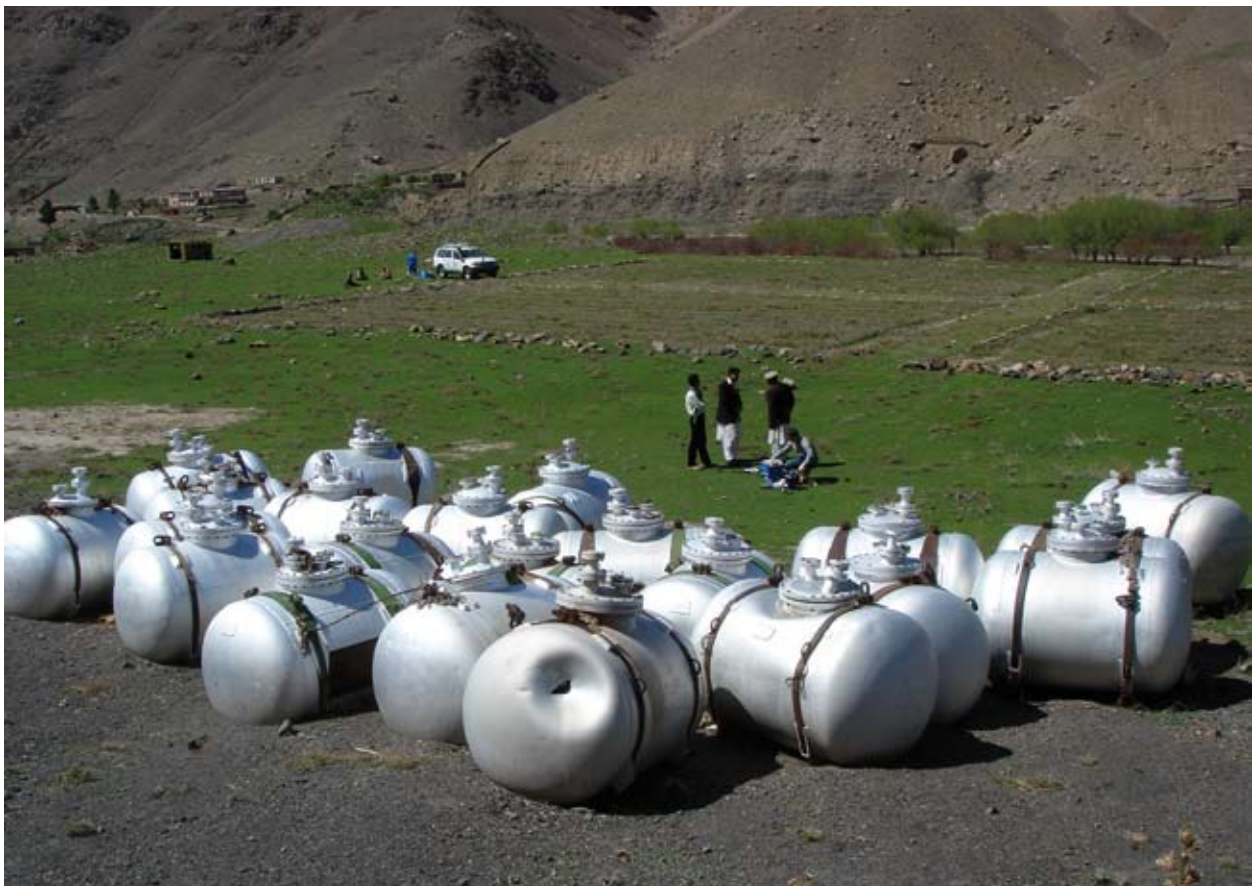
SCUD missile fuel containers stored at ground level.

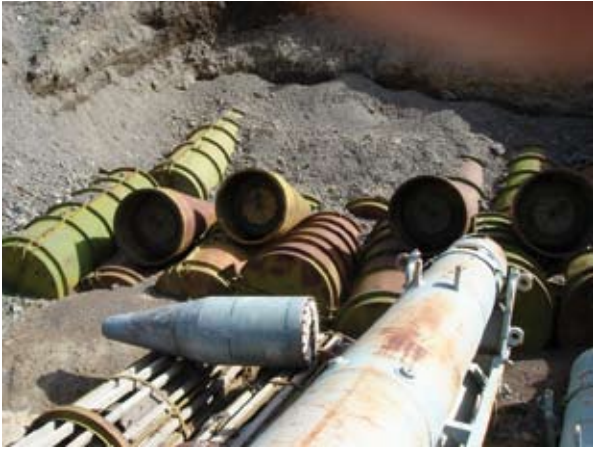
Markings on the exposed warheads made it clear they were originally manufactured by a Russian source. However, it was not possible to determine whether any were live/active or calibrated for immediate use.

SCUD missile warhead casings

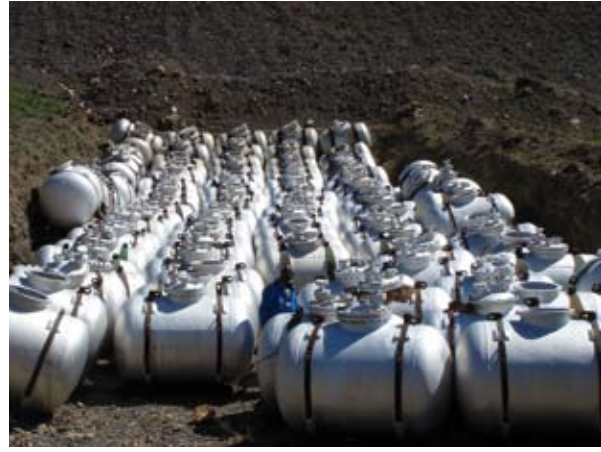
SCUD missile fuel containers stored below ground level in a shallow trench.

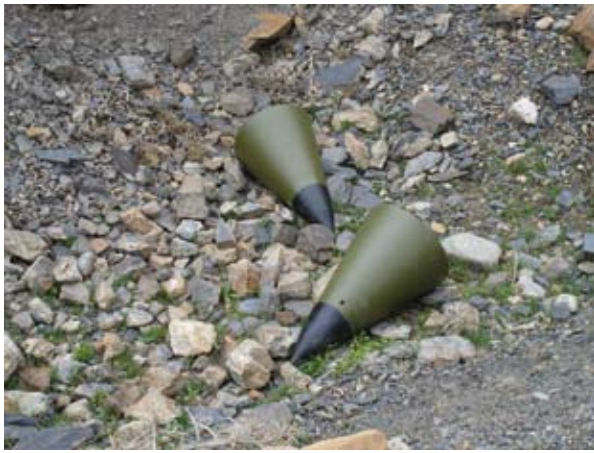
It is understood that these covers fit over the warhead and contain the missile fuse, but no fuse was found in either.

The base of these covers measured approximately 0.4 metres and the length from base to tip was approximately 0.5 metres. Each warhead cover weighed approximately 10 kg.

Warhead Covers found on site

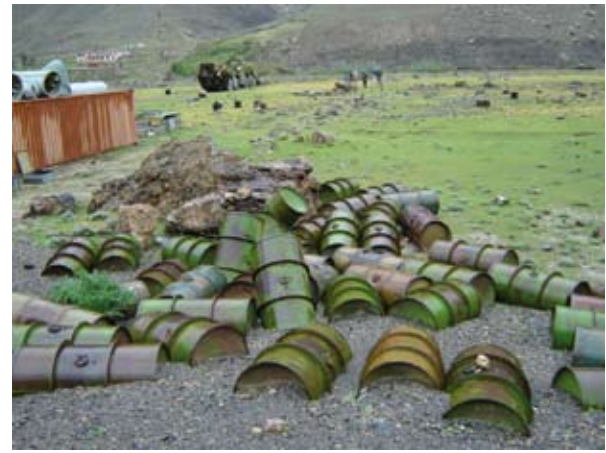
Partially buried nitric acid storage containers

Although most of the nitric acid containers were in reasonable condition, a number of them appeared to be leaking. On-site analysis of soil samples taken in this area indicated a pH of less than 3.0, suggesting that leaching or spills had occurred there in the past.

The protocols described above to lift and transport the UDMH containers should also be applied for the removal of the nitric acid containers on site. Additionally, an excavator may be required to expose the partially buried containers. It is recommended that a toothless excavation bucket be employed to prevent rupturing containers during the removal operation, and that a reasonable amount of lime ( $\text{CaCO}_3$ ) be available to neutralize any spills or previously impacted soil.

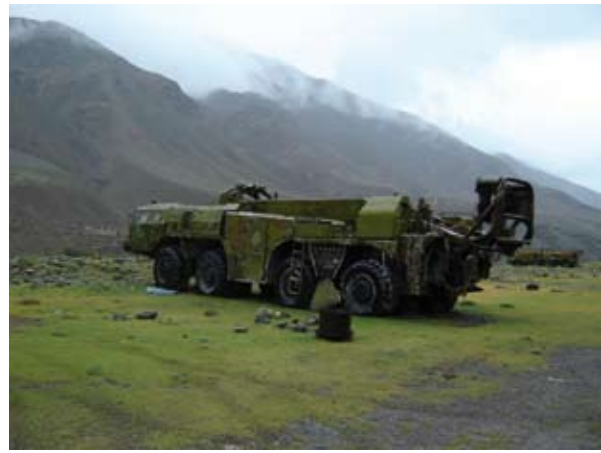
Finally, a derelict missile launcher was found in this area of the site. Research indicates that this vehicle was used to launch Russian-manufactured SCUD missiles R-300 9K72 Elbrus/SS-1C SCUD-B/C, which used a mixture of UDMH and nitric acid for fuel (UNEP, Nov 2005).

Derelict SCUD missile launcher

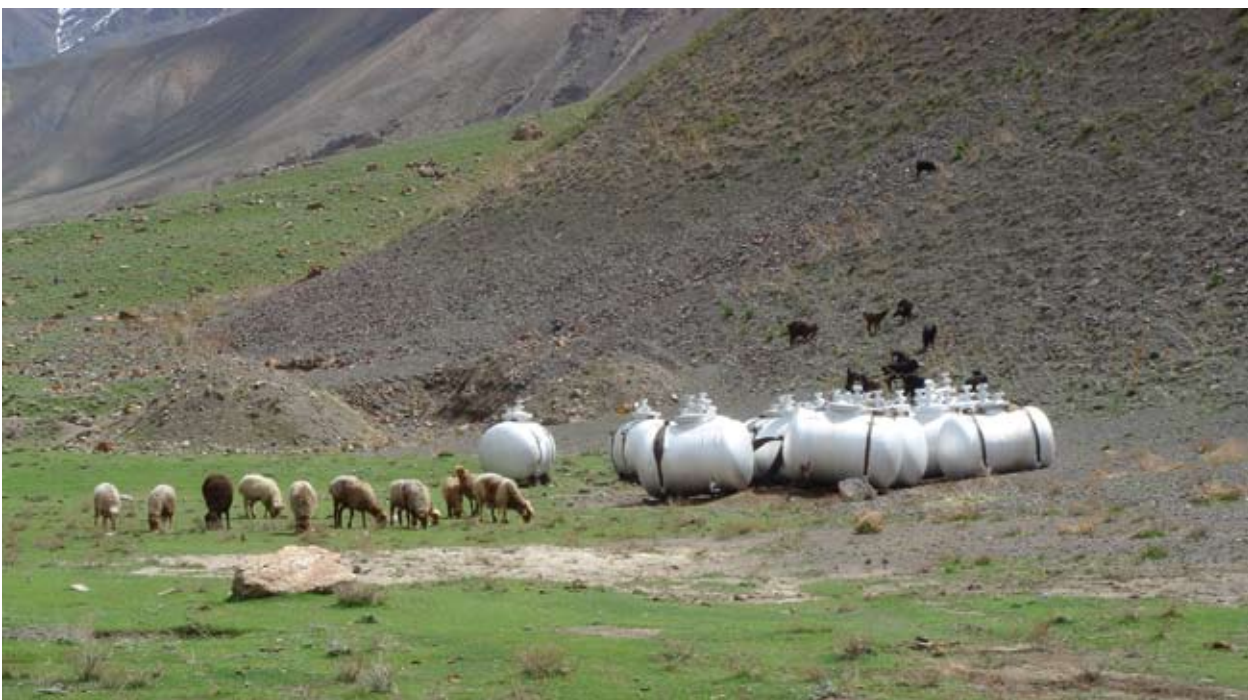
The site is used on a regular basis as grazing land for herds of goats and cattle. Although it does

Goats grazing near rocket fuel containers

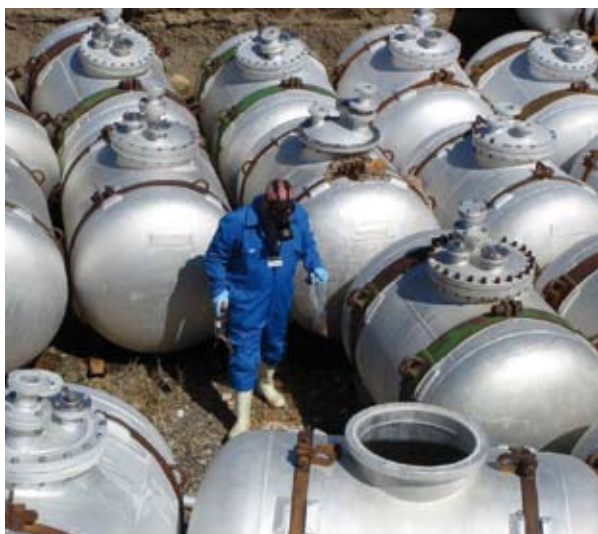
Sampling shallow soil at site 2

Experts used a small hand auger to recover superficial soil samples from ten to twenty individual locations within each area.

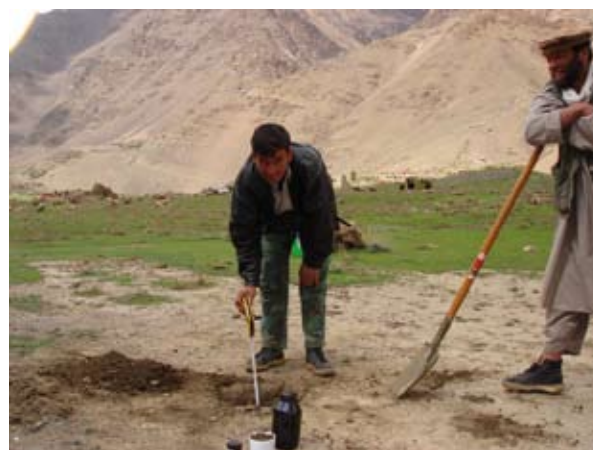
Where olfactory or visual signs of contamination were noted, a shovel was used to acquire samples from deeper within the soil profile.

Obtaining a soil sample from deeper within the soil profile

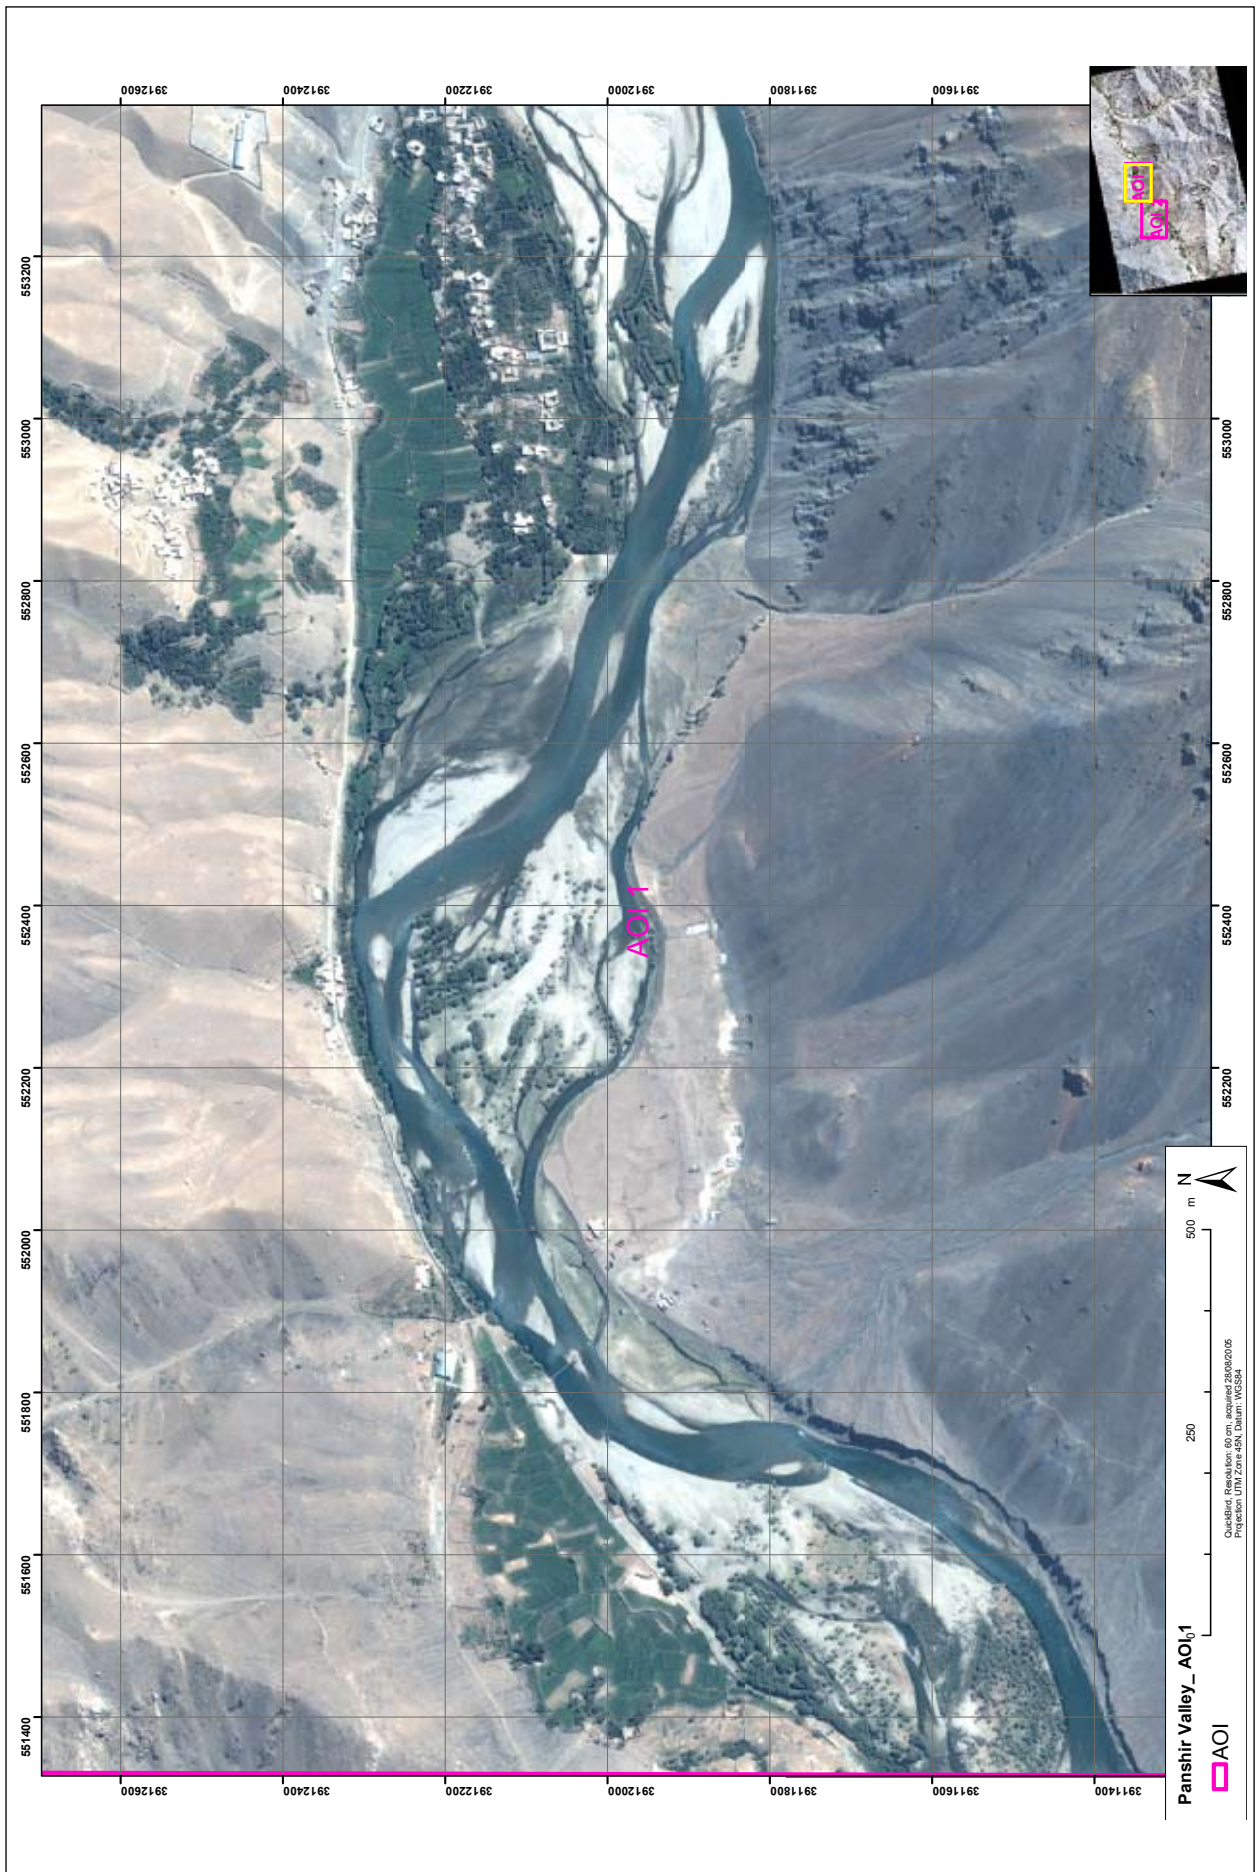
FIGURE 2: SITE LAYOUT & KEY AREAS OF INTEREST  
 SITE: ASTANA, AFGHANISTAN  
 SCALE: AS SHOWN

Military equipment, can be found in several stockpiles on the site. For this assessment, these stockpiles were divided into four main sites warranting particular concern. The specificities of these individual areas are discussed in detail below, and shown graphically in Figure 3.
