SEYCHELLES

Post-Tsunami Environmental Assessment

UNEP

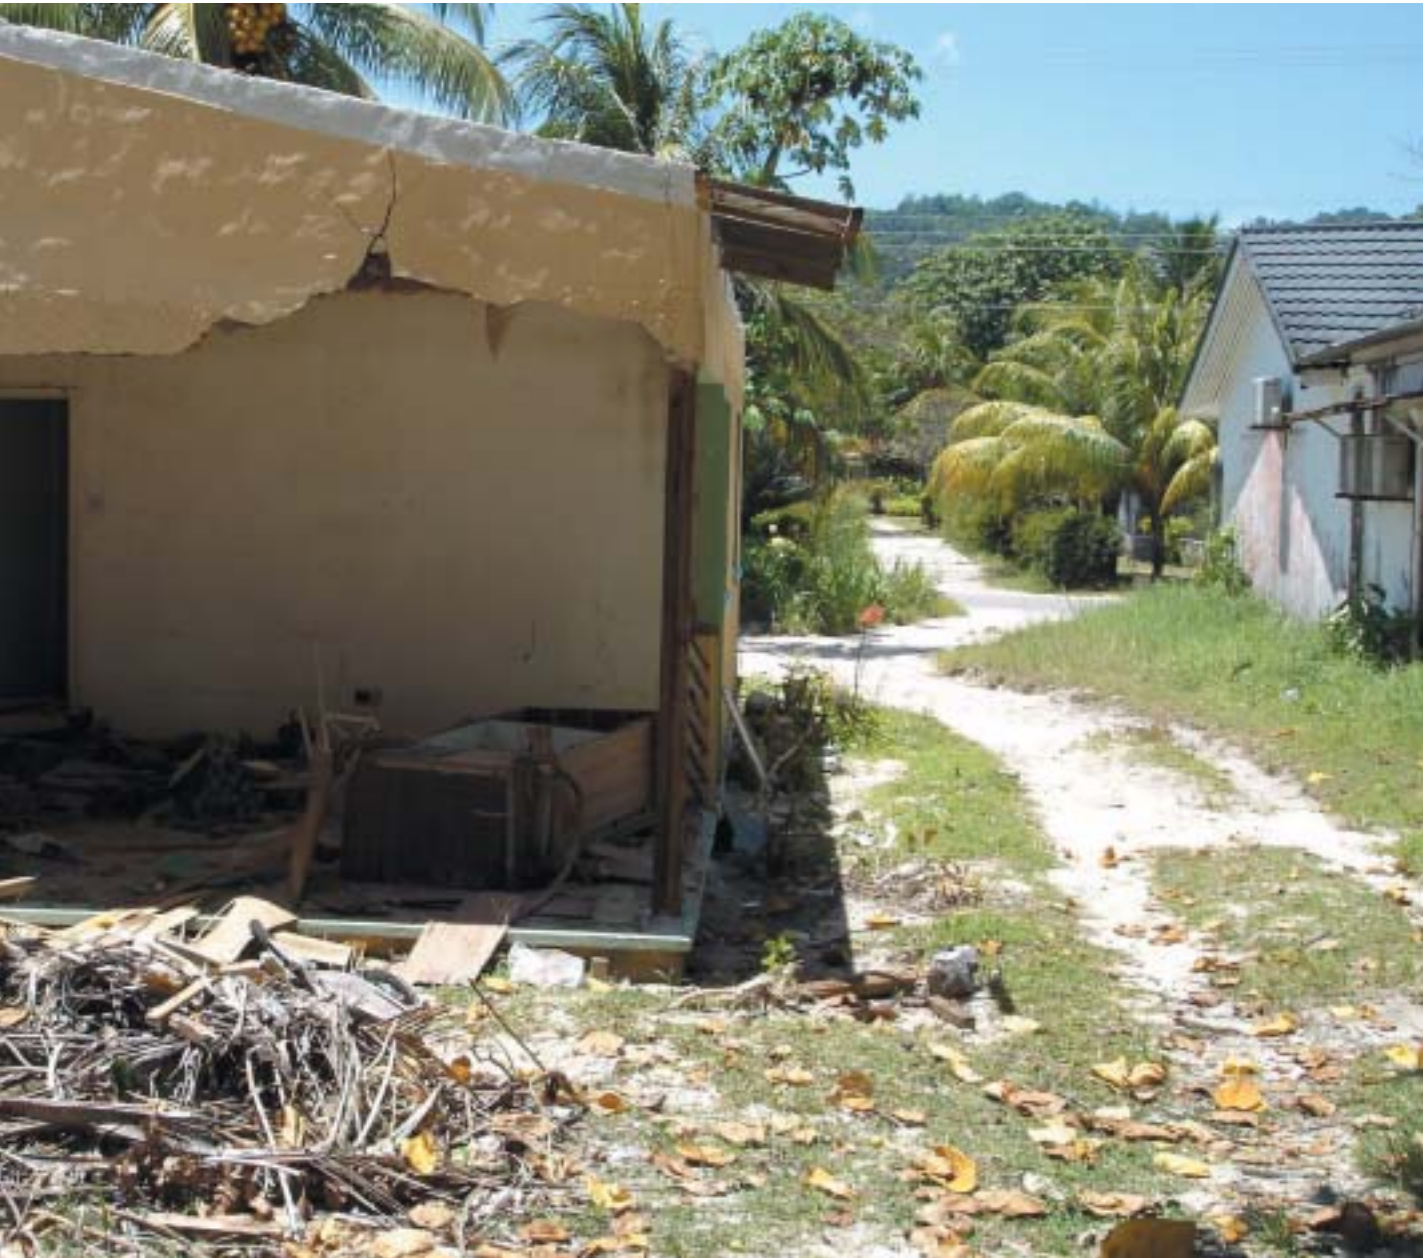
A house damaged by the impact of the tsunami surge.
Credit: M. Collins

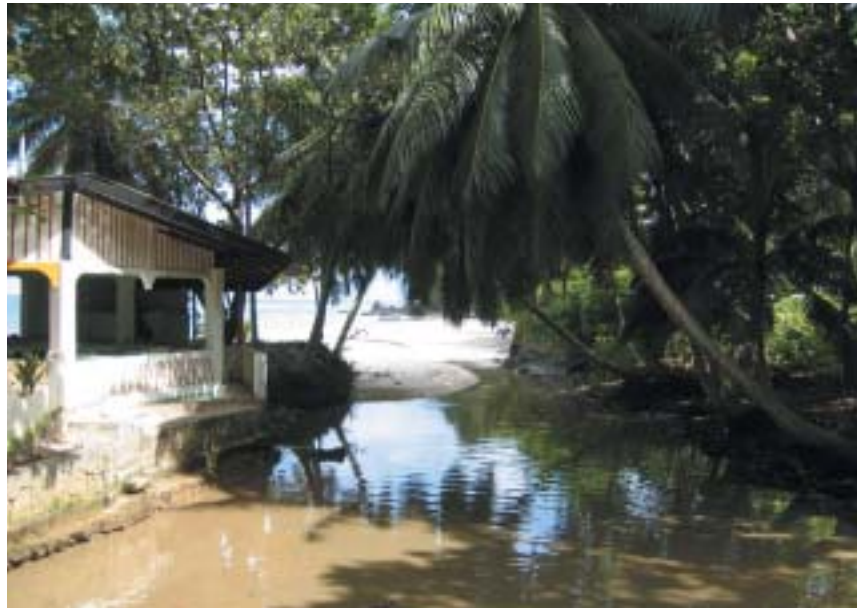
A clogged beach-side discharge channel.
Credit: M. de Vries

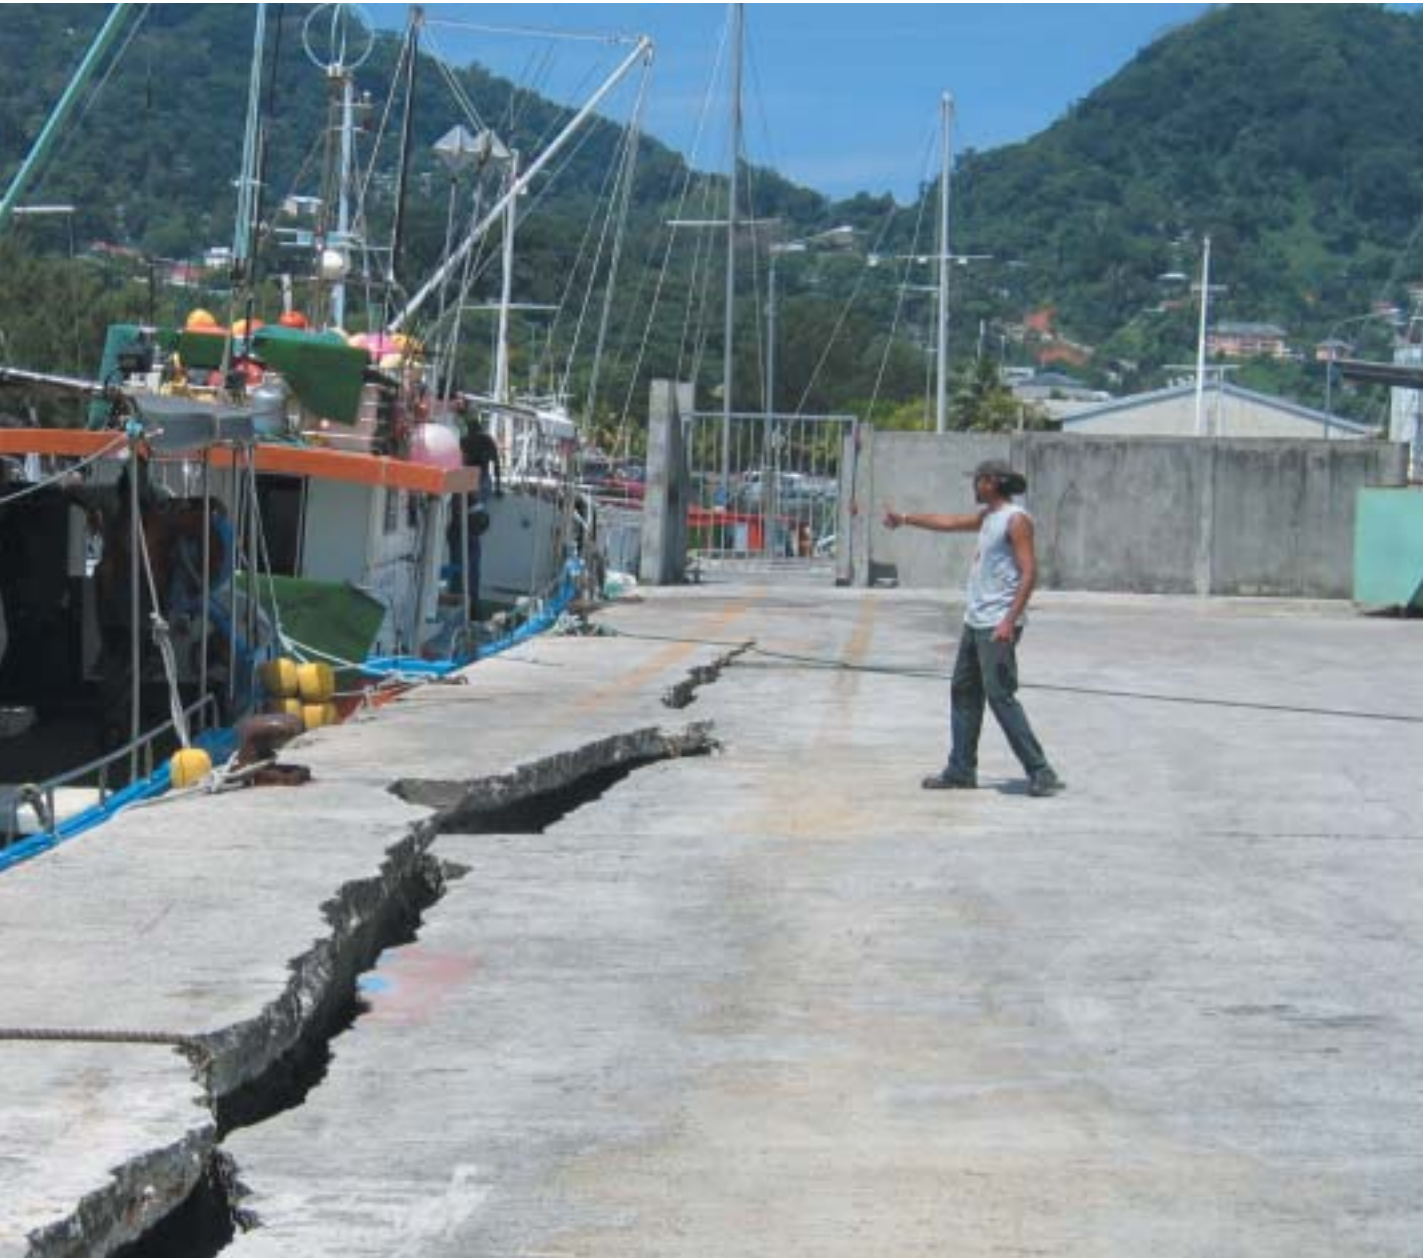
Peer damage caused by the tsunami storm surge.
Credit: M. de Vries

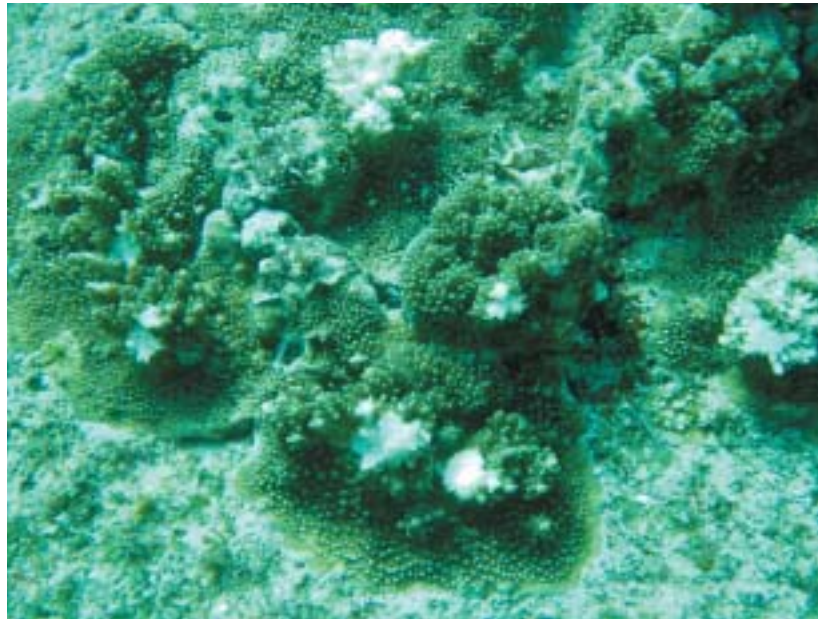
Coral reef with tsunami abrasion damage (white patches).
Credit: D. Obura

Granitic reefs suffered less damage than reefs with a calcium carbonate (limestone) substrate. Granitic surfaces were either immovable as they form the bedrock of the islands, or, in the case of boulders and rocks, were too dense and/or of too compact a shape to be displaced by the force of the tsunami. Even on carbonate rock surfaces that were consolidated and firm, attached corals showed little breakage and mechanical damage or overturning.

Tsunami damage to the loosely consolidated reef frameworks previously damaged by mass mortality of corals in the El Niño of 1998 is perhaps more of a threat to continued reef development than mortality to corals alive at the time of the tsunami. Mortality of the many ‘branching’ and small ‘massive’ corals in 1998 produced a large amount of loosely consolidated rubble that has been eroding since then, creating mobile rubble fields not conducive to new coral settlement and survival. Over the years, however, these rubble fields and branching frameworks have slowly consolidated into a loosely packed matrix, becoming more suitable for new reef growth. However, this reef matrix was not robust enough to resist the tsunami waves, in terms of either the force of water or collisions with mobile rubble and rocks. Thus, in these situations, the tsunami not only destroyed all the framework-consolidation that had

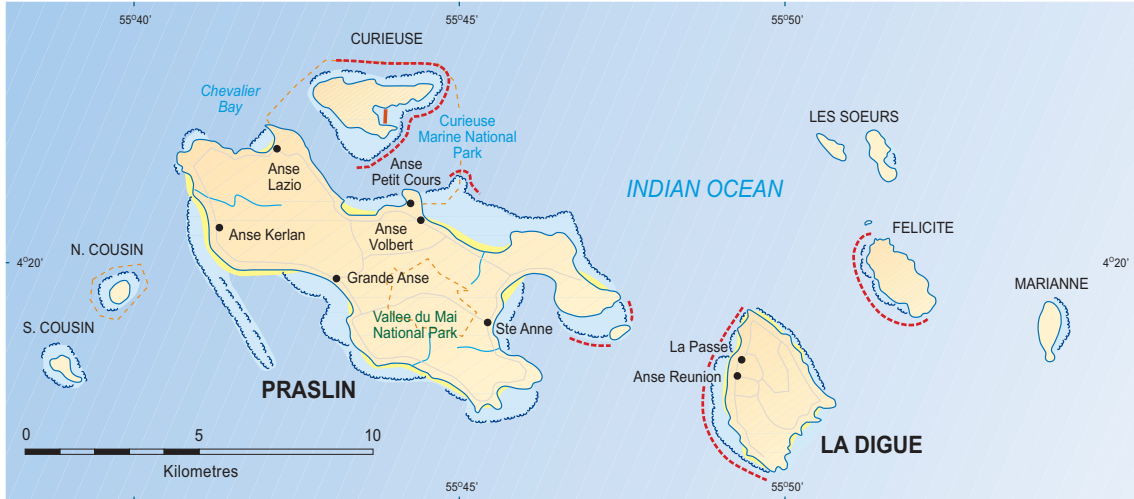
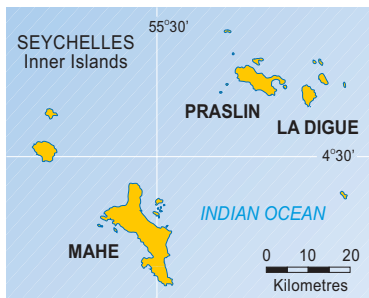
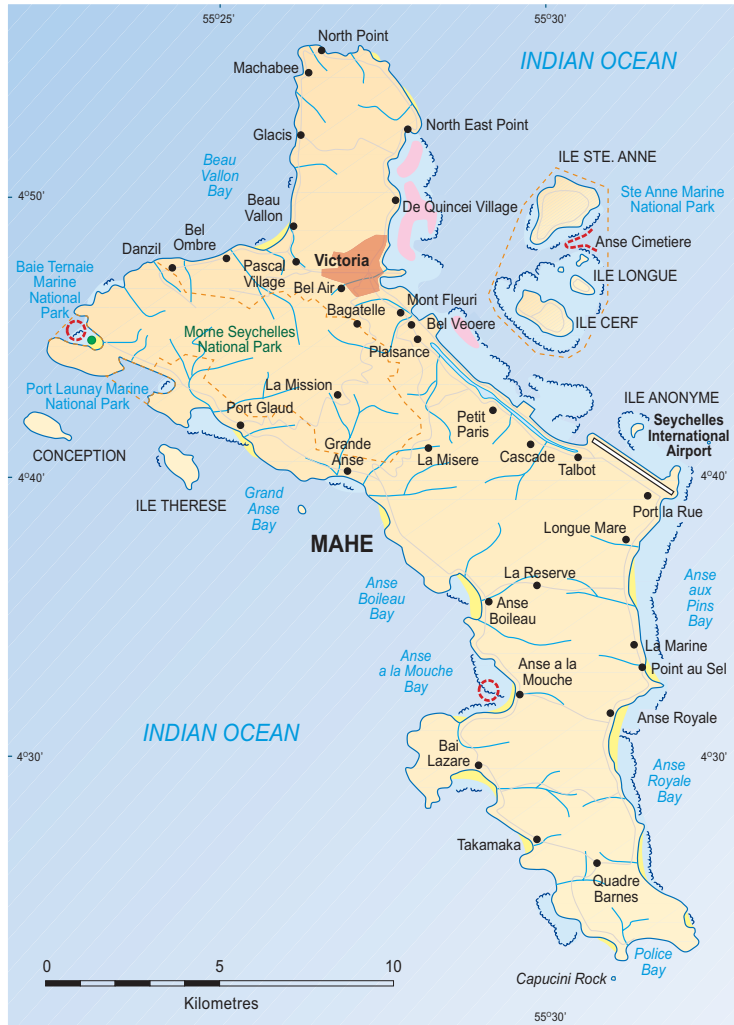
Tsunami impacts on coral reefs and sea grass beds

The geographic location of each island strongly influenced the degree of damage. The northern islands clustered around Praslin (including Curieuse, La Digue, Felicite and the rocks of Isle Coco and St Pierre) showed very high levels of damage – approaching 100% – on the carbonate reef substrates mentioned above. By contrast, sites around Mahé, including carbonate reefs damaged during the El Niño-induced bleaching of 1998, showed much lower levels of impact – generally below 10% – due to the shelter provided by the outer northern islands and dissipation of wave energy as the tsunami travelled over the greater distance of shallow water from the outer edge of the banks to Mahé.

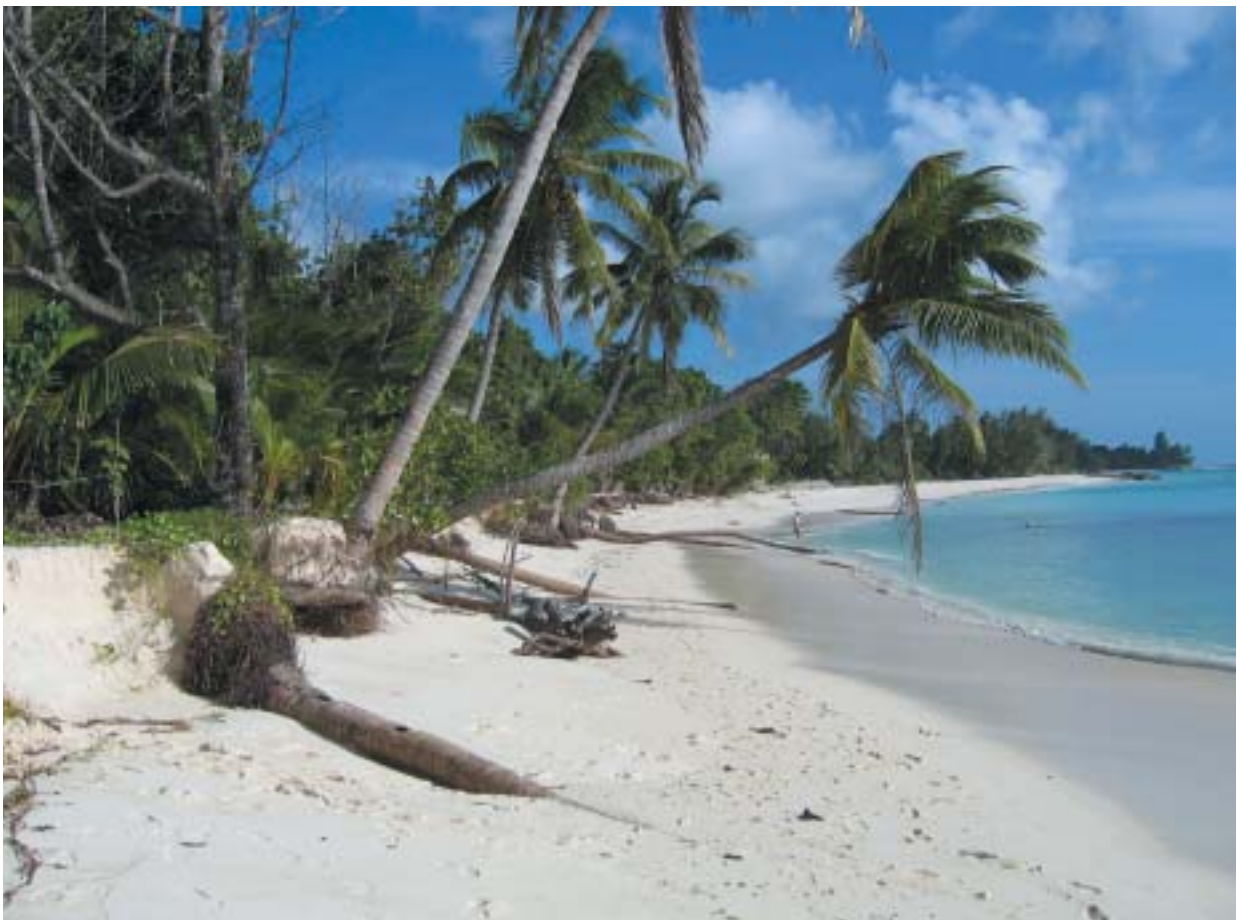
Eroded turtle beach at Anse Kerlan, Praslin. Credit: M. de Vries

The effects of the tsunami on coastal erosion are clearly visible not only on the exposed eastern side of the islands, but also on the western side, for example on the Anse Kerlan beach in northwest Praslin. The refracting tsunami waves caused beach erosion cliffs of more than 2.5 m height in places – see the Case Study above.

Hydrodynamic studies are needed in order to recommend either building of groynes (which could affect the turtles) or replenishment of lost sand. More immediately, the authorities must restore coastal vegetation and instigate a regular monitoring programme. Training and capacity building are also essential.

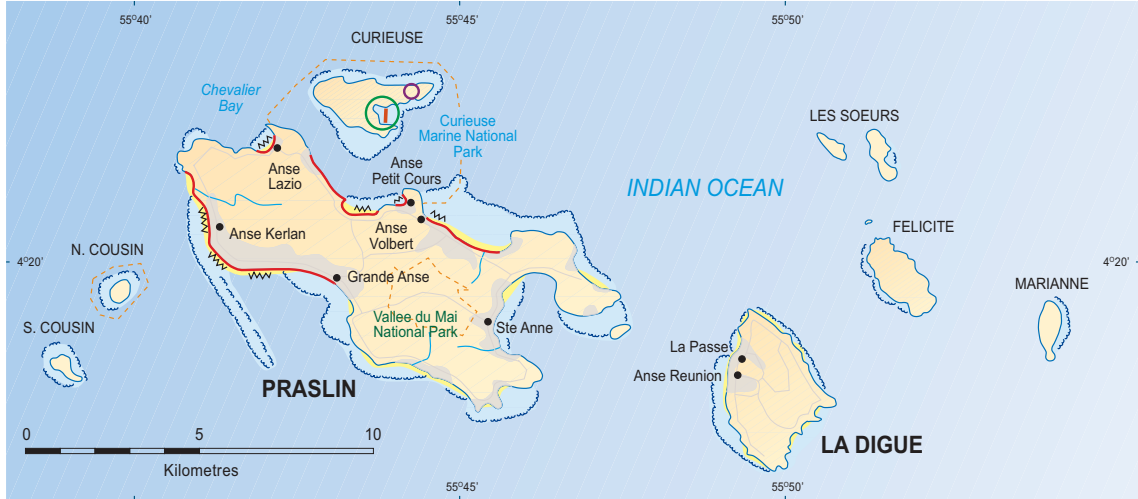
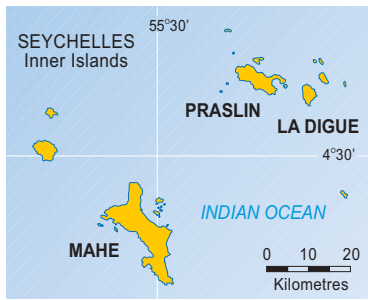
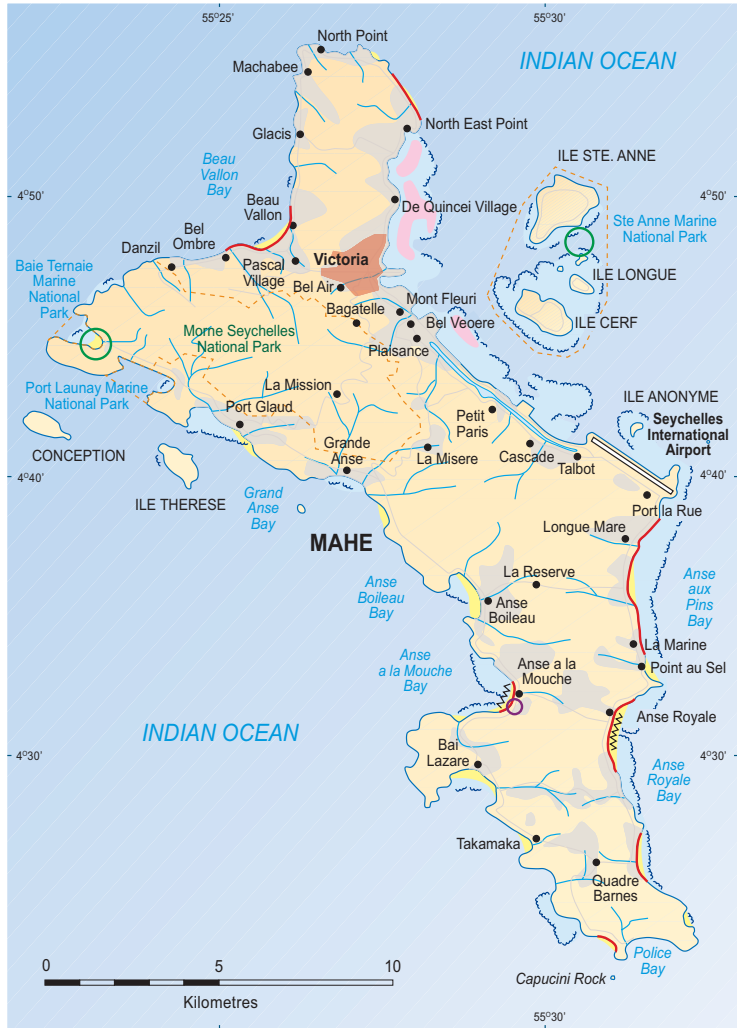
Seychelles Shoreline vulnerability and tsunami impacts

- Beaches regularly affected by erosion
- ~ Coastal erosion and scarps caused by tsunami wave surge and backwash
- Damage to coastal vegetation and infrastructure of the protected areas
- Impacts on marine turtle nesting sites and tortoise pens (artificial cages)

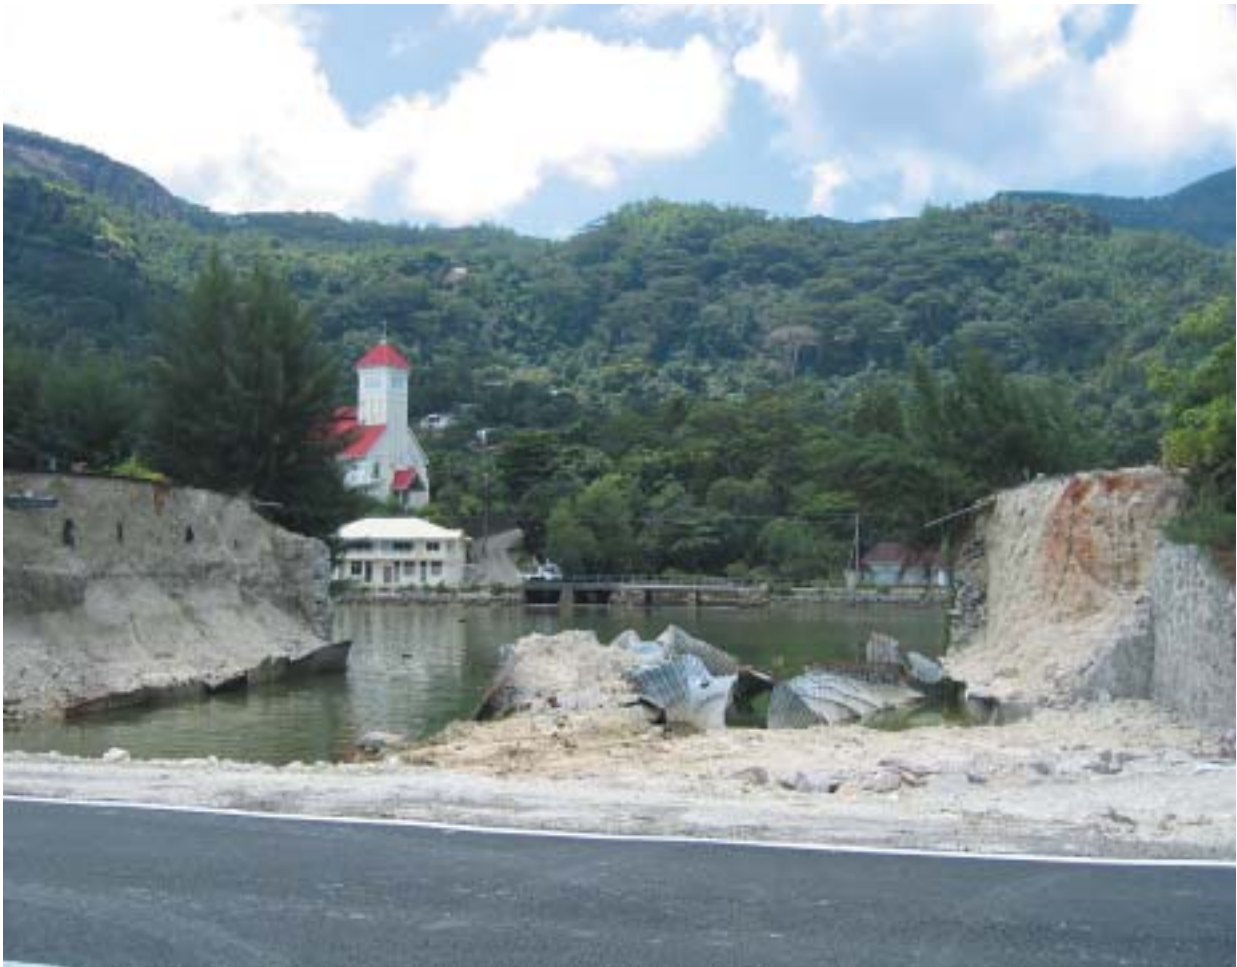
The remains of a road swept away by the tsunami (photo taken from repaired section). Credit: M. de Vries

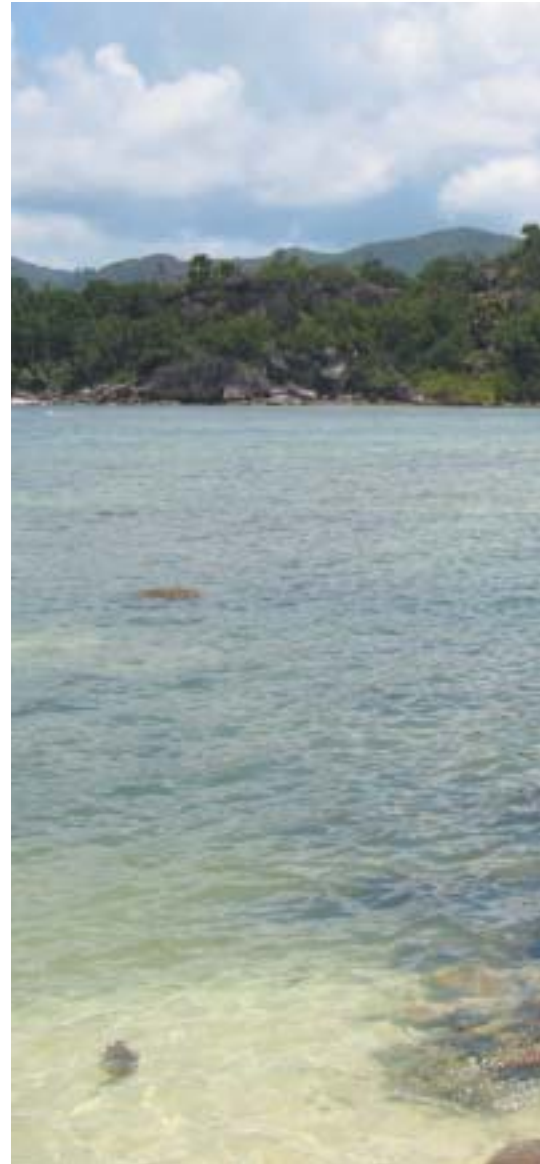
The tsunami destroyed the breakwater and walkway in Curieuse National Marine Park.
Credit: M. de Vries

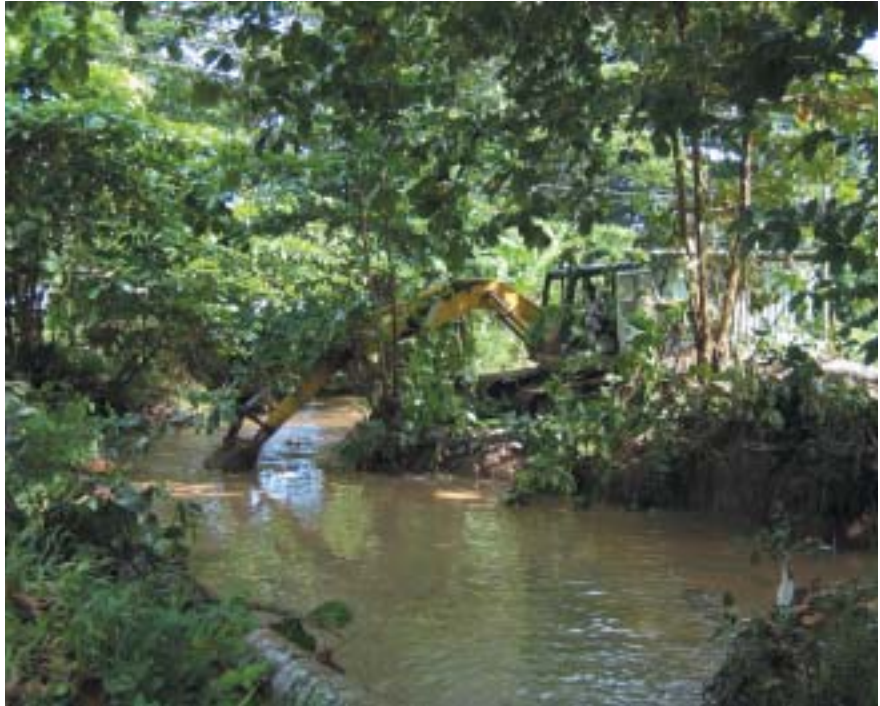
Dredging a clogged discharge channel.
Credit: M. de Vries

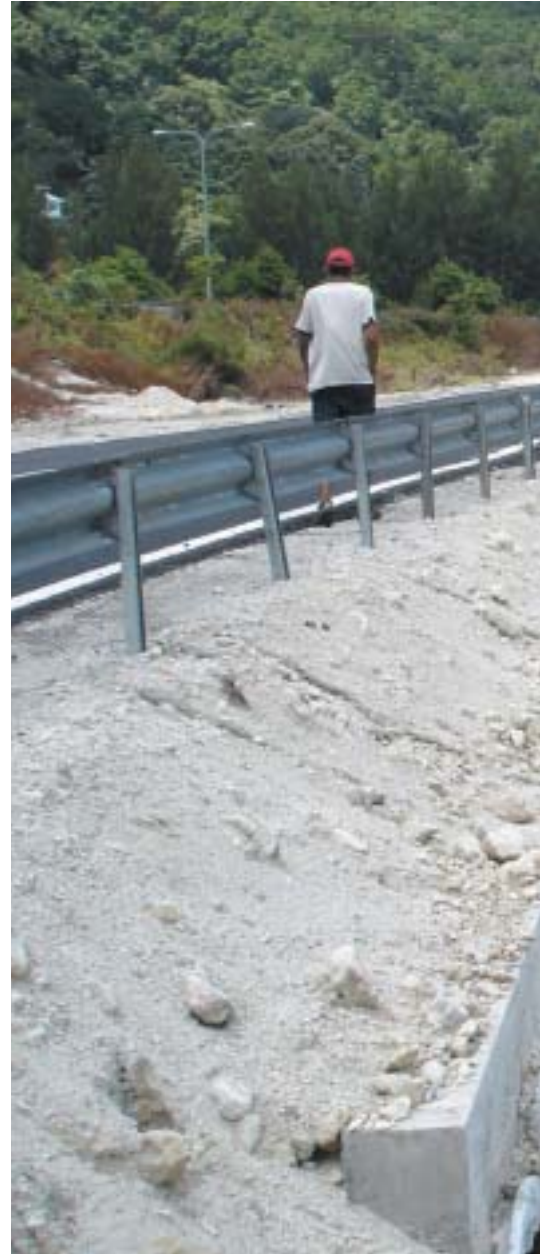
A reconstructed bridge on the airport highway following the tsunami.
Credit: M. Collins
