Environmental Assessment of the Gaza Strip

following the escalation of hostilities in
December 2008 – January 2009

United Nations Environment Programme

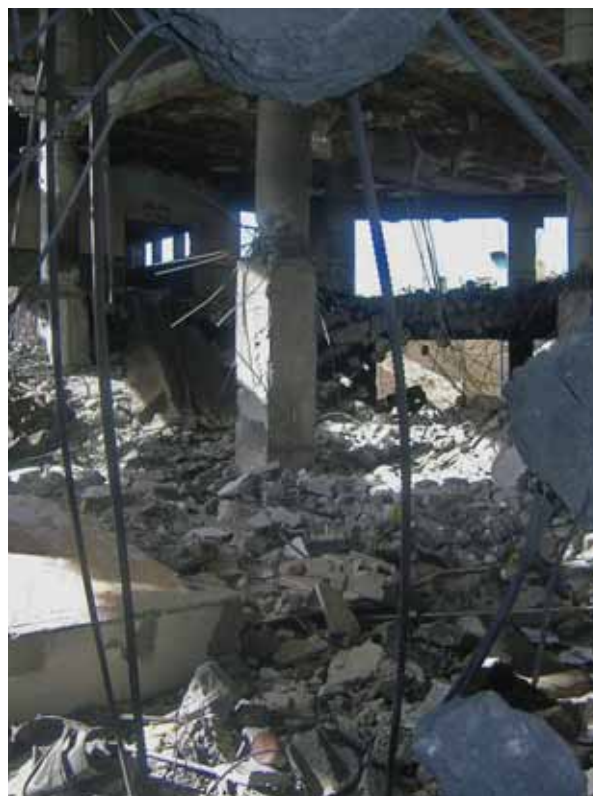
Damaged building in the Gaza Strip

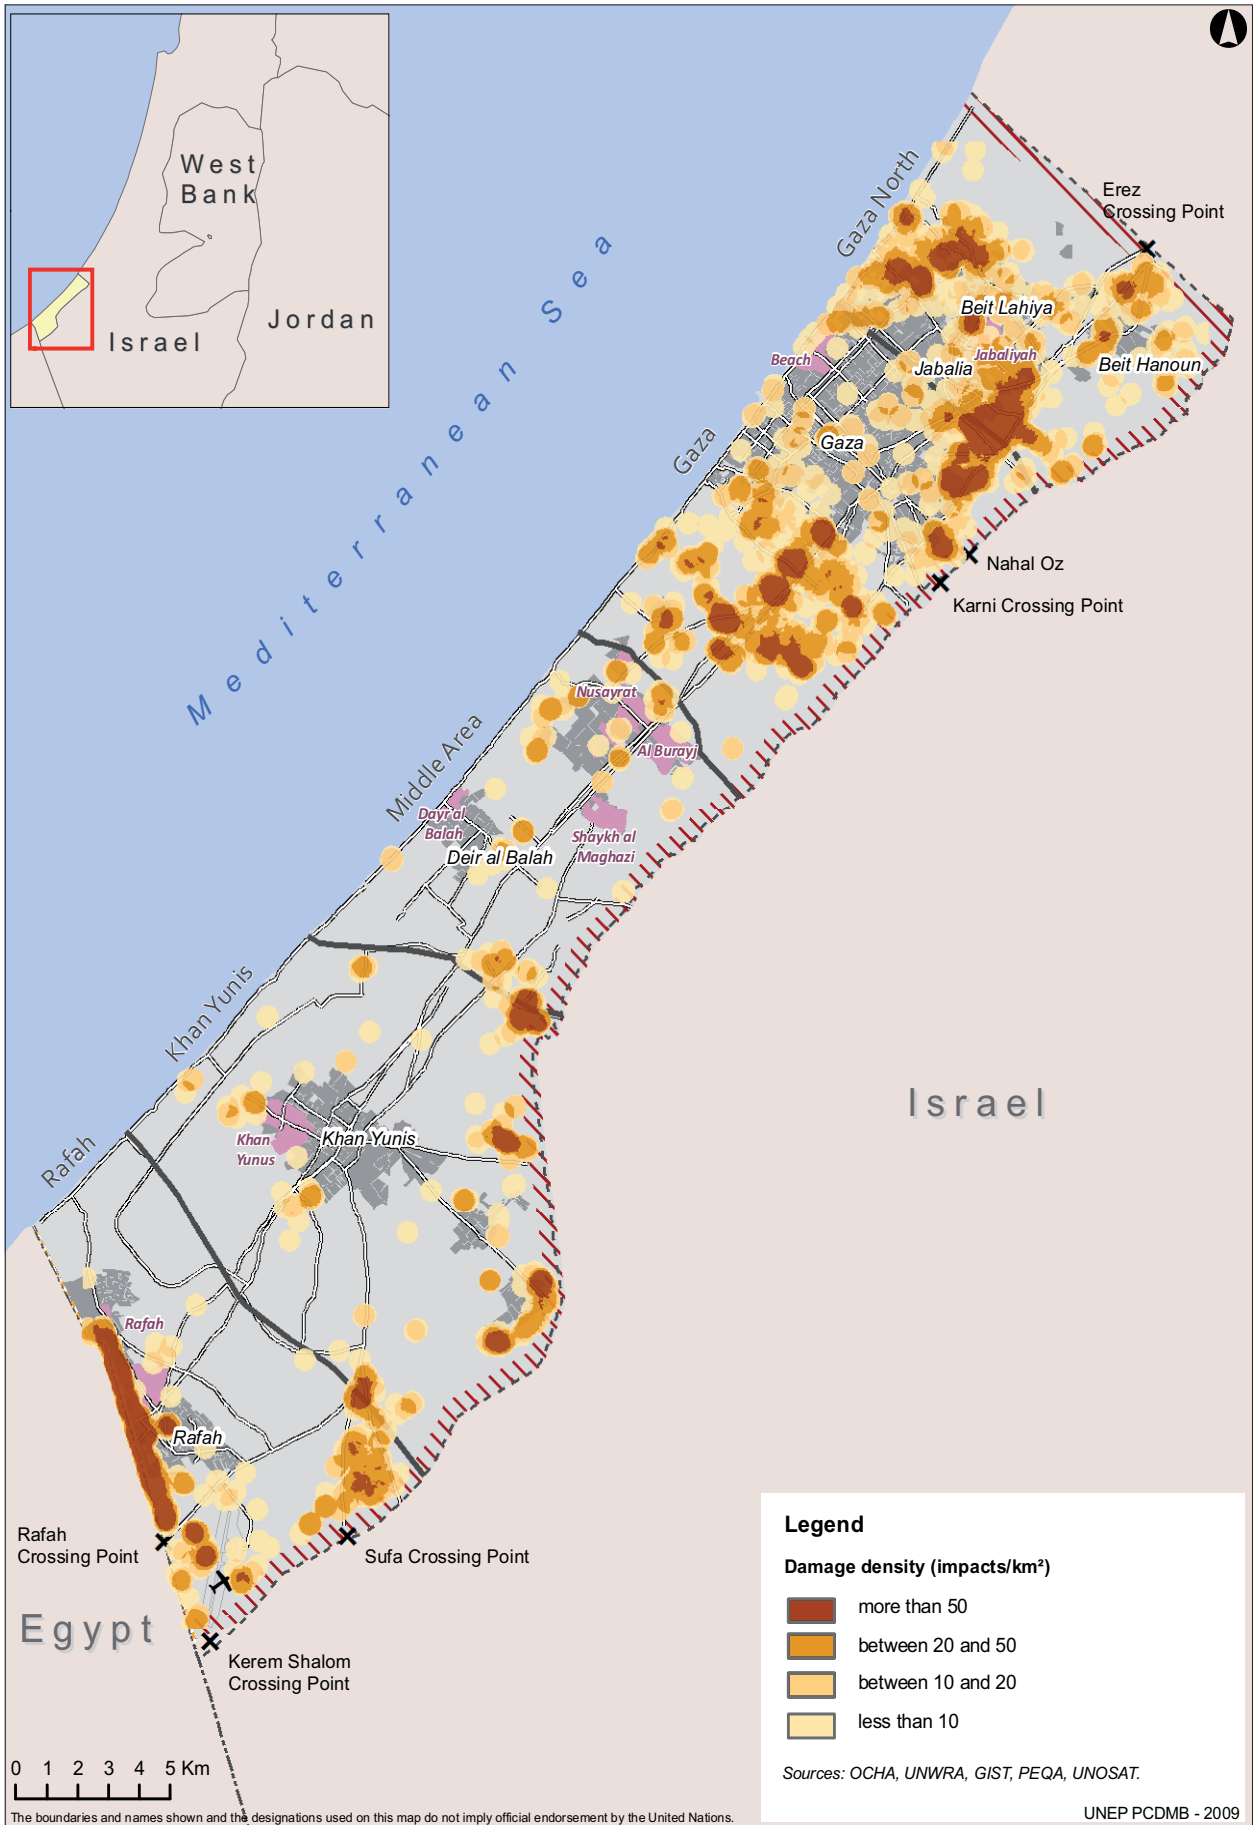
Map 3. Damage analysis map

The limited spatial resolution of the satellite imagery significantly reduces the confidence level for damage identification within dense urban areas. It is highly probable, therefore, that the damage assessment underestimated the actual building and infrastructure damage at the time of satellite image acquisition.

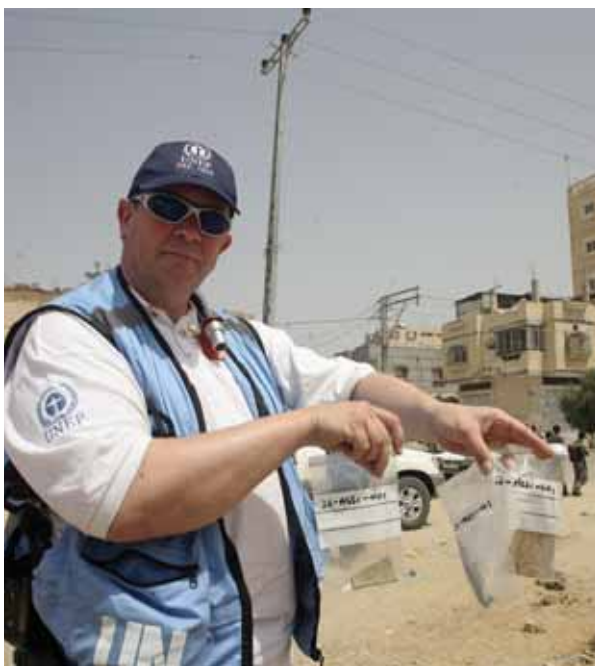
At each location that was visited, the UNEP team made a brief inspection of the site on foot. Where materials that were suspected of containing asbestos were observed, location details were recorded both on paper and using a digital camera with a GPS. A representative sample was taken using appropriate hand tools and techniques. The potential for asbestos fibre release during sampling was minimized by the use of a dust-suppressing water spray where required. Each sample was then sealed in labelled polythene bags and sent to a laboratory in Switzerland for analysis for asbestos type.

UNEP expert in Rafah with asbestos samples

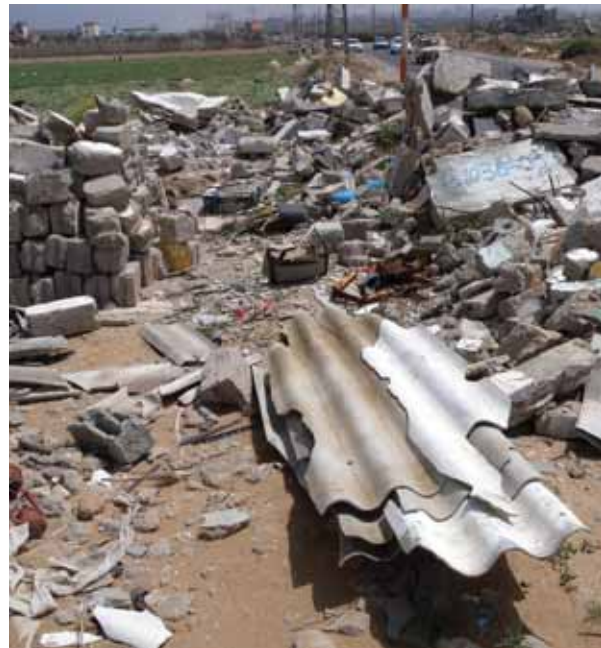
Asbestos in rubble

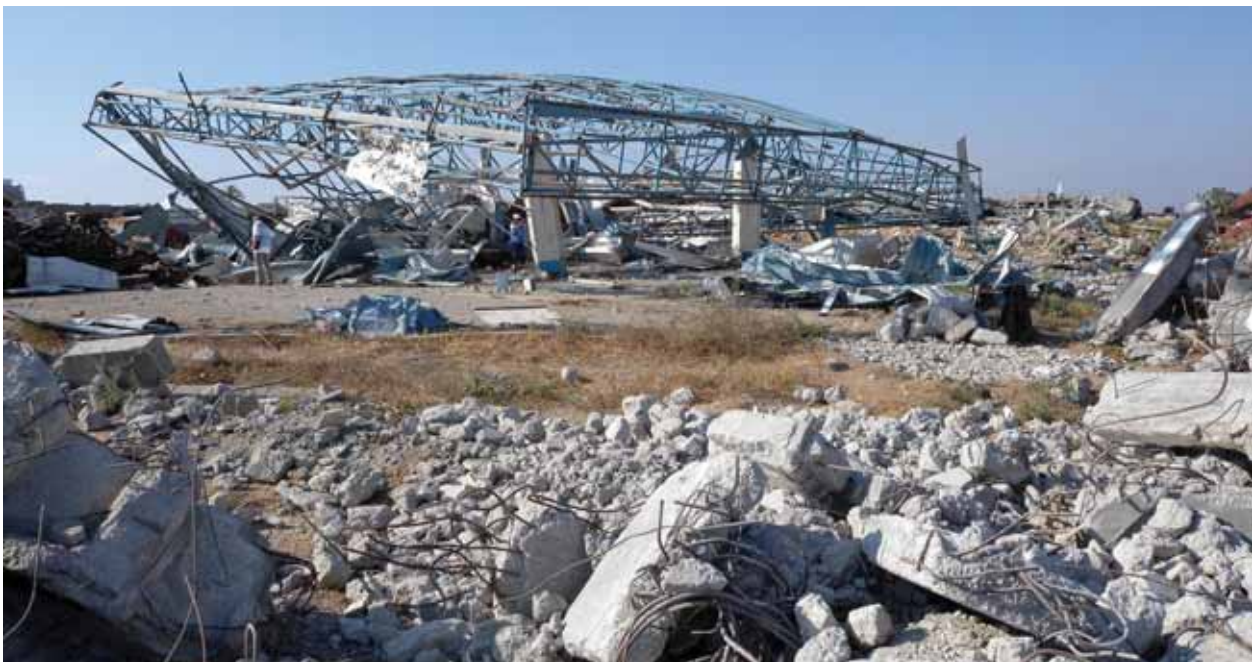
Demolished gasoline station in Northern Gaza Strip

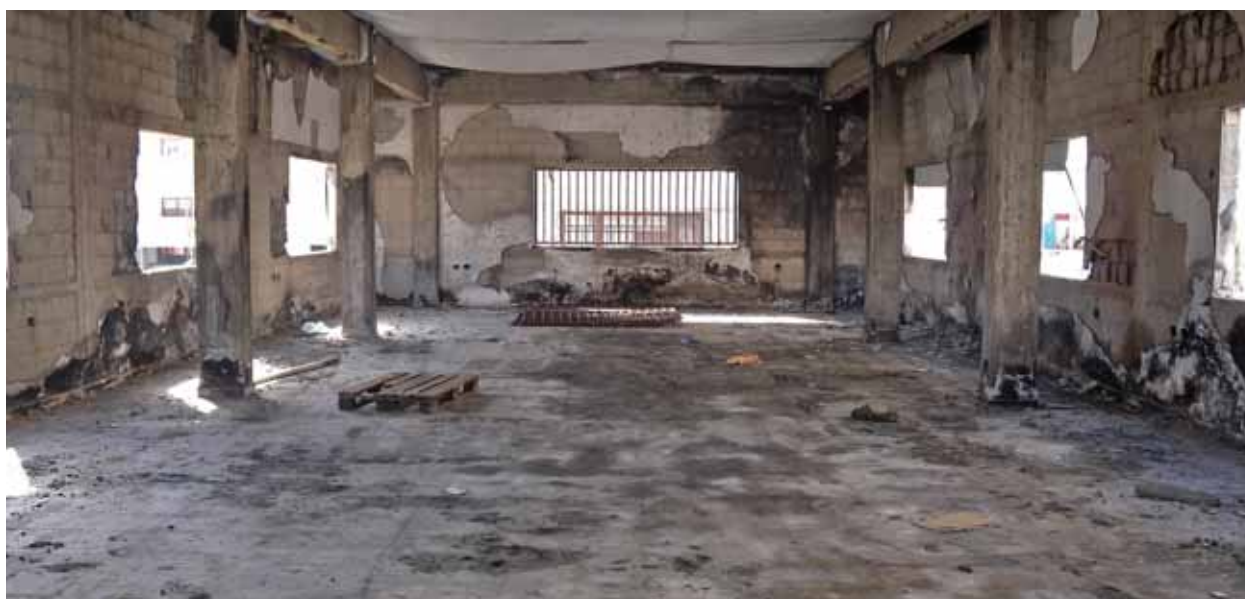
In addition, a number of buildings were hit by ammunition that caused fires and partial or total destruction of the structure. Building fires contaminate the building and/or the resulting rubble with polynuclear aromatic hydrocarbons (PAHs) and, if chlorinated compounds are present, with dioxins and furans, all of which are extremely hazardous.

Burnt out interior of the Red Crescent building in Gaza City

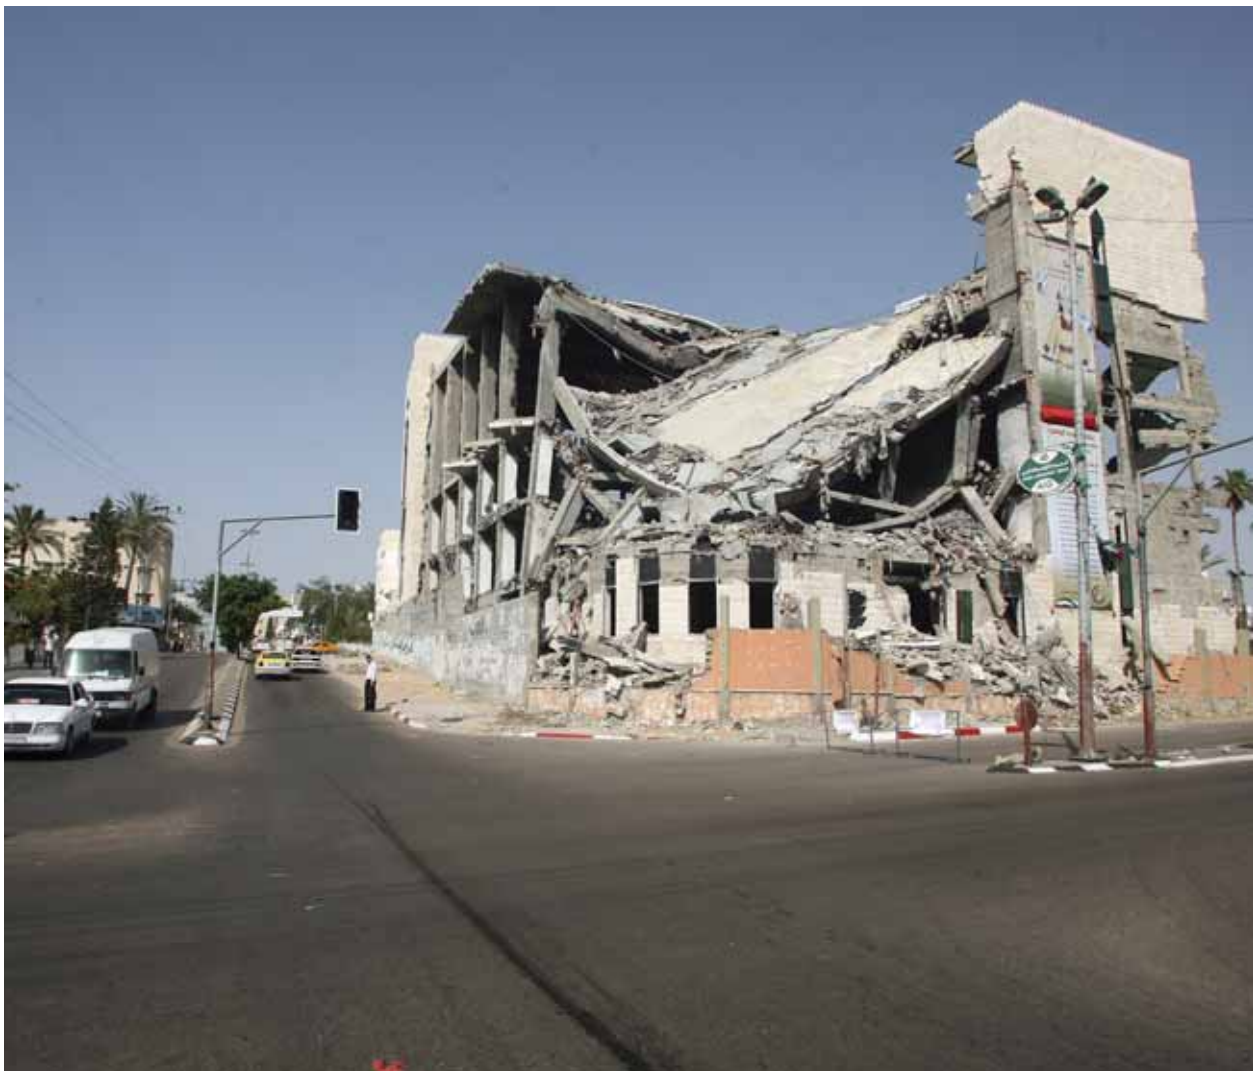
Hanging rubble in partially demolished buildings, like this one in Gaza City, poses a major challenge

However, the problem urgently requires a solution which, considering the special circumstances in the Gaza Strip, should ideally not only be low tech and low cost, but also in line with international standards of work health and safety. It is therefore recommended to engage a professional health and safety expert to assist the teams undertaking the demolition.

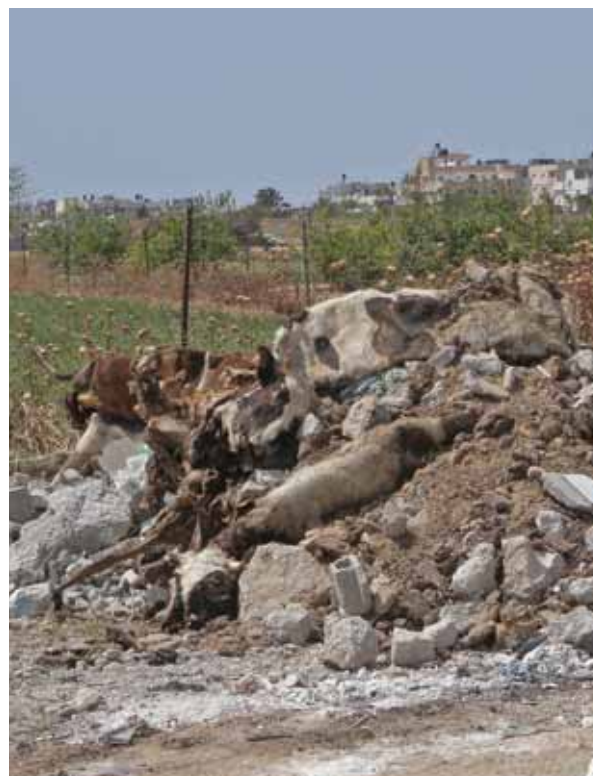
According to the Palestinian National Early Recovery and Reconstruction Plan for Gaza 2009-2010,² over 35,750 cattle, sheep and goats and more than one million birds and chickens were killed during the recent events. These animals could not be consumed for religious and hygiene reasons. The owner of a damaged stable that the UNEP assessment team visited in May 2009 in a commercial/agricultural area east of Jabaliyah stated that he had lost more than 200 goats and sheep during the attack, which severely damaged his stable. He stated that the municipality of Gaza had ordered him to bury the animals and cover them with lime. Nevertheless, close to the site, many animal cadavers could still be seen lying unattended as late as May 2009. Although the total mass of cadavers can only be estimated, it appears to range between 1,000 and 1,500 tonnes.

Dead animals at the roadside in Beit Hanoun

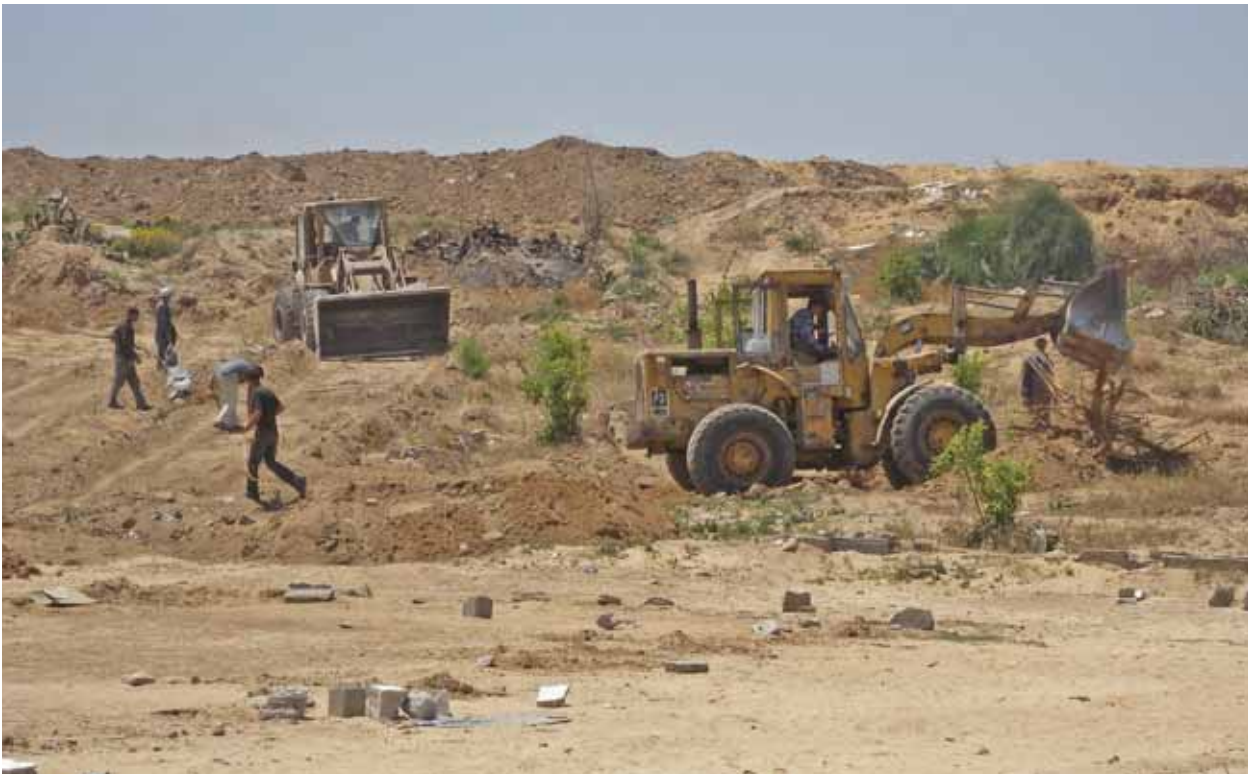
Farmers rehabilitating an olive plantation bulldozed during operation Cast Lead, east of Gaza City

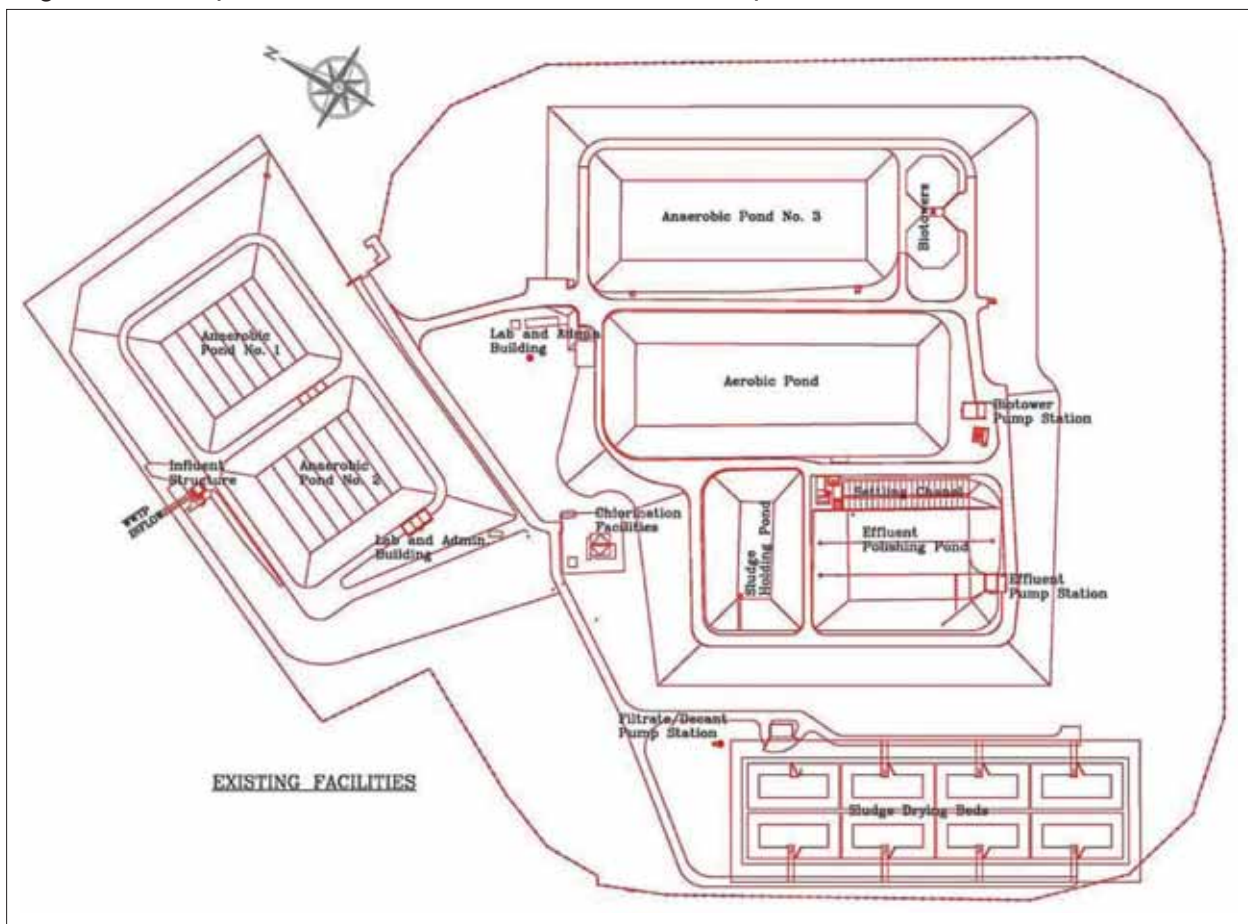
Figure 1. Layout of the Az Zaitoun wastewater treatment plant⁵

During the recent conflict, anaerobic pond no. 3 was damaged, its embankment destroyed, and more than 100,000 m³ of wastewater and sludge spilled into adjacent agricultural areas.⁶ UNDP estimated that 55,000 square metres of agricultural land were impacted by this spill.

As can be seen from Figure 1,⁵ the CMWU is planning to upgrade the Gaza sewage treatment plant in the area of the waste deposits by constructing two more trickling towers (new “bio-towers”). The location chosen for these towers is the waste dump site mentioned previously. However, this is not stable ground and the waste will have to be removed before any construction begins.

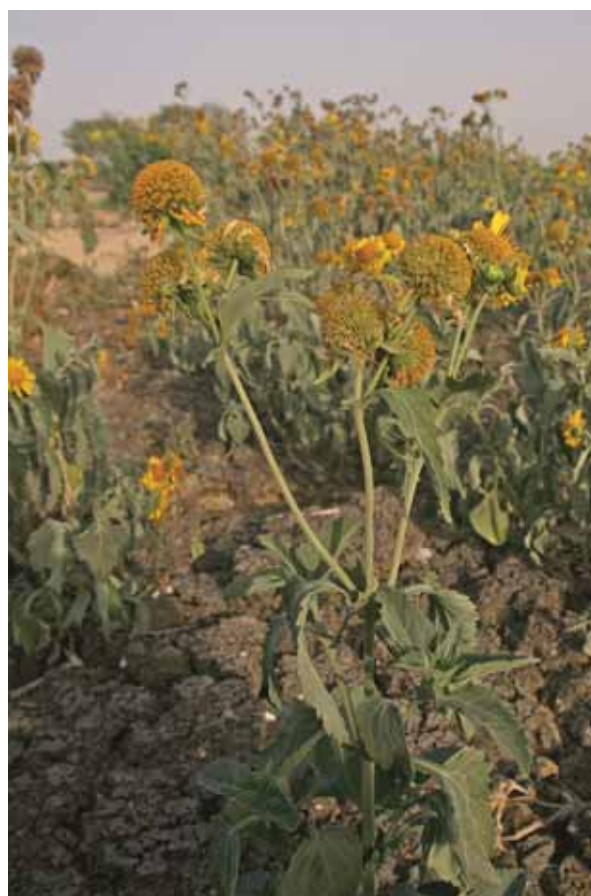
Untreated (and even partly treated) sewage sludge contains large quantities of pathogens as well as elevated levels of heavy metals. In most countries, the disposal of sewage sludge is regulated based on its quality, the quantity to be applied and the type of land where it might be applied. The uncontrolled spreading of untreated sewage and settling of sewage sludge

Plants growing on dried sewage sludge near Az Zaitoun plant

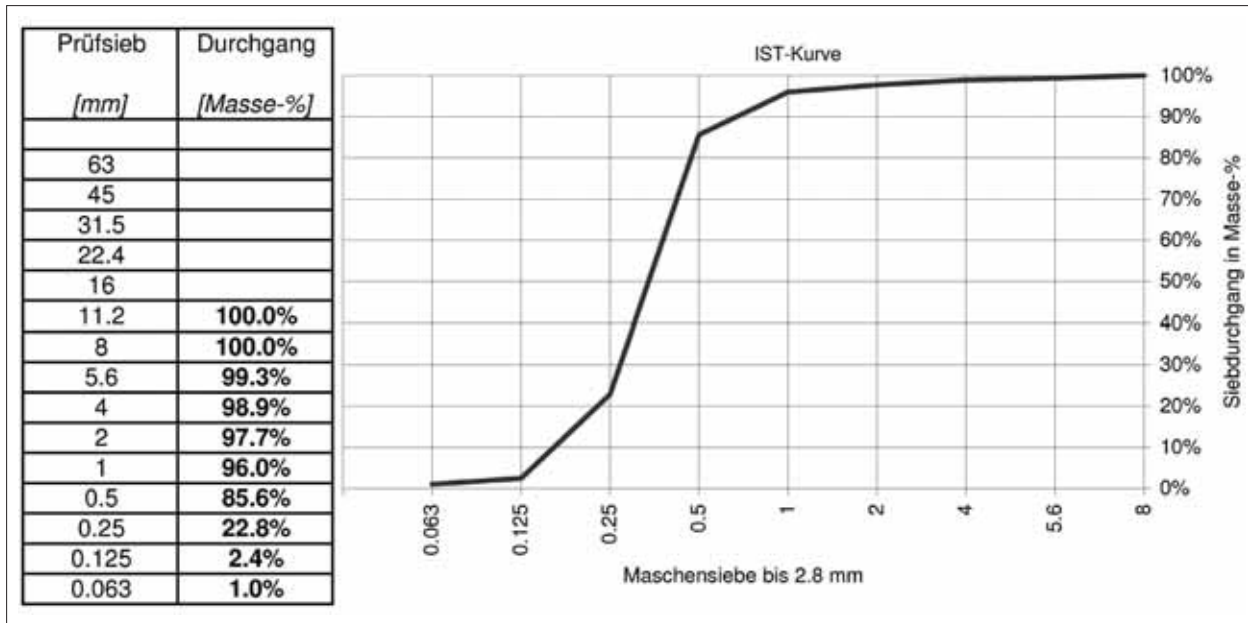
Figure 2. Grain size analysis of sample 05-SOIL-02

The curve in Figure 2 shows that the grain size of 90 percent of the sample size varies between 0.125 mm and 1.0 mm. According to the grain size analysis results, the hydraulic conductivity is $k_f = 2.6 \times 10^{-4}$ m/s, which is average to high for sand. The underlying soil is highly permeable.

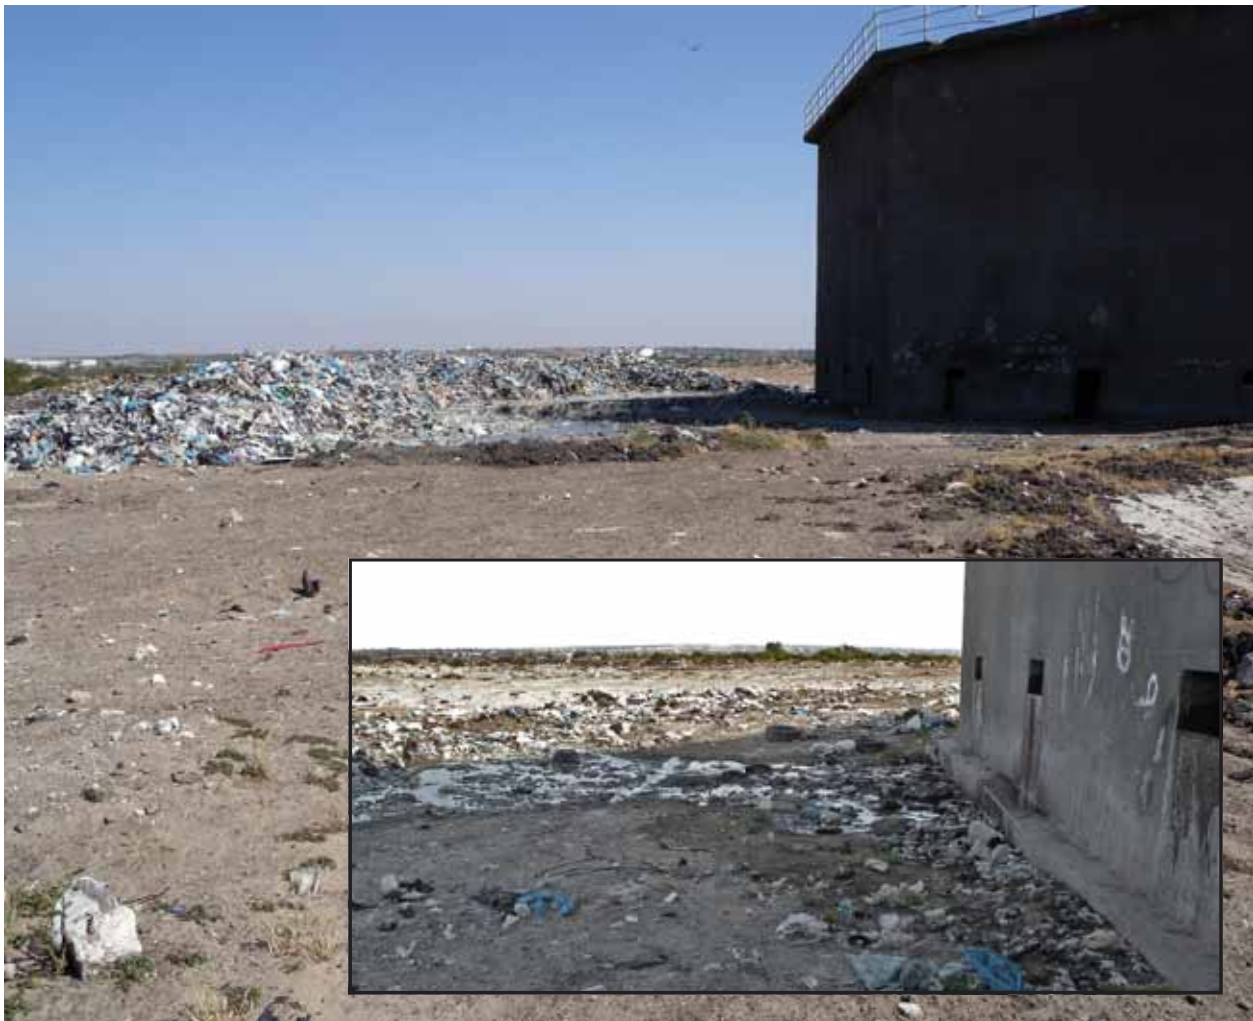
Az Zaitoun wastewater treatment plant trickling tower leakage

Leakage from the Az Zaitoun wastewater treatment plant trickling towers onto an adjacent pile of waste

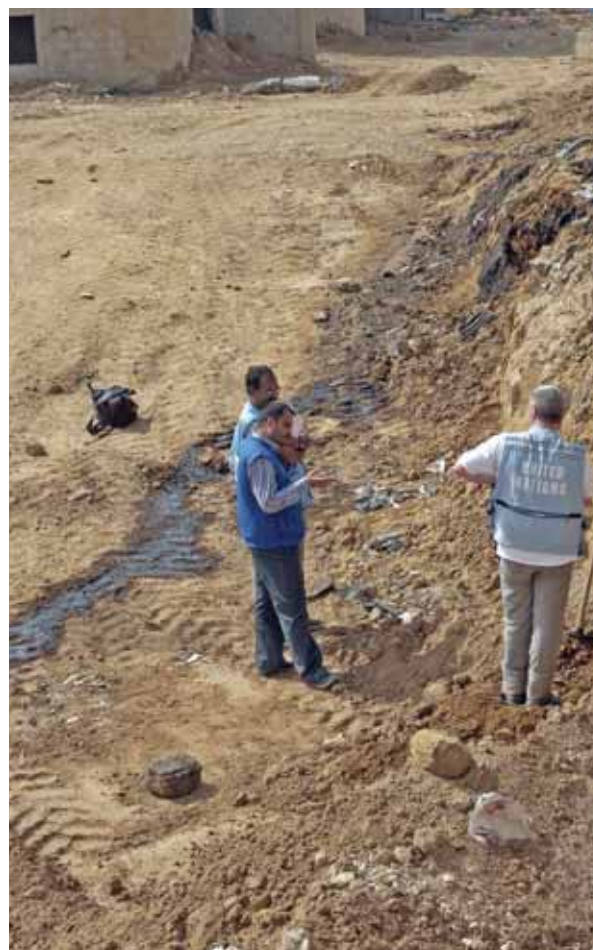
No base lining or leachate control systems were found in the landfill sites visited in the Gaza Strip. Leachate was observed on some sites, such as in the Rafah landfill. In these cases, the risk of groundwater contamination is only limited by soil permeability and desiccation, and the soil's ability to absorb contaminants. The soil pathway in landfill areas usually affects outflows of landfill leachate on neighbouring land. These effects are usually very limited and restricted to a few thousand square metres immediately around the landfill. The soil contamination in this case depends on the organic and inorganic contaminants in the leachate, which may vary widely. However, over a period of time, the leachate can reach and pollute the groundwater.

Landfill leachate leaking from Rafah landfill

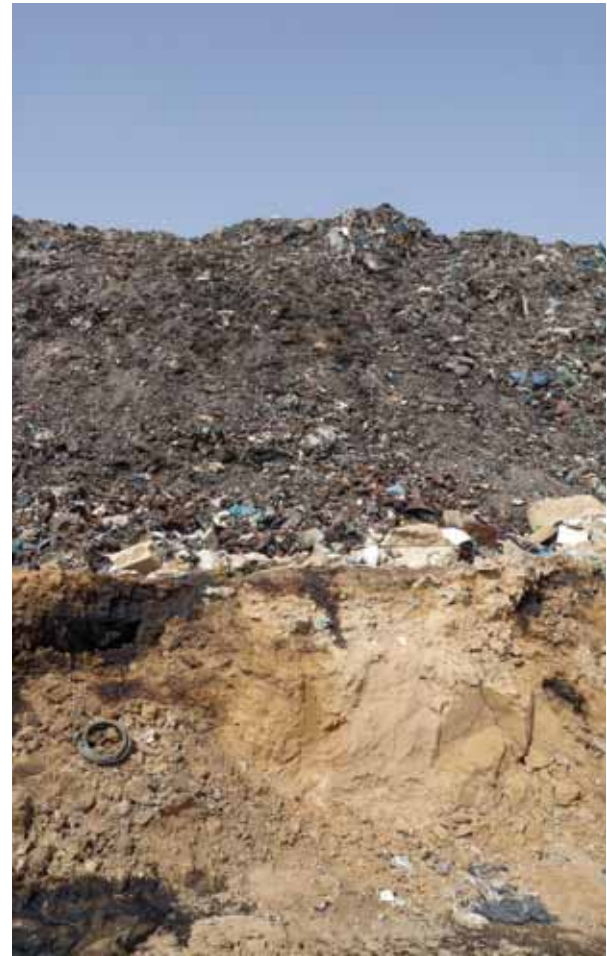
The curve in Figure 4 shows that the grain size of 90 percent of the sample mass varies between 0.063 mm and 0.5 mm. According to the grain size analysis results, the hydraulic conductivity is $k_f = 4.6 \times 10^{-5}$ m/second, which is average for a silty sand. In combination with the low precipitation and high evapo-transpiration in the Rafah area, this may be sufficient to reduce the impact of the landfill on the groundwater. However, if there are cracks present, they will facilitate direct percolation of highly concentrated leachate into the groundwater.

Base of the Rafah landfill

In any case, the slope of the landfill should be diminished to minimize the risk of slope failure. In addition, the slope should be covered with silty sand and/or clay to minimize infiltration of

precipitation. In daily operations, the waste should be compacted as a measure against vectors and to minimize pore volume.

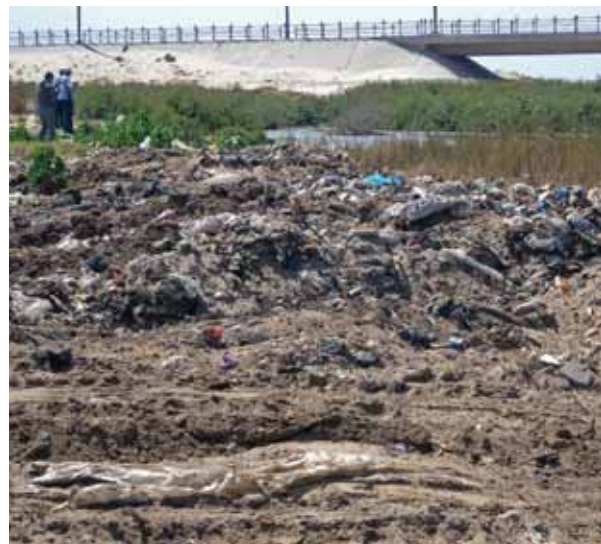
Wadi Gaza waste dump site

20,000 m² is used as a waste dump site. The waste itself is being used for land reclamation, and the bed of the stream is being filled with it. Taking into account a waste height of 1-2 metres, an estimated 20,000-40,000 m³ of waste has been deposited in this area so far. It was not possible to determine whether the recent hostilities had led to an increase in waste dumped at this site.

As sewage-related contamination and waste deposition on this site could not be reliably distinguished, the soil samples taken from this site are discussed in the section on sewage. Considering the ecological value of Wadi Gaza, waste dumping should be stopped immediately. The removal of waste inhibiting the flow of water into the wadi should also be considered, although this is a secondary issue compared to the urgency of the sewage problem.

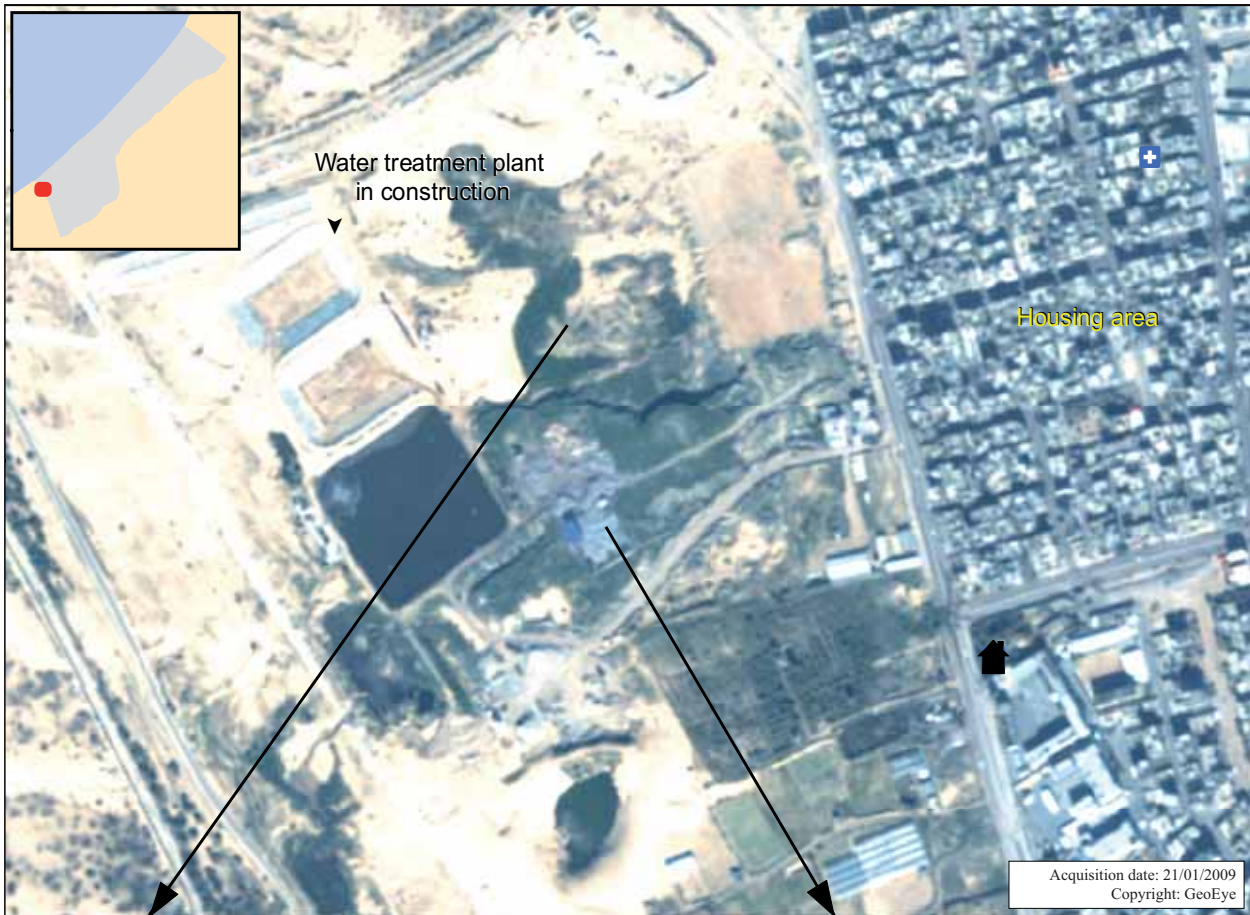
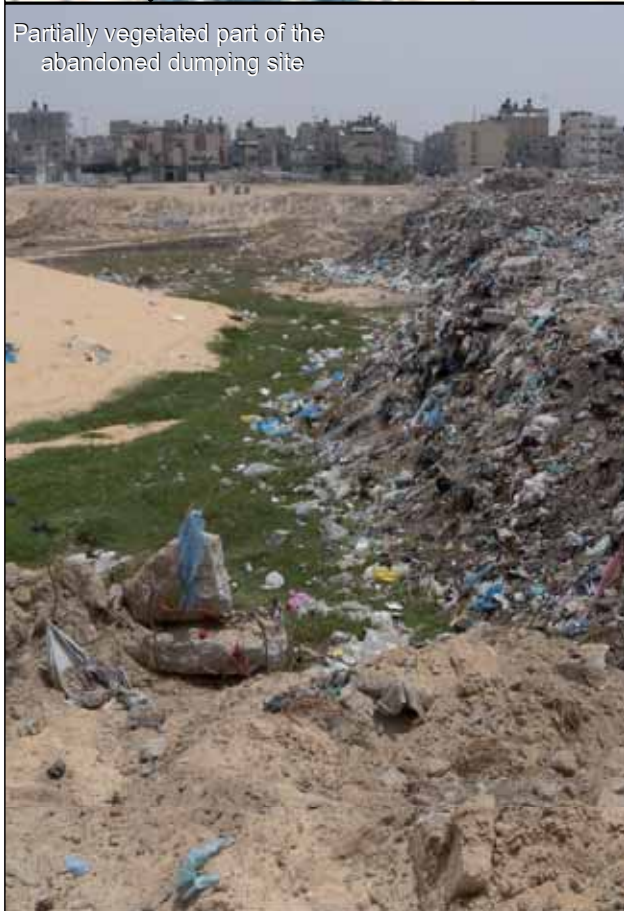
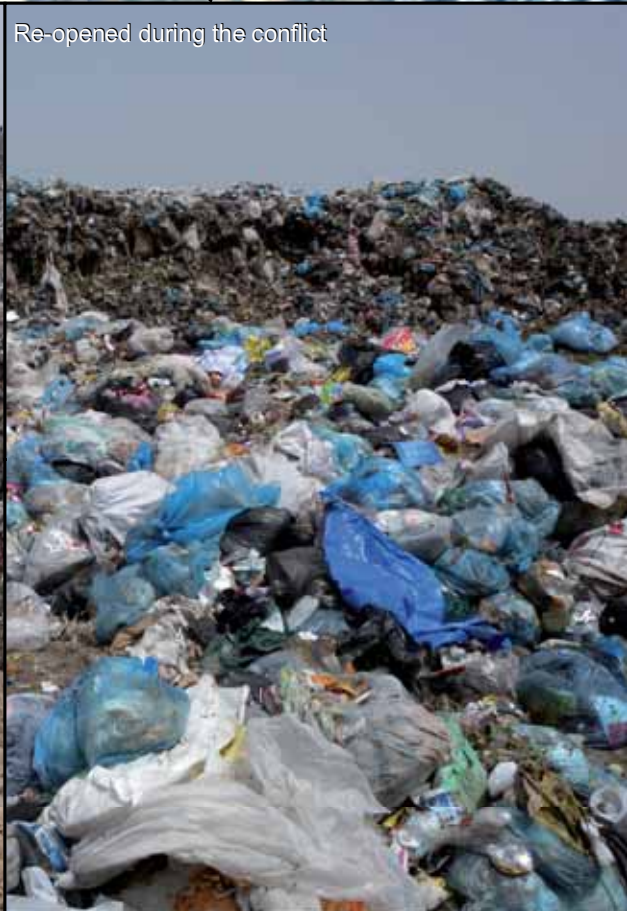
Map 13. Tal El Sultan old landfill site

Tal El Sultan old landfill site (Site no. 8)

The site should be closed and its contents removed to a properly located and designed landfill site. After due diligence has been carried out, the site should be restored.

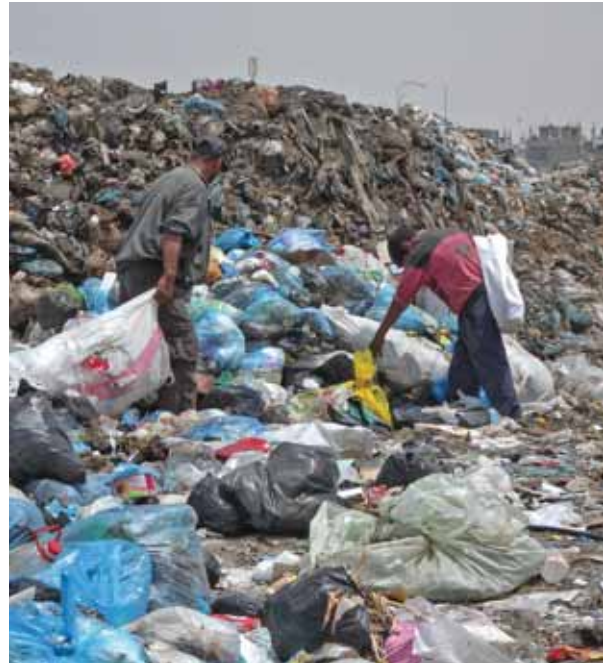
transmit diseases such as leptospirosis, salmonellosis, meningitis, and rat bite fever. Other disease vectors in the area are sand flies (*Phlebotomus sp.*) that lay eggs in places rich in organic matter and transmit leishmaniasis, and common flies.

Scavenger on the Tal El Sultan old landfill site

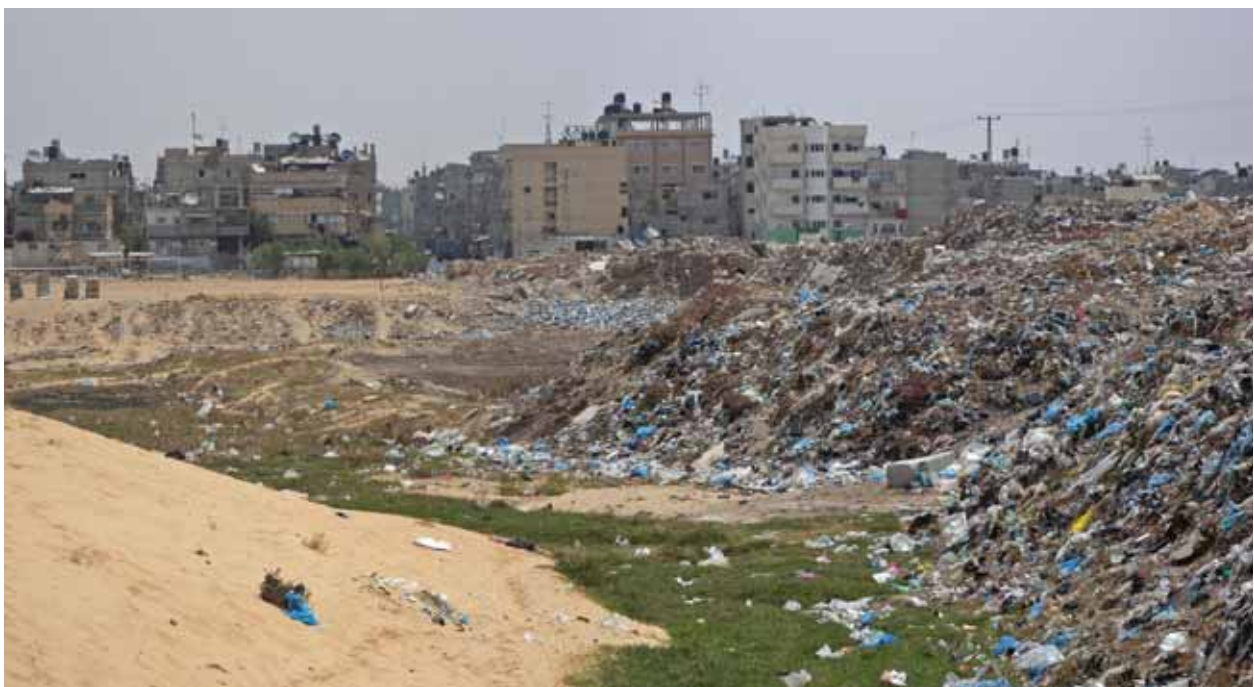
The decommissioned Tal El Sultan landfill site was reopened during the recent hostilities

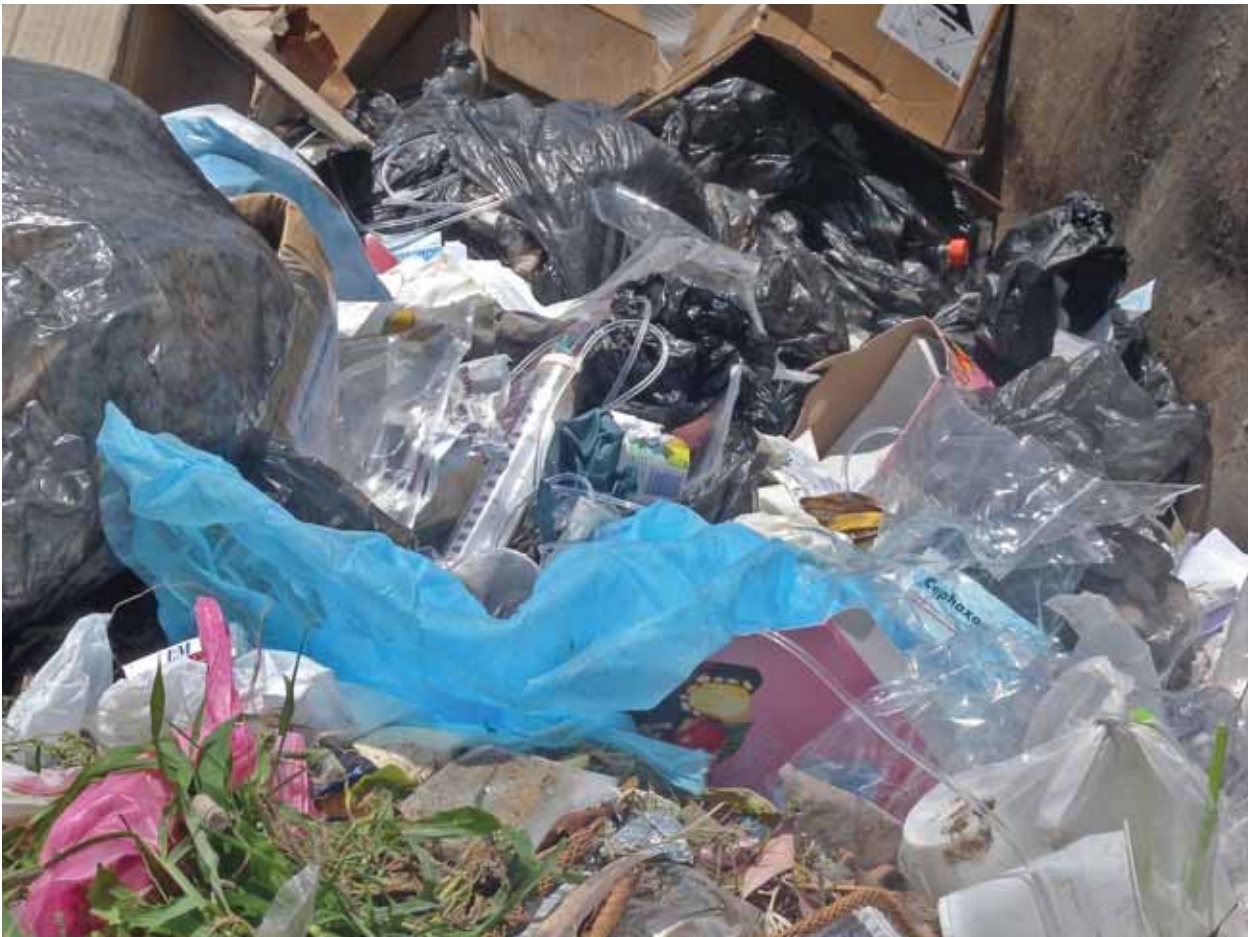
Hazardous healthcare waste in a Gaza City hospital container

Much of the backlog has now been cleared through incineration and disposal to landfills. Indeed, visits to landfills revealed evidence of HHCW in the waste stream. At nearly every site, sharps, needles, bandages, and other related materials were found. In all cases, the waste was not disposed of in separate areas, or in marked or specially coloured plastic bags, but was openly accessible.

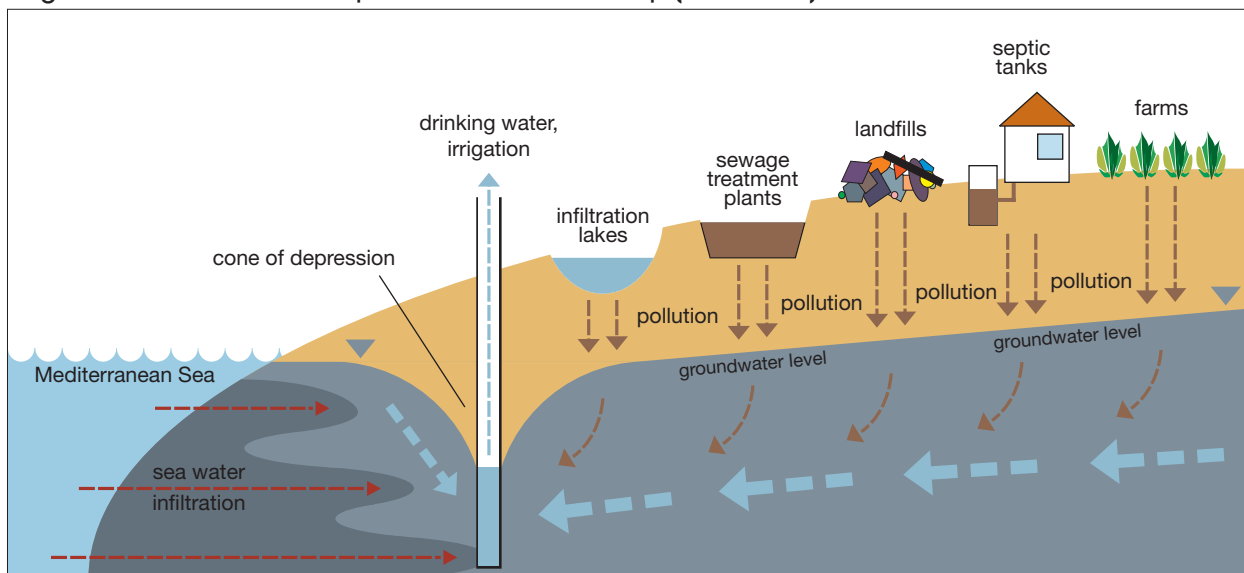
Figure 6. Groundwater pollution in the Gaza Strip (schematic)

levels are declining in areas where abstraction is greatest, while salt water infiltration from the sea is causing the aquifer to become more saline. The salinity levels in most parts of the Gaza Strip are now above the WHO approved guideline of 250 mg/litre, and often much higher.
