Environmental Assessment of the Gaza Strip

following the escalation of hostilities in
December 2008 – January 2009

United Nations Environment Programme

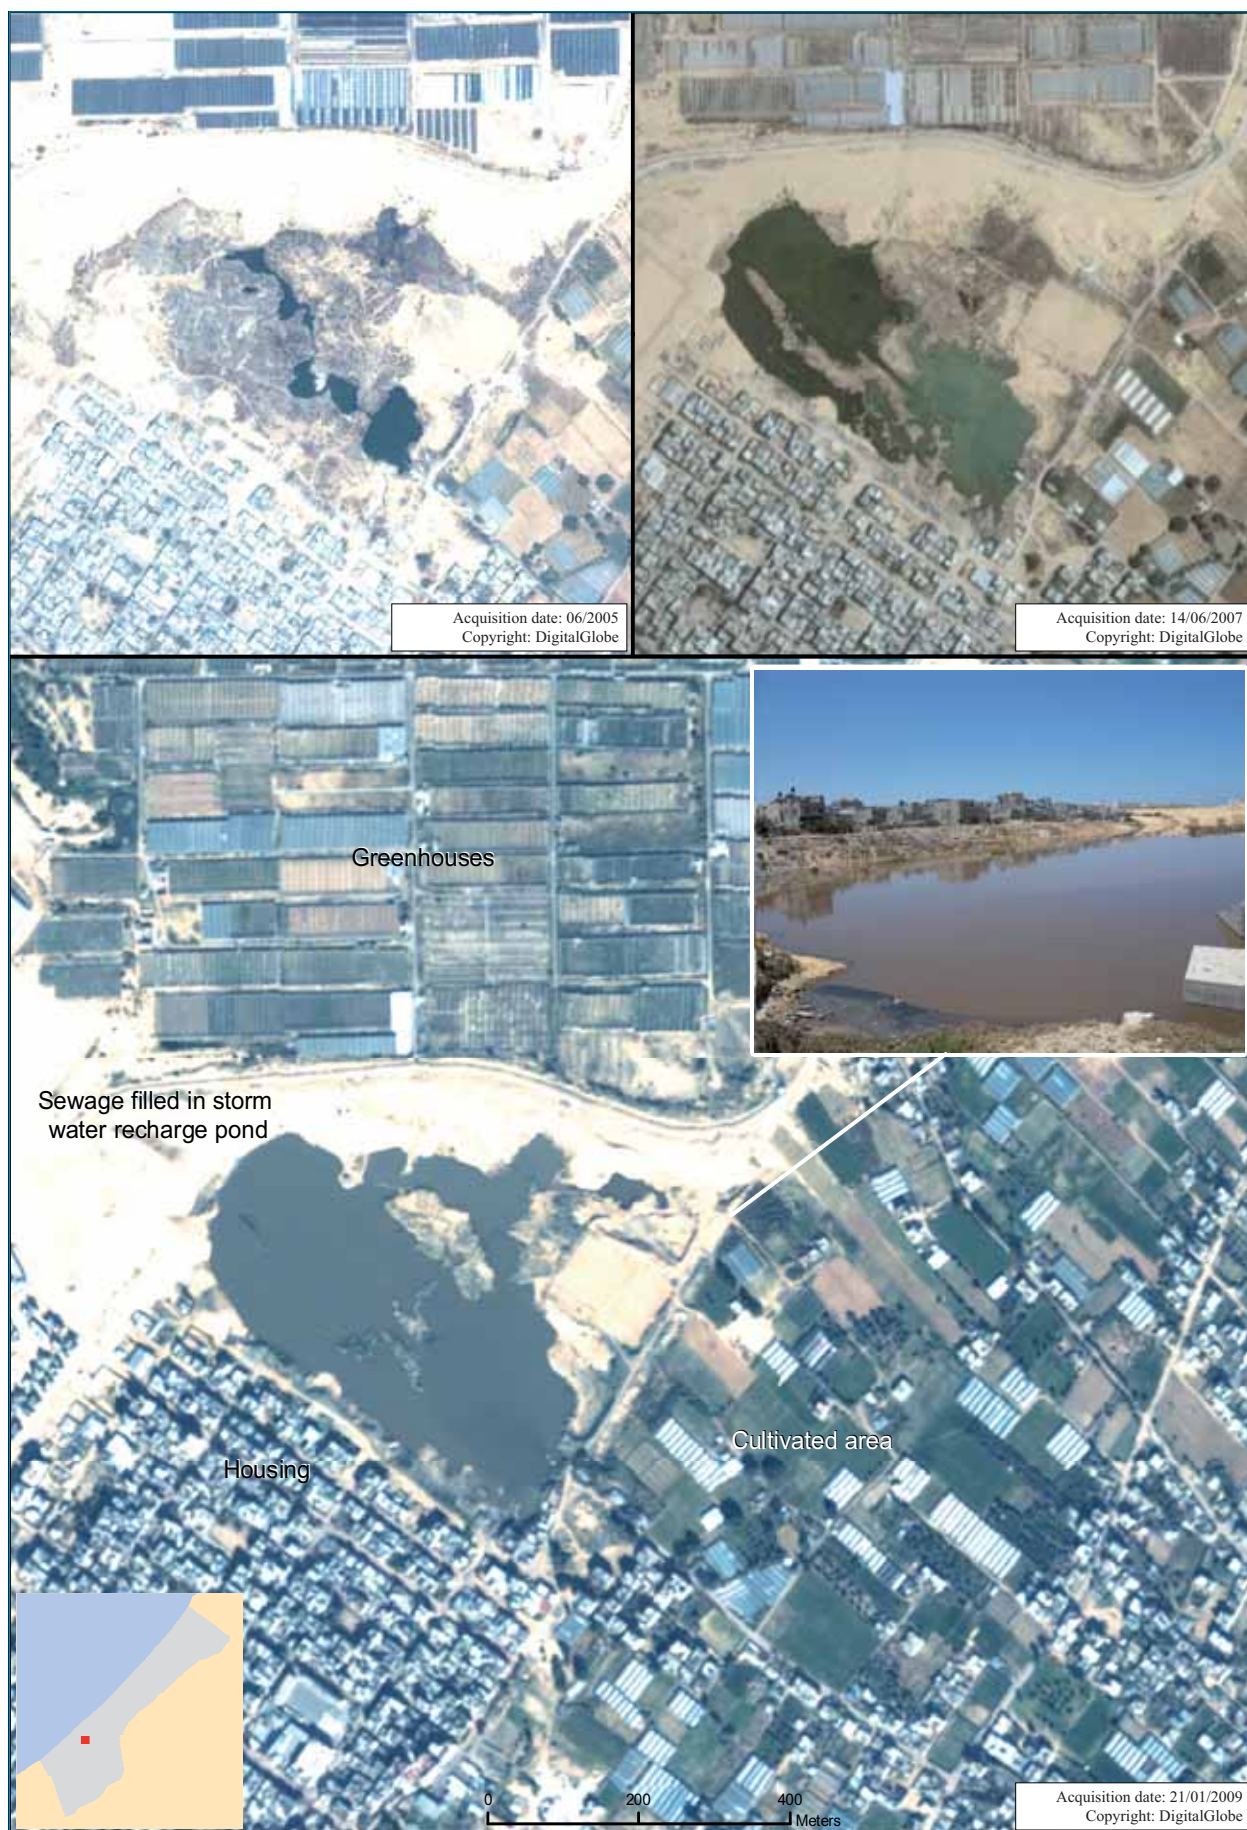
Map 14. Sewage in storm water recharge pond

separately. Sewage would be sent for treatment to the sewage treatment facilities, and storm water would be recharged from these ponds. The location and design of these ponds was intended to facilitate easy and quick recharge. However, whenever the sewage pumps fail, the infiltration ponds become convenient dumping grounds for raw sewage. The net effect is that raw sewage infiltrates into the groundwater.

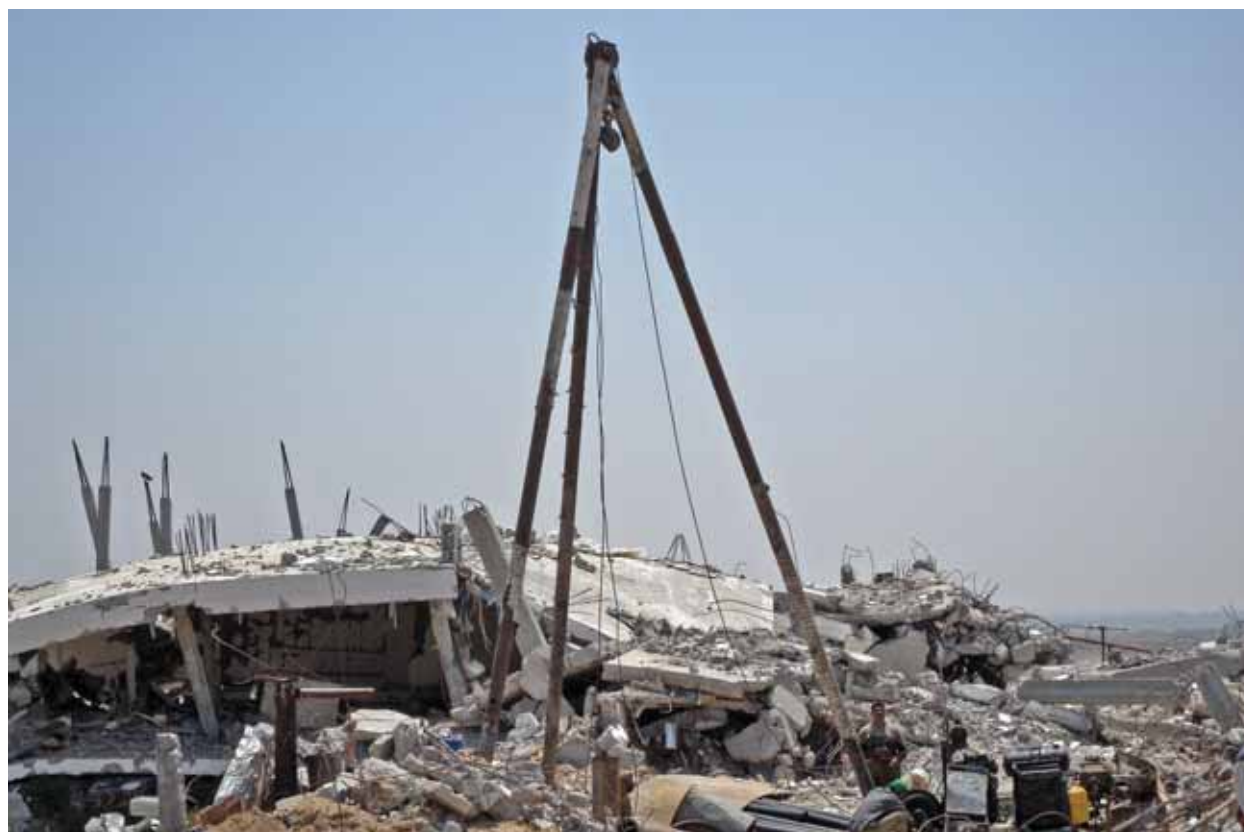
of land have been reclaimed for agriculture over the past few decades, especially during the Egyptian mandate on the Gaza Strip that ended in 1967. This expansion of agricultural areas has involved the drilling of as many as 4,000 agricultural wells. And because of the difficult political and economic conditions of recent years in the Gaza Strip, people have become more and more dependent on agriculture, resulting in additional, random wells being drilled without permission from the authorities. As many as 2,000 wells are estimated to have been drilled in this way, and they have of course led to further discharge, which has contributed to more rapid deterioration of the aquifer.

Private well drilling operation in northern Gaza Strip

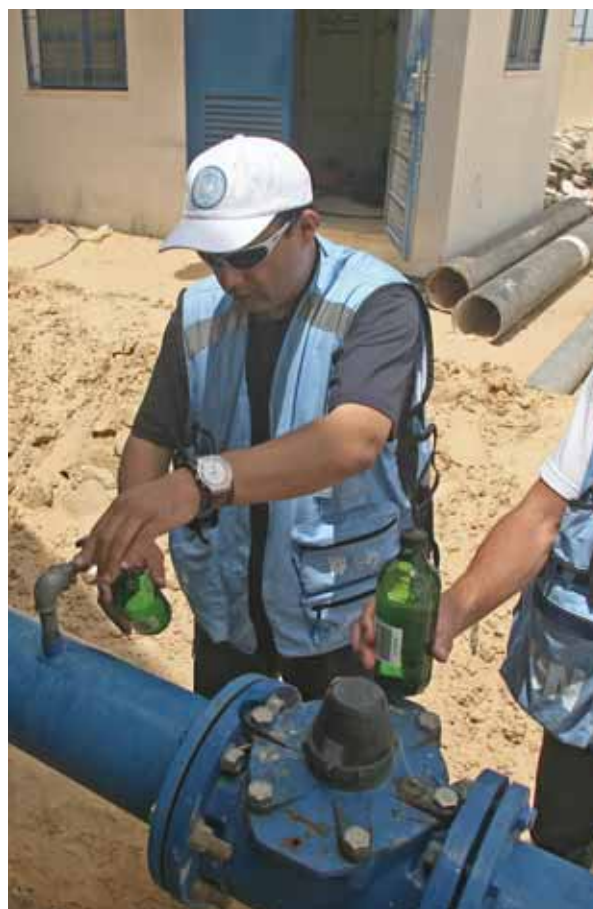
UNEP experts sampling drinking water

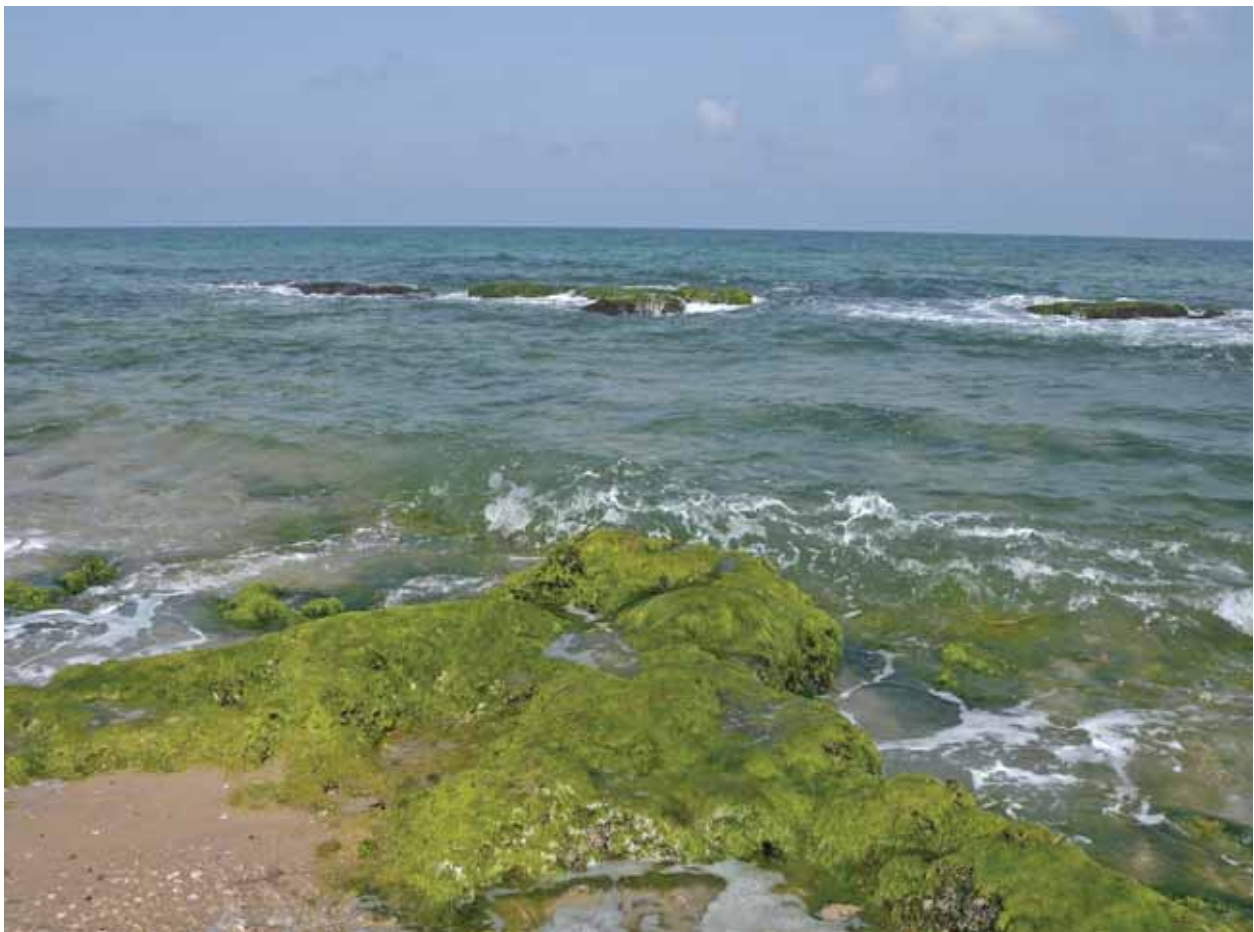
Prolific algae growth due to sewage outflow into the Mediterranean Sea

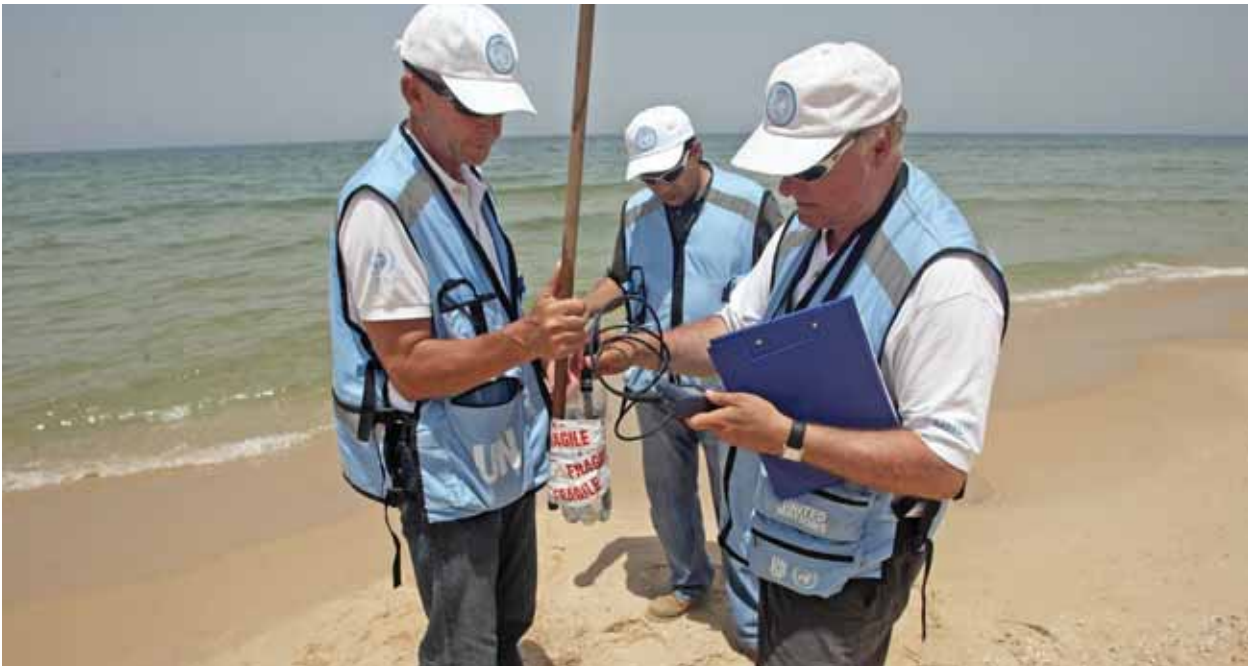
UNEP experts sampling seawater

A number of small sewage outlets can be found along the Gaza coastline, either in the form of pipes or of open sewers that empty onto the beach. Larger sewage pipes releasing more significant volumes (in the range of one to several cubic metres per second) are located in the south in Rafah and El Nuseirat. Other outlets are located, for example, in Deir El Balah Refugee Camp, Shati, Gaza City and Beit Lahia. The outlets in Rafah and El Nuseirat release partly treated sewage. Wadi Gaza is also causing pollution to the coastal waters from untreated sewage. From the flourishing growth of green algae along the coastline, it is obvious that the coastal zone is subjected to eutrophication.

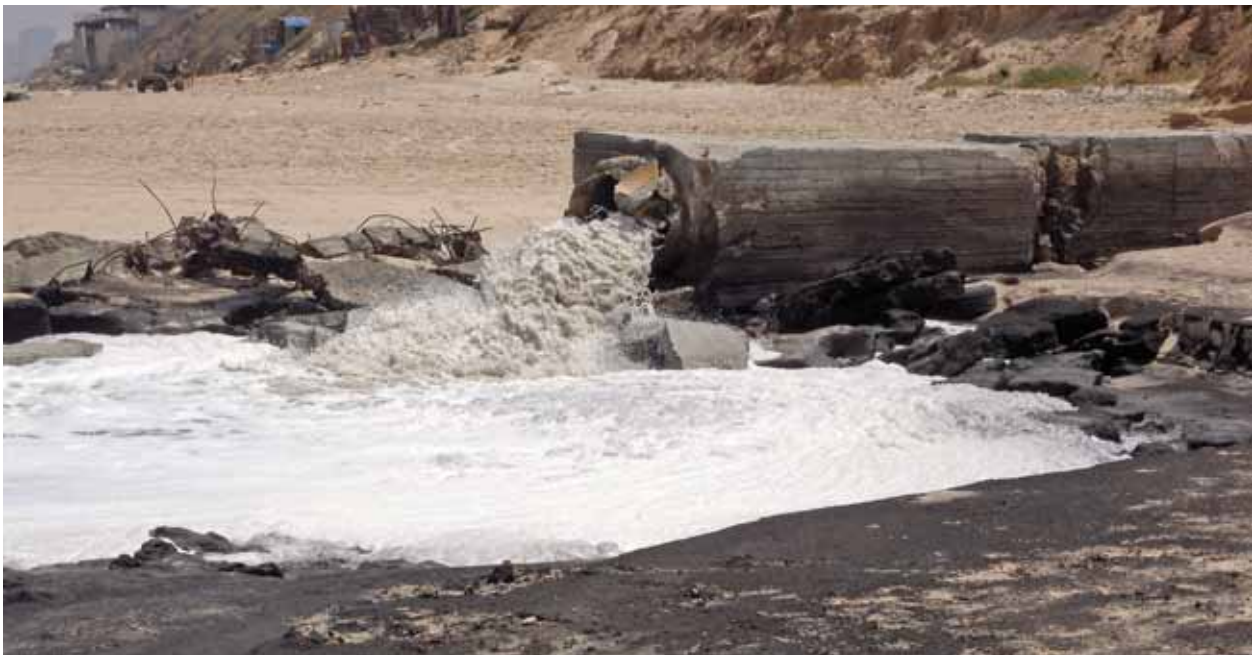
One of many outfalls of untreated sewage into the Mediterranean Sea

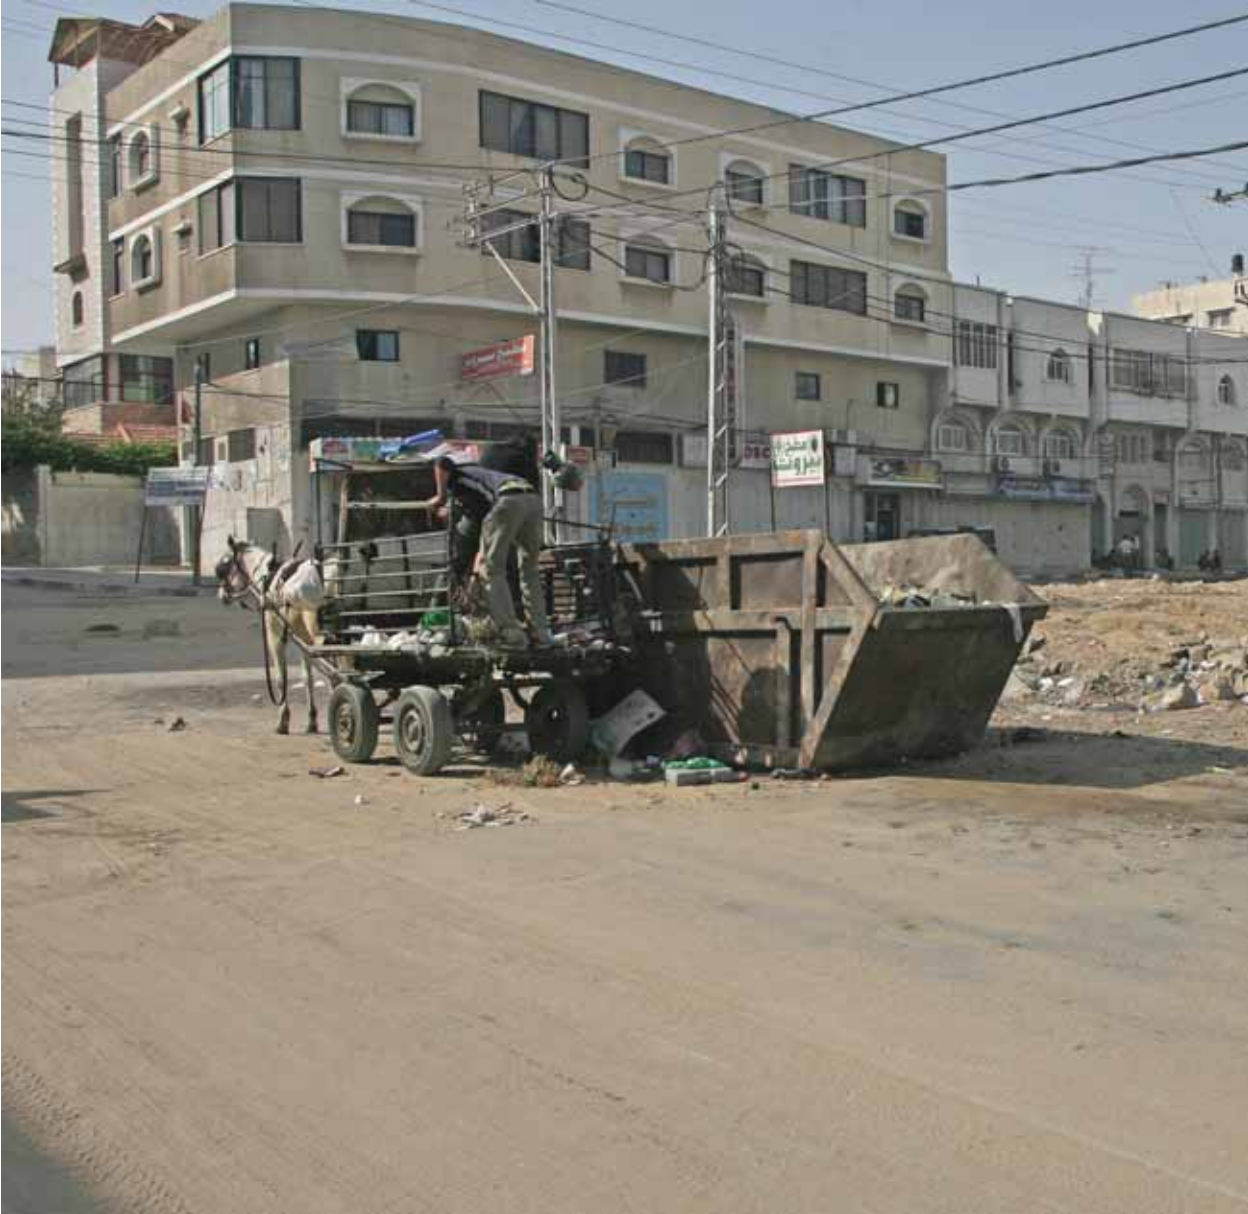
In the absence of effective public systems, private waste collectors have entered the market
