Environmental Assessment of Ogoniland
Site Specific Fact Sheets

OBOOLO

Site fact sheet

Site Name	OBOOLO
Site Number	qc_002-003
LGA	ELEME
Main community	OBOLLO
Surrounding communities	OBOLLO OBOLLO EBUBU
Investigated area (ha)	1.83
Category	SPDC Pipeline ROW
Eastings (WGS 84, Zone 32N)	293582
Northings (WGS 84, Zone 32N)	527577

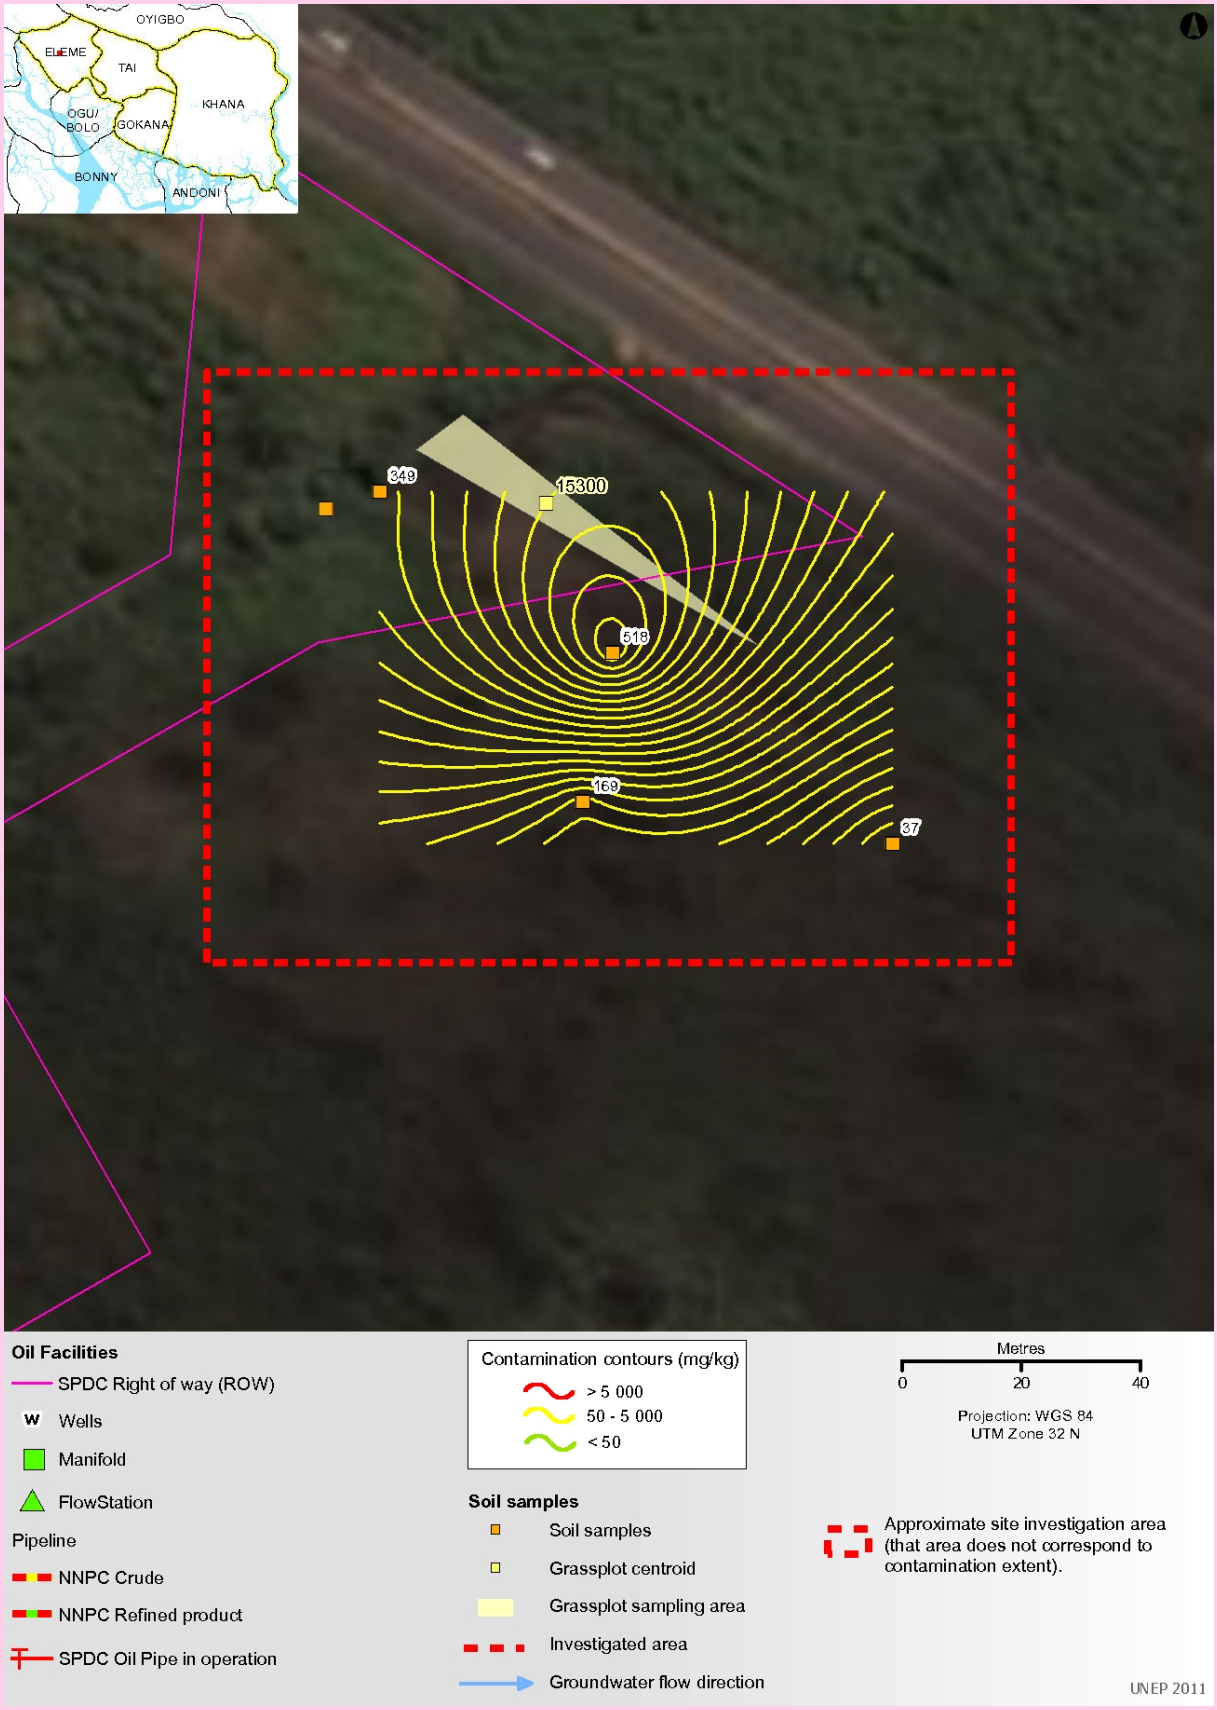
Soil Contamination Map

The values shown next to soil sample points represent the average TPH value for all samples taken from the borehole at that location.
