Environmental Assessment of Ogoniland
Site Specific Fact Sheets

ALETO

July 2011

Site fact sheet

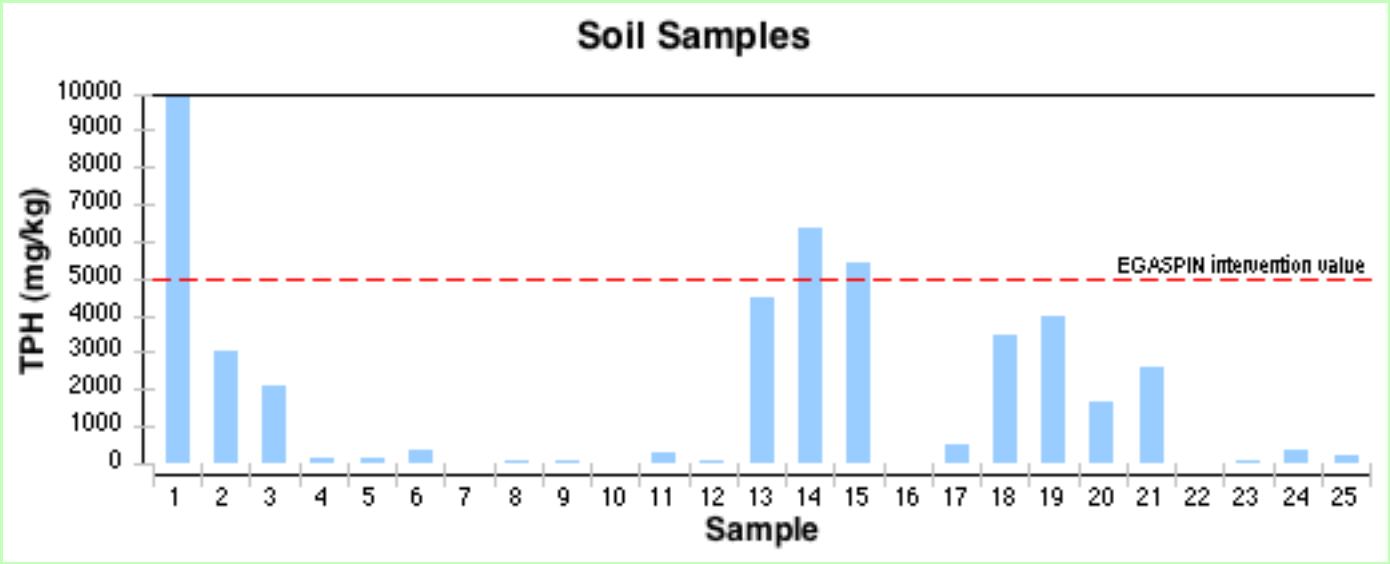
Soil Samples
TPH (mg/kg)
10000
9000
8000
7000
6000
5000
4000
3000
2000
1000
0
EGASPIN intervention value
1 2 3 4 5 6 7 8 9 10 11 12 13 14 15 16 17 18 19 20 21 22 23 24 25
Sample

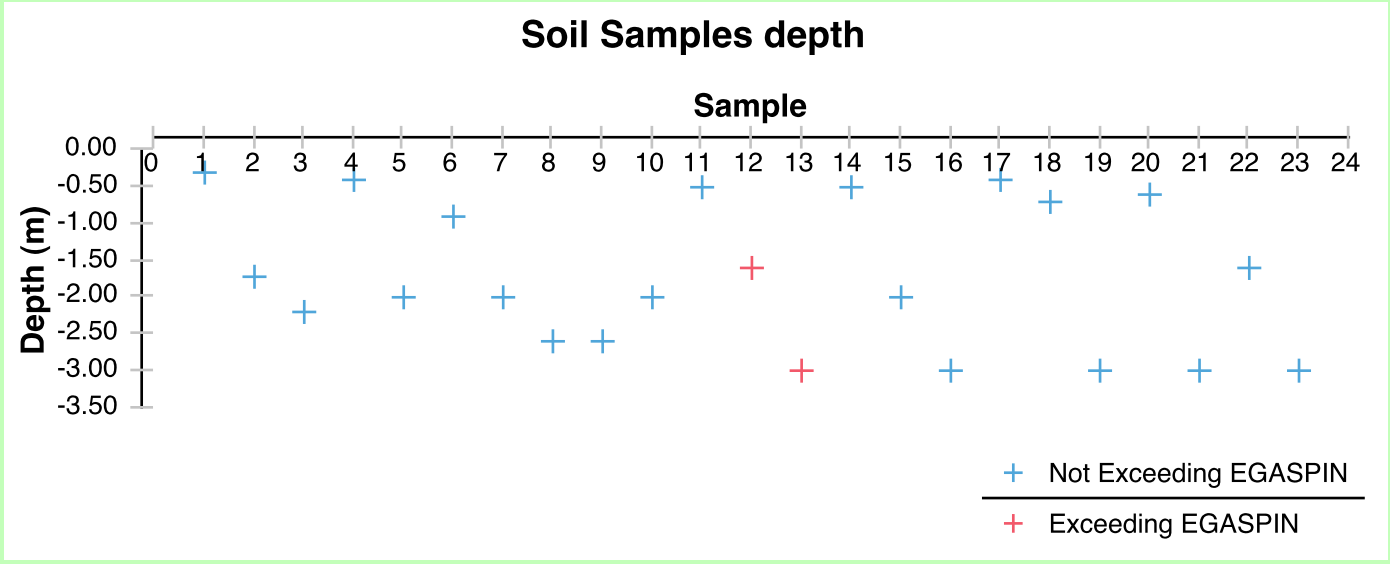
Soil Samples depth
Sample
Depth (m)
0.00
-0.50
-1.00
-1.50
-2.00
-2.50
-3.00
-3.50
0 1 2 3 4 5 6 7 8 9 10 11 12 13 14 15 16 17 18 19 20 21 22 23 24
Not Exceeding EGASPIN
Exceeding EGASPIN

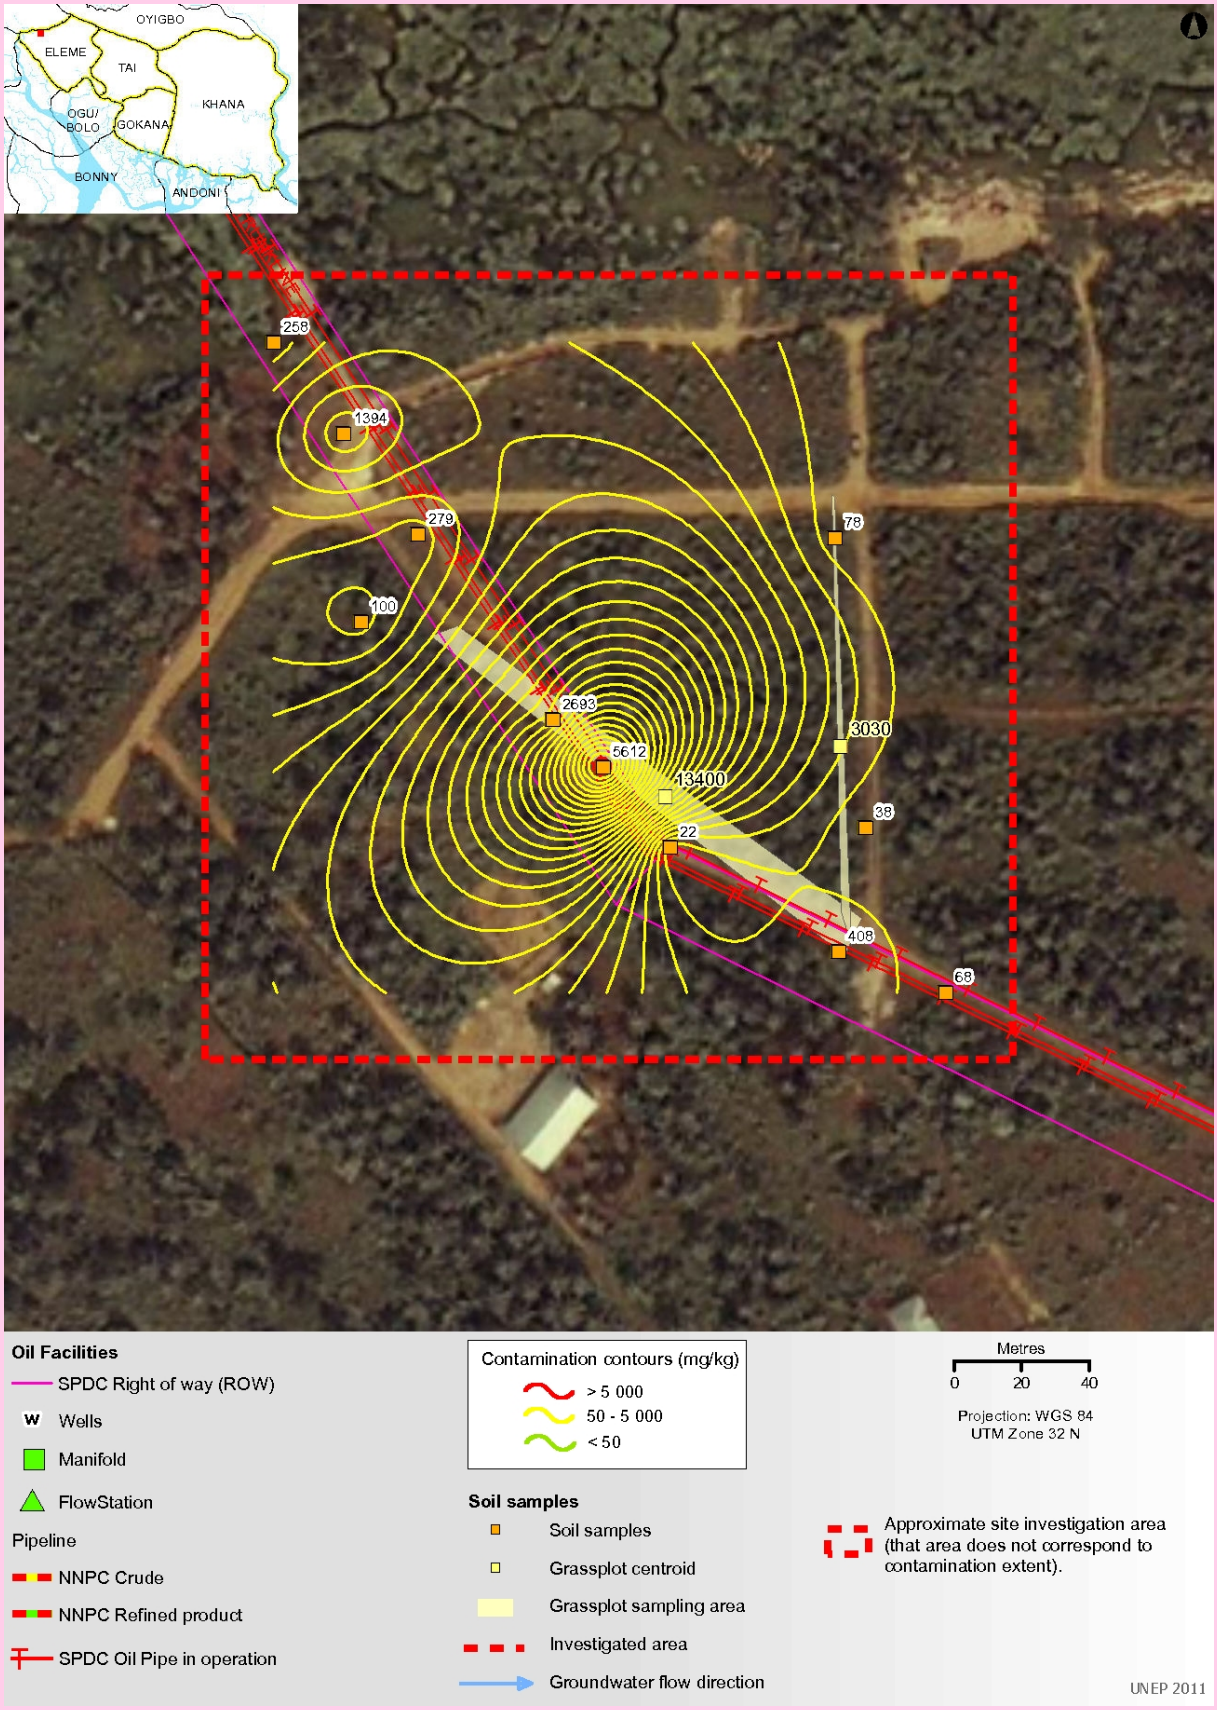
Soil Contamination Map

Number of soil samples	25
Deepest investigation (m)	3
Maximum soil TPH (mg/kg)	13,400.000
Number of soil measurements greater than EGASPIN intervention value	3
Deepest sample greater than EGASPIN (m)	3
Number of soil measurements below 1m	15
Number of soil measurements below 1m greater than EGASPIN intervention value	2
Number of ground water samples	0
Maximum groundwater TPH (µg/l)	Not applicable
Number of groundwater measurements greater than EGASPIN intervention value	0
Number of community well samples	0
Presence of hydrocarbons in community wells	Not applicable
Number of CL sediment samples	1
Maximum CL sediment TPH (mg/kg)	1,520.000
Number of CL sediment measurements greater than EGASPIN intervention value	0
Presence of hydrocarbons in sediment above EGASPIN intervention value	Not found

The values shown next to soil sample points represent the average TPH value for all samples taken from the borehole at that location.

Recommendations for risk reduction	- Communities should be informed in community meetings about health and safety precautions. - A community based security and surveillance system should be put in place so that there is voluntary compliance with the restrictions which are needed to protect public health. - The impacted area should be demarcated and appropriate signage put in place to indicate that the site is impacted. - Highly contaminated core areas should be fenced and guarded until emergency cleanup measures have been carried out. - Impacted swamps and creeks should be demarcated and appropriate signage put in place to indicate that the area is impacted. - Floating oil on the surface, if any, should be collected and treated off site. - The site should be remodelled to prevent run off from the contaminated area into the downstream swamps. - Runoff from the area should be monitored and if necessary collected and treated while the cleanup plan is developed and implemented. - Additional soil sampling along with trial pits should be done at the contaminated site to delineate the site to be excavated for clean up. - A detailed plan should be prepared for clean up of the contaminated soil and risk reduction at site. - A system of ground water monitoring wells should be installed to act as early warning for communities which are not yet impacted by ground water contamination. - While undertaking the clean up, management of excavation water should be handled properly to ensure that no pollutants are emitted into the environment without control.
