# ENVIRONMENTAL AUDIT OF THE SITES IMPACTED BY THE "PROBO KOALA" TOXIC WASTE DUMPING IN ABIDJAN, CÔTE D'IVOIRE

This series of fact sheets was prepared as part of UN Environment's environmental audit of the sites impacted by the "Probo Koala" toxic waste dumping in Abidjan, Côte d'Ivoire. The fact sheets provide complete analysis results, observations and the recommendations for each of the sampling sites. They should be read in conjunction with the full assessment report, available at: [www.unep.org/CotedIvoire](http://www.unep.org/CotedIvoire)

# SITE 3: VRIDI CANAL 2 (PETROCI)

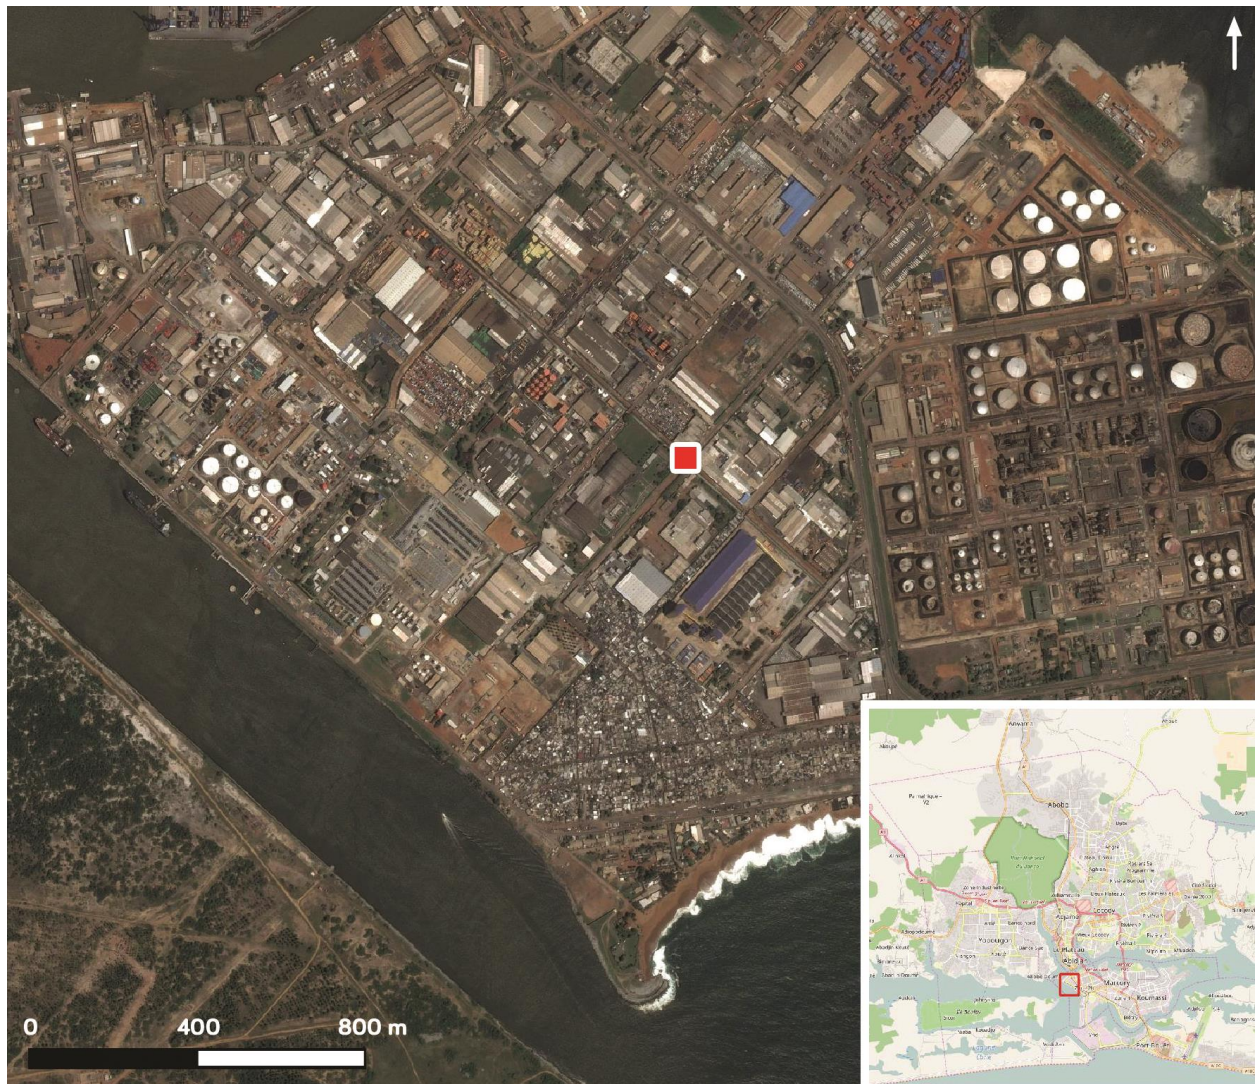
Site name: Vridi Canal 2 (Petroci)  
UN Environment site reference no: 3

The site is located along the same road as Site 2, within the Vridi Canal industrial zone, on grounds owned by the Ivorian national oil company, Petroci. The site of interest represents the location at which the pipe connected to the drain into which Probo Koala wastes were dumped at Site 2 intersects with a concreted canal flowing to the lagoon. The pipework and canal were reportedly remediated by Trédi in 2006-2007, and continue to carry drainage to the lagoon.

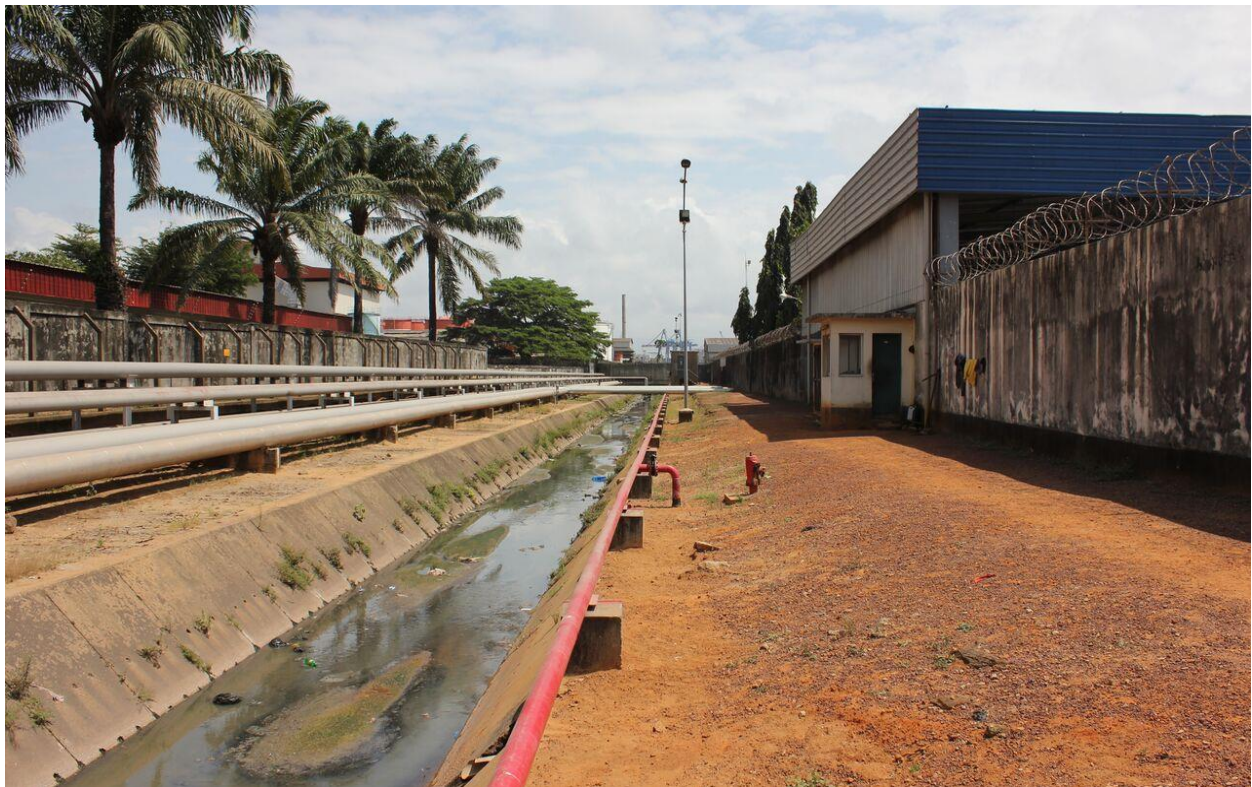
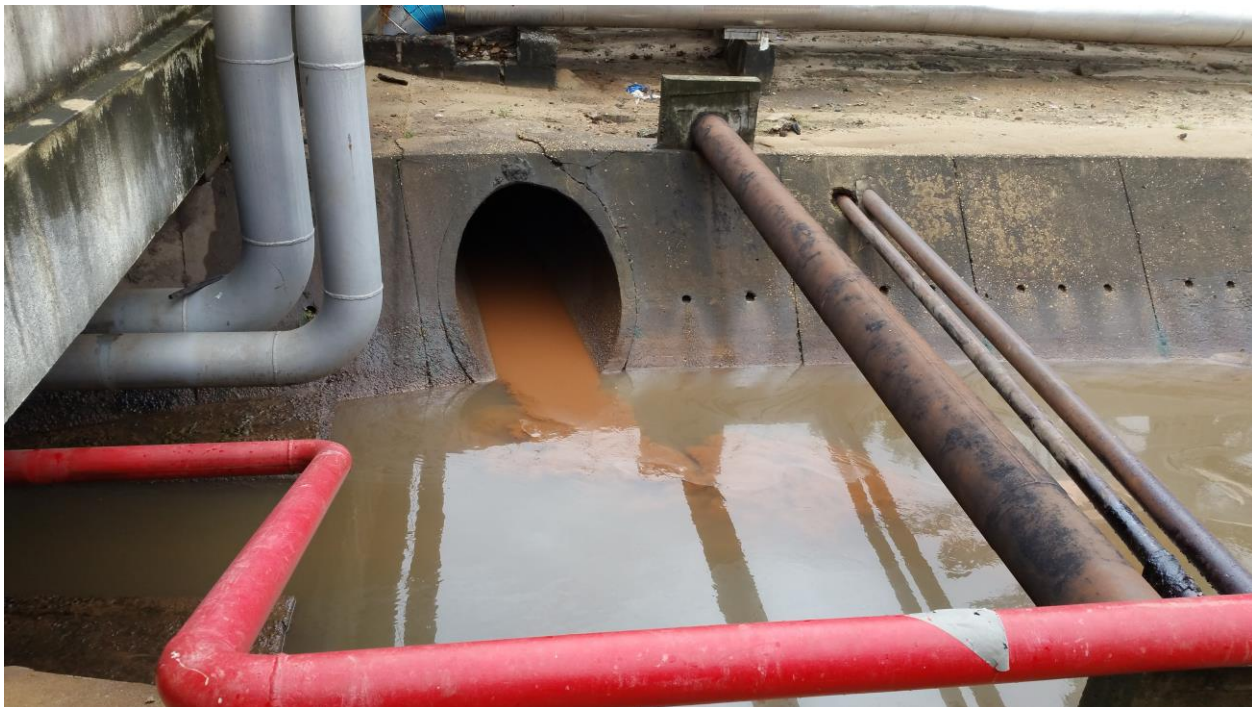
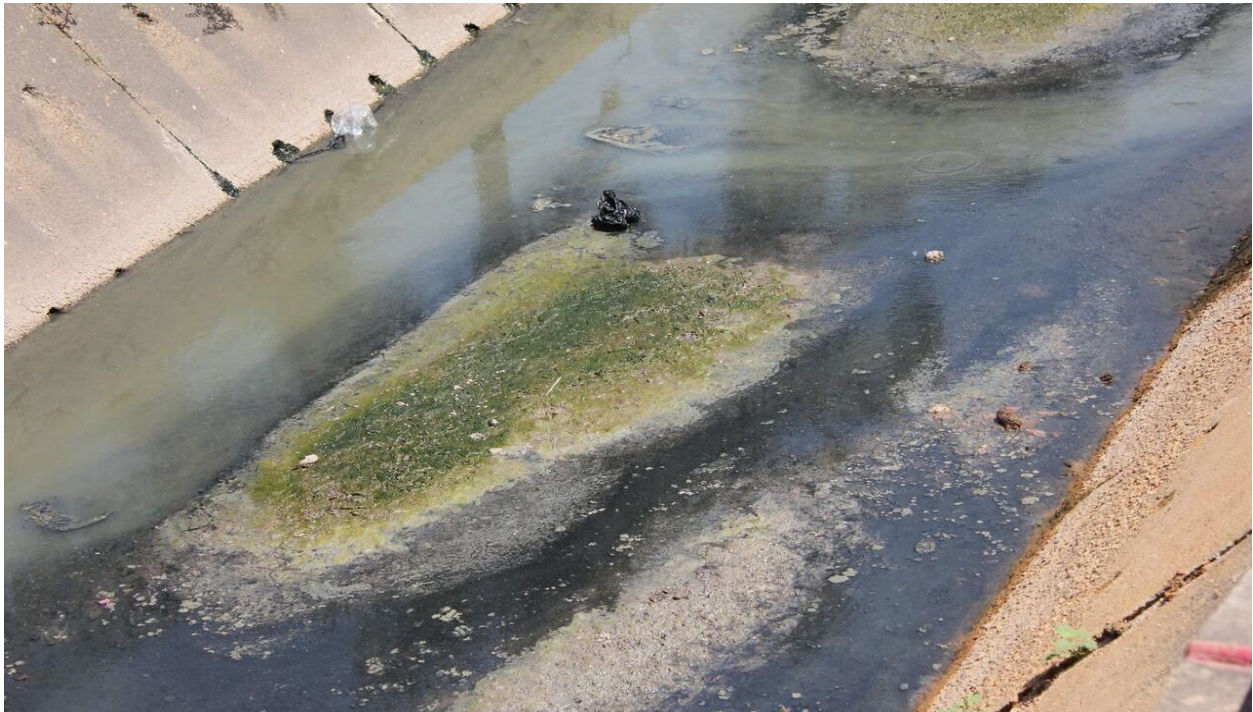
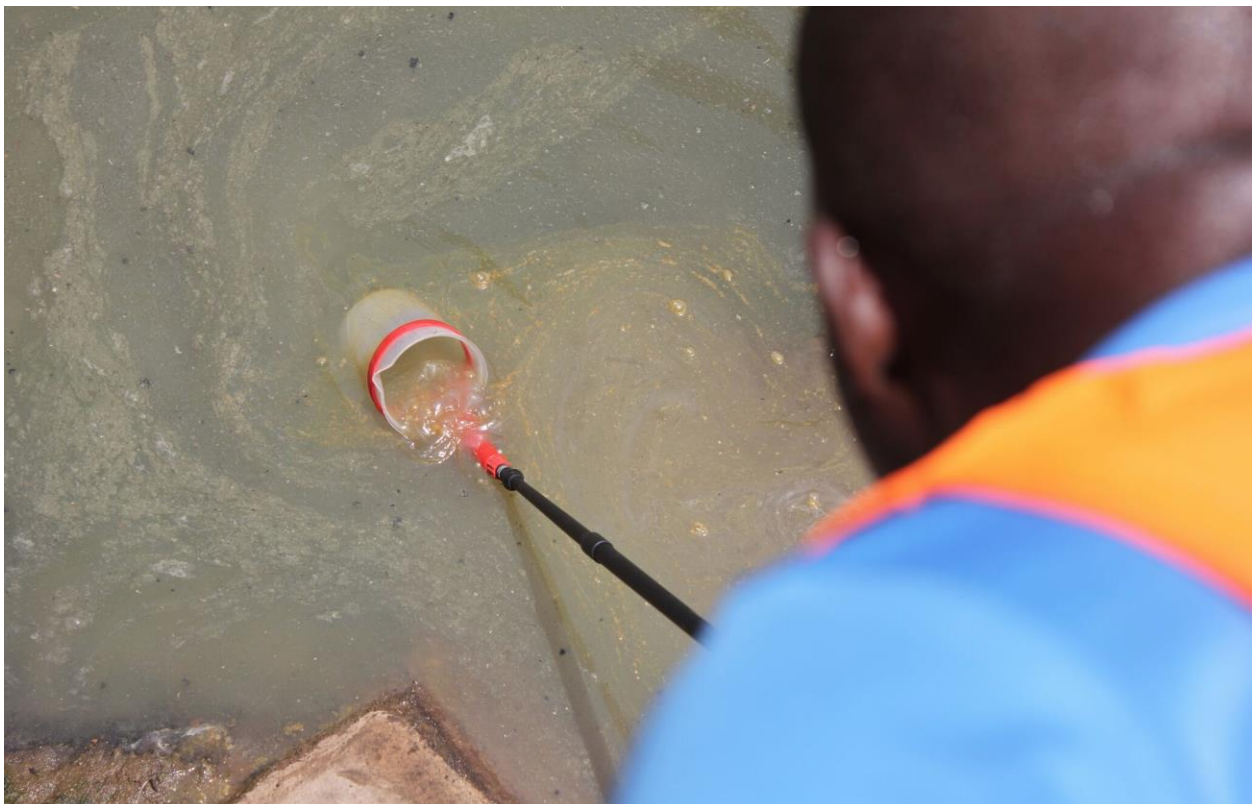
## Site Photos

One air sample, one groundwater sample and one surface water sample were collected at this site. As the pipe and canal were concreted, no soil samples were retrieved from this location.
