**AFTER
THE TSUNAMI**
Rapid Environmental
Assessment

United Nations Environment Programme

2. NATIONAL RAPID ENVIRONMENTAL ASSESSMENT - INDONESIA

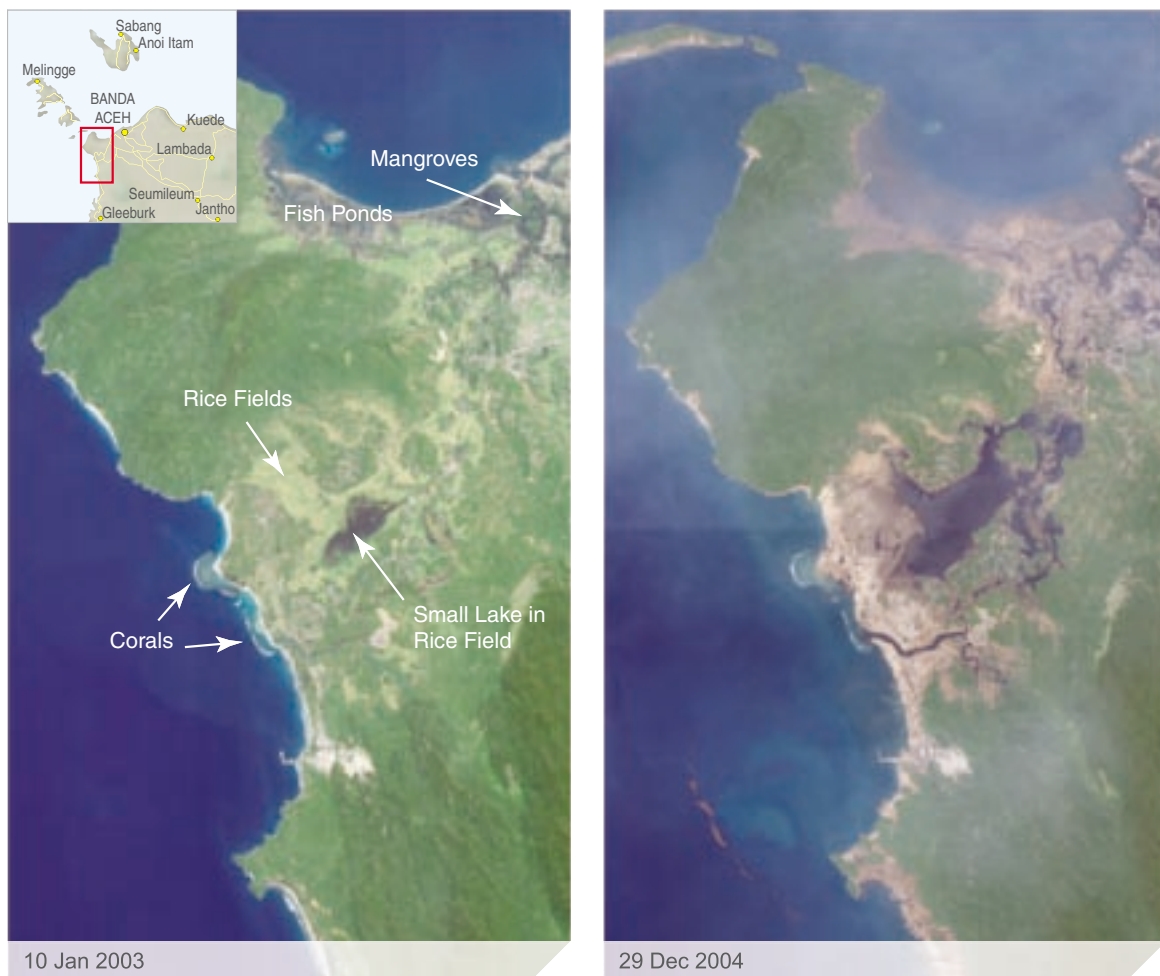
Case study: Overall damage to ecosystems in Sumatra

These images show a combination of a rocky, hilly headland along with a small river delta and swampy coastal strip. A low-lying wetland area connects the northern and western ocean fronts. An integration of natural and agricultural ecosystems operating prior to the tsunami combined rice cultivation, and fish/shrimp ponds (tambak), alongside natural delta mangrove forests and wetlands. Coastal forests and onshore reefs are also present. The effect of the tsunami is clearly evident. It scoured out the low lying delta land, destroyed fish ponds and removed mangrove cover. Volumes of soil and silt have evidently been carried out to sea expanding the area of the small lake by a factor of approximately 10. There has been removal of the sandy beaches (important in some locations for turtle nesting) and deposition of silt or mud on the reef. Apparently minor effects on the integrity of the rocky vegetated shoreline surrounding the headland are likely due to the resilient nature of the substrata, as well as dense natural vegetation cover and the sloping nature of the shore.

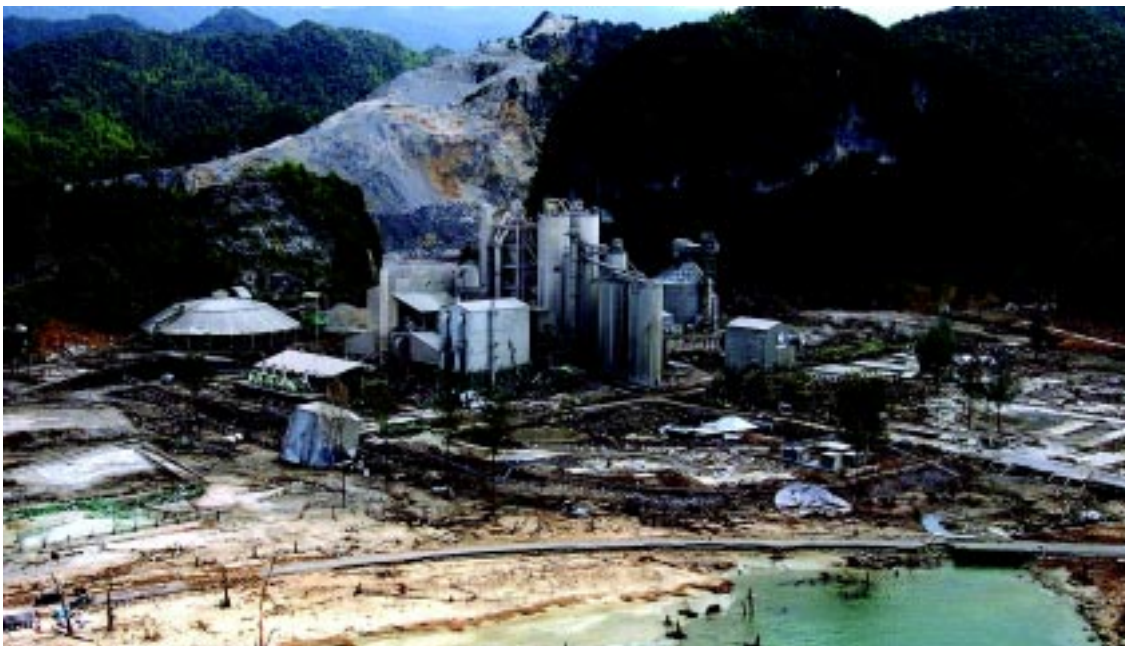
Lhok Nga, Indonesia (5 January 2005). Aerial view of a cement factory at Lhok Nga, south of Banda Aceh, Indonesia. The plant employed more than 600 people before the earthquake. The tsunami damaged an estimated 80 per cent of the facility and killed one-third of the workers. © Reuters/Choo Youn-Kong

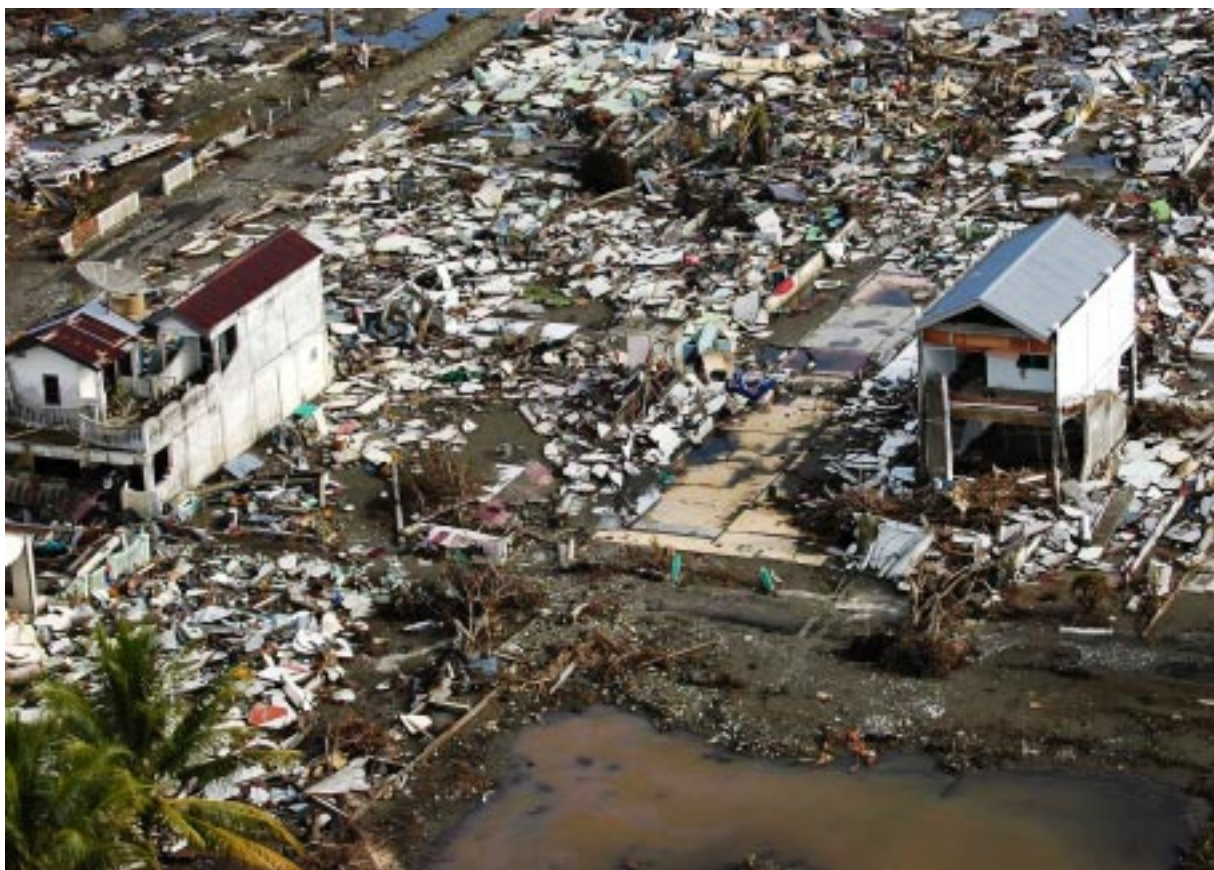
Meulaboh, Sumatra, Indonesia (6 January 2005). Damage from the tsunami seen from a United States Navy helicopter.
© Jordan R Beesley/US Navy/Getty Images

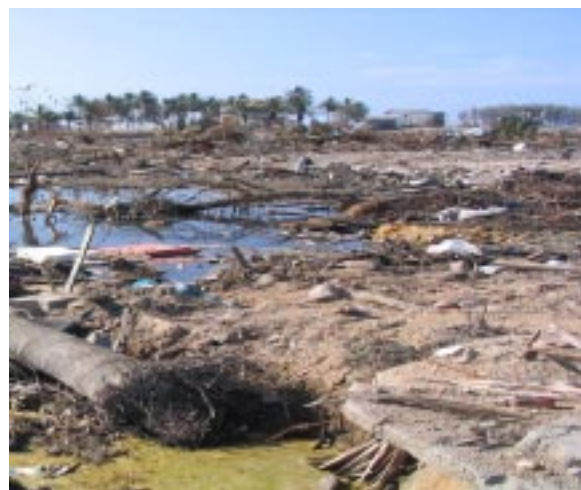
Phang Nga Province, Thailand (January 2005). Coastal area not protected by mangrove forests and severely impacted by the tsunami (location "1" on the map).

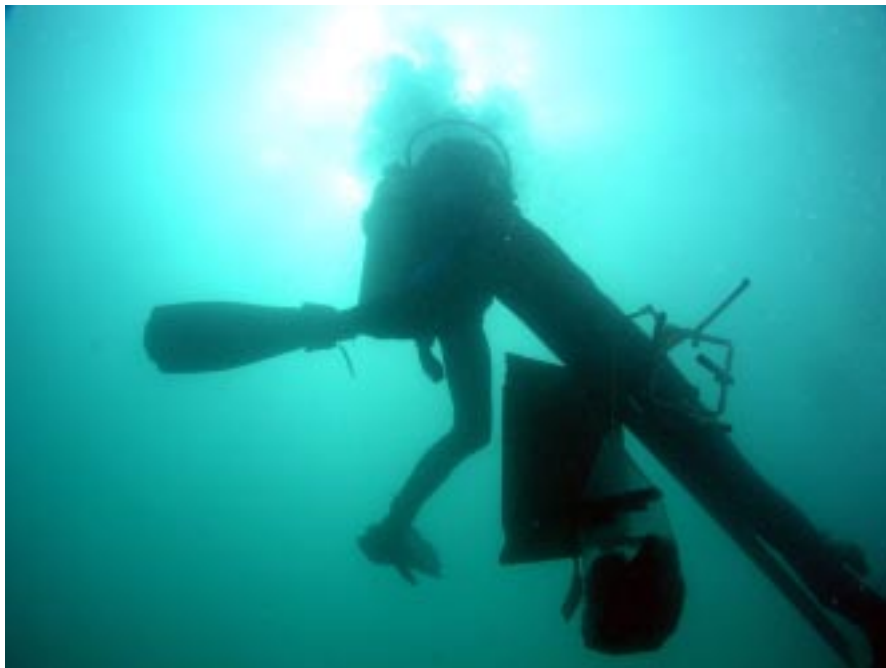
Patong, Phuket Province, Thailand (15 January 2005). As part of the coordinated clean-up operations, large and small debris being lifted to the surface to prevent further damage to the coral reefs. © Department of Marine and Coastal Resources, Ministry of Natural Resources and Environment.

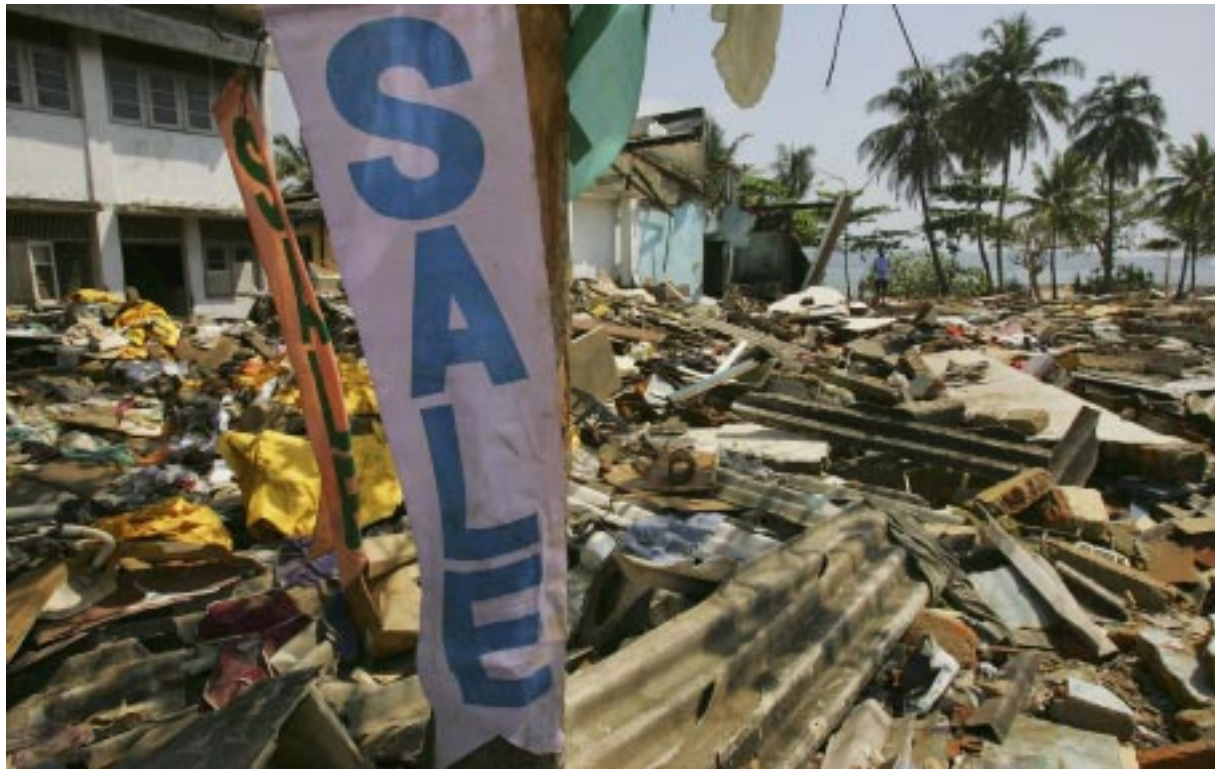
Galle, Sri Lanka (14 January 2005). Debris is seen everywhere in downtown Galle, Sri Lanka, where small shops were reduced to rubble by the 26 December Asian tsunami. © Paula Bronstein/Getty Images

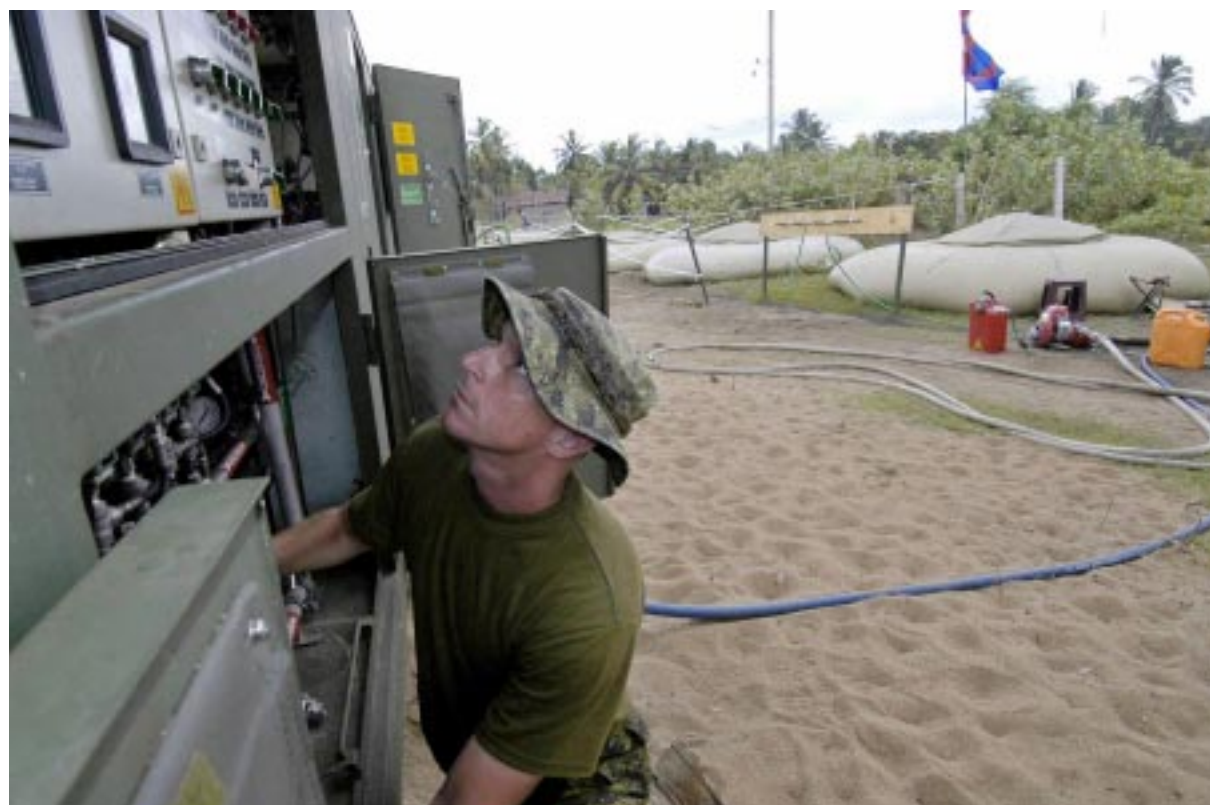
Kalmunai, Sri Lanka (3 February 2005). Checking the water purification machine in Sri Lanka's eastern town of Kalmunai. A 200-member Canadian military contingent is conducting relief operations on the east coast, providing clean drinking water for 80,000 tsunami survivors. © Prakash Singh/AFP/Getty Images

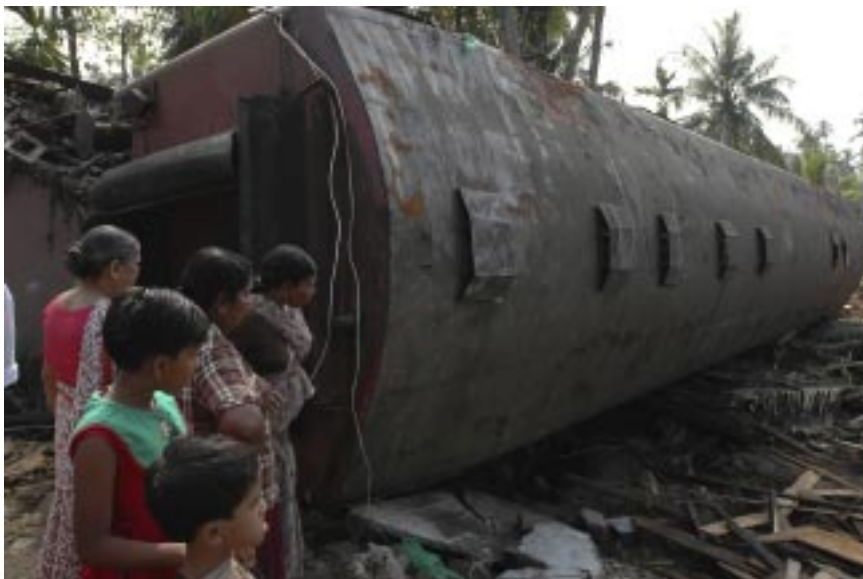
Hikkaduwa, Sri Lanka. The 26 December tsunami overwhelmed a passenger train in southern Sri Lanka, killing some 1,500 passengers. Over half are now enduring significant hardship due to the absence of rail services in the southern corridor, which are not expected to be restored before May 2005. © Shehzad Noorani/Still Pictures

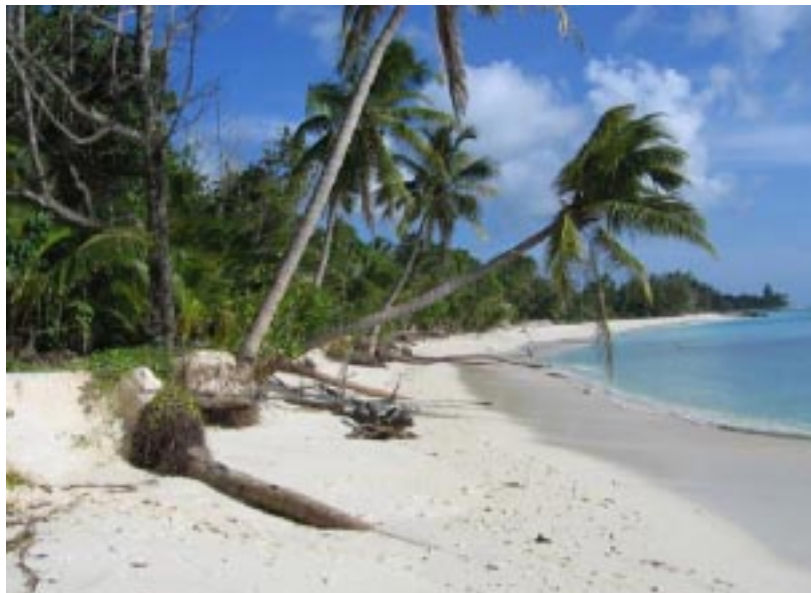
Anse Kerlan, Seychelles (5 February 2005). Eroded turtle nesting beach.
© Mark Collins/UNEP

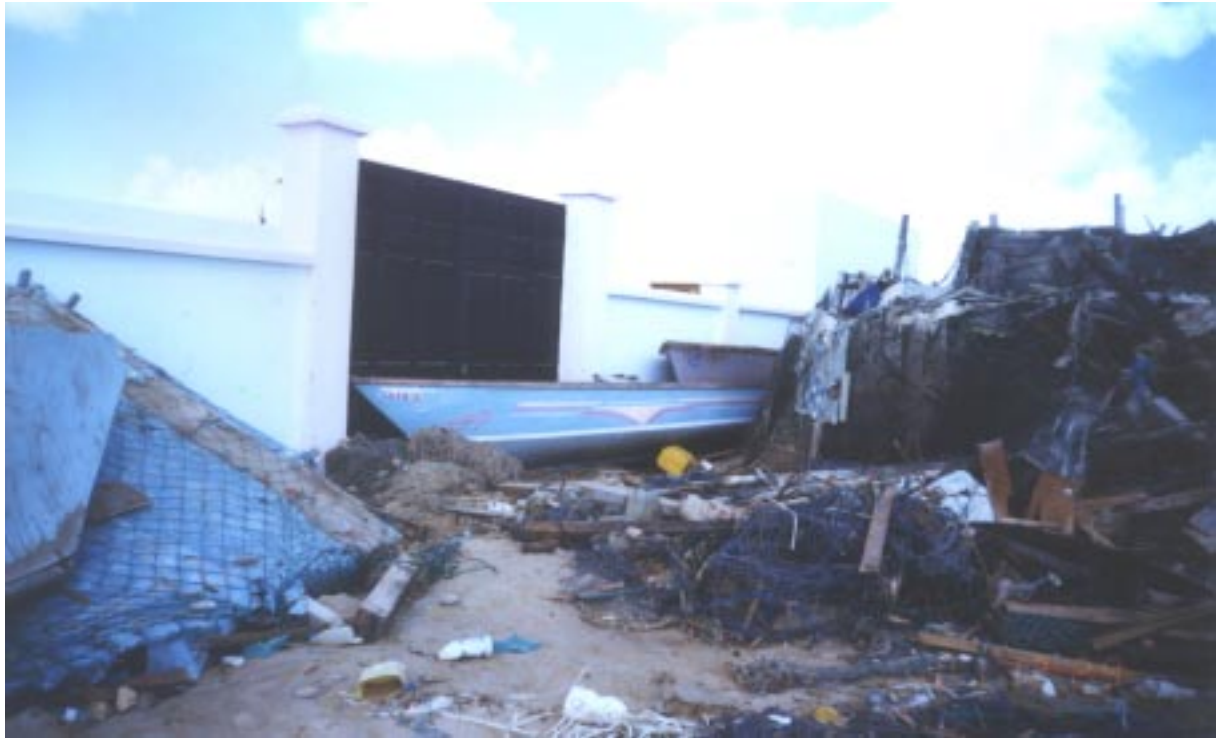
Muhayfif, Yemen (28 December 2004). Tsunami debris outside the offices of the Al Mahra Fisheries Association.
© Al Mahra Rural Development Project
