Maziwi Island off Pangani (Tanzania):

History of its destruction and possible causes

UNEP Regional Seas Reports and Studies No. 139

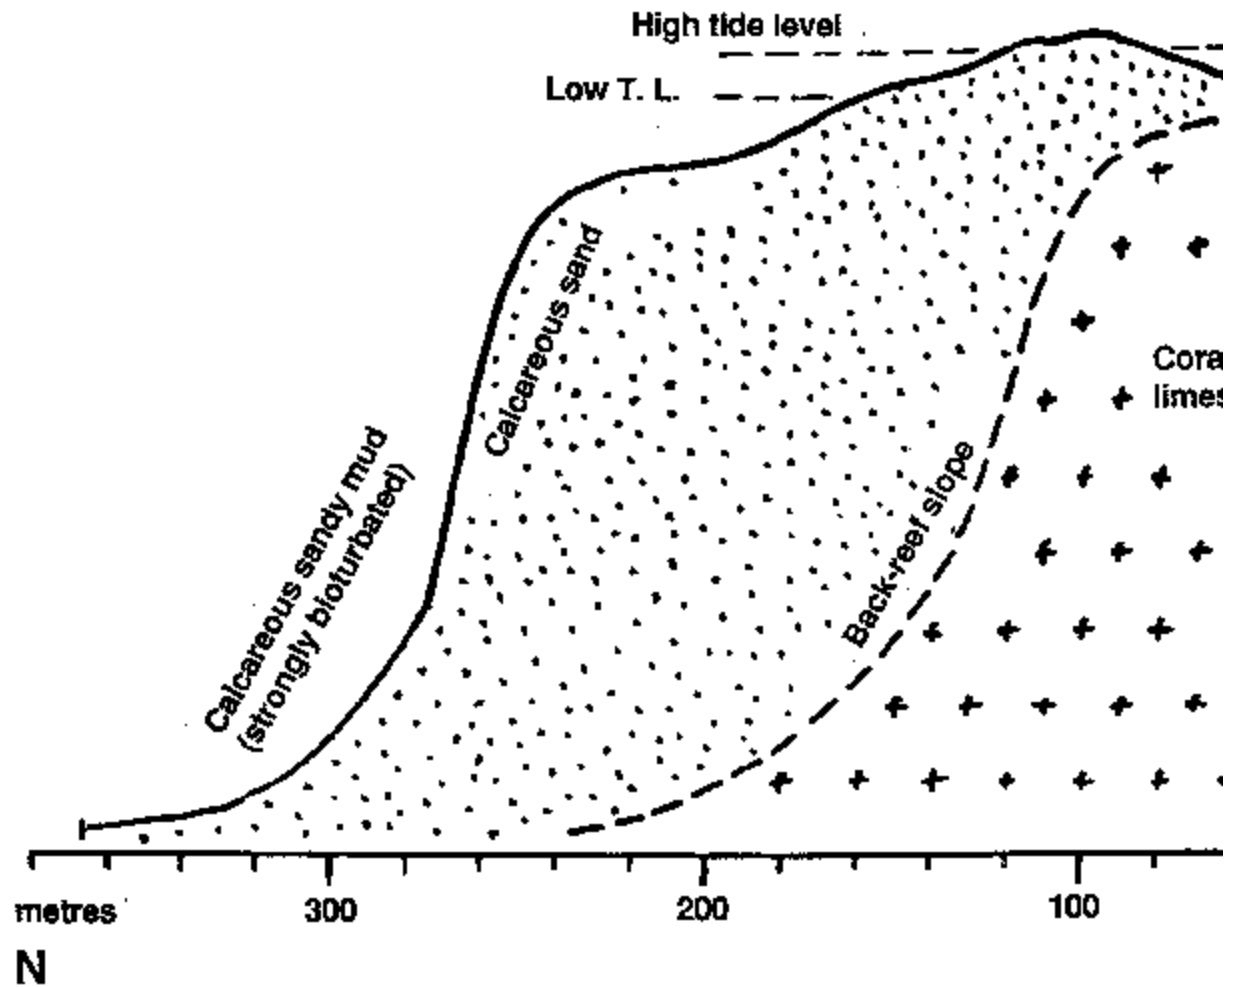
Fig. 9

On the western margin of the reef platform a sand spit composed of carbonate particles (obviously derived from the coral reef flat) occurs (figs.7-10). From the air this sand spit looks tongue- to hook-shaped, its convex side pointing north and westward. The easternmost portion of the sand spit is founded on the coral platform, while its central and western parts cover the back-reef slope and marginal parts of the back-reef lagoon.

Dead coral reef flat
covered by a thin
blanket of calcareous sand
