# Technical Report

## Status of Used Lead Acid Battery Management

## Kingdom of Cambodia

Prepared by Project Team  
Department of Environmental Pollution Control  
Ministry of Environment

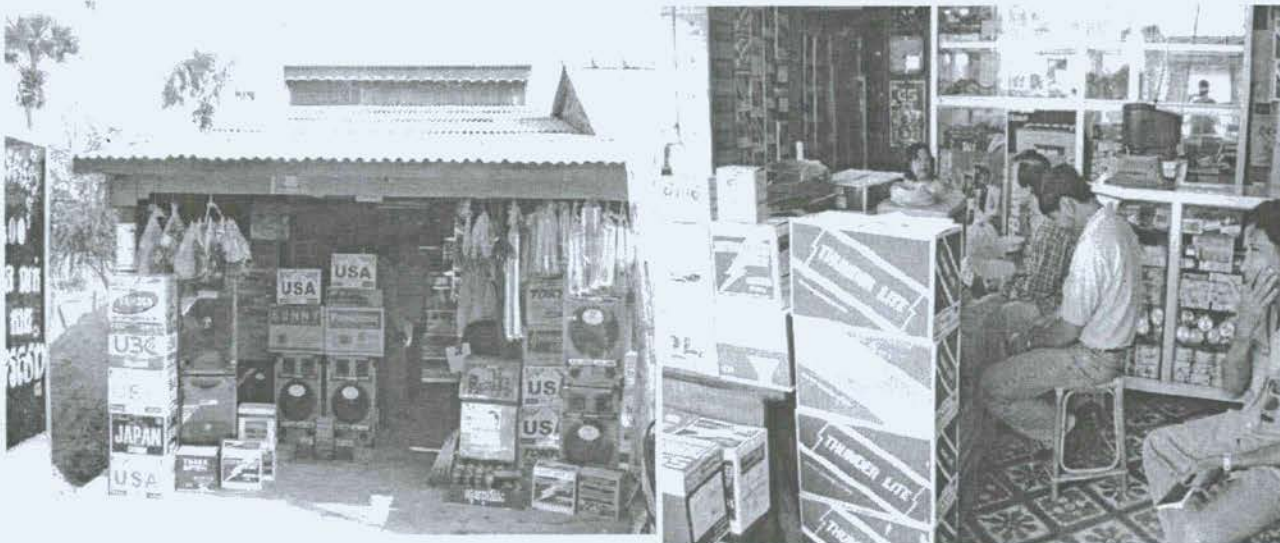
**Picture 2:** Typical view of a battery shop in a remote and a downtown area

25 small automotive battery retail outlets were visited in the remote and downtown areas of Battambang Province, Svay Rieng Province, Sihanouk Ville and Phnom Penh. Generally, shops are selling new lead acid batteries for trucks, cars, motor cycles and domestic use (burglar alarms, back up systems, and so on).

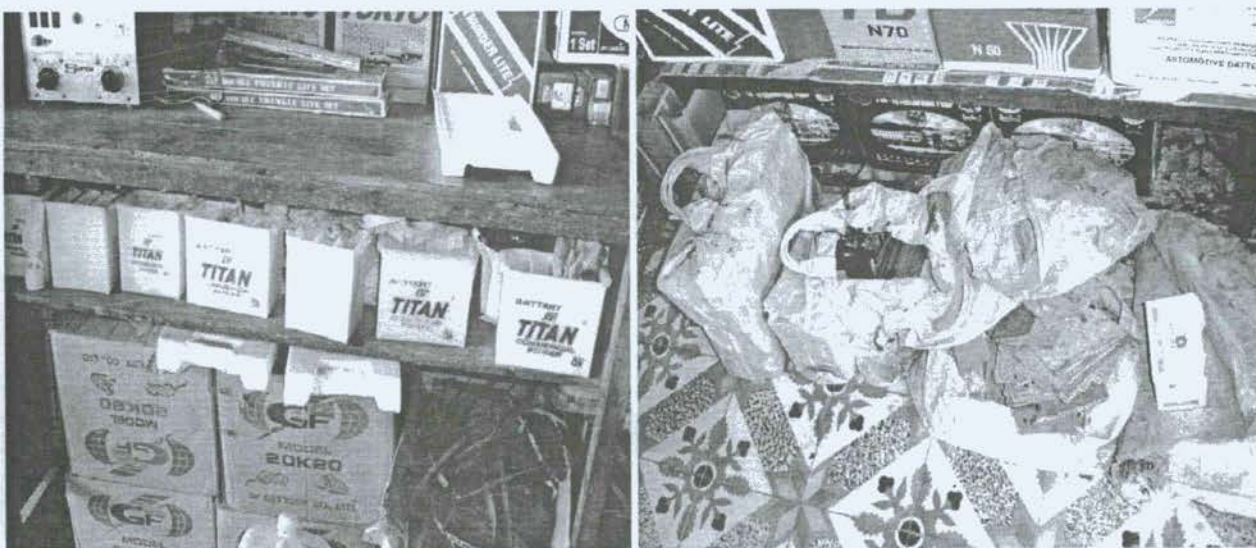
**Picture 3:** Lead plates and battery boxes for new LAB

Each shop had a stock of 100 to 400 new and boxed lead acid batteries imported from Vietnam, Japan, Korea and Thailand. Some battery components are made by local people in Cambodia and these can be seen in picture No. 2. All the batteries on sale were good quality and branded names. The majority of the batteries appeared to be made with the latest maintenance free (MF) technology using lead/calcium alloys grids. Sales varied, but on average, the shops would expect to sell from 10 to 20 batteries per day in the downtown areas and 1- 5 in the remote areas of the provinces.

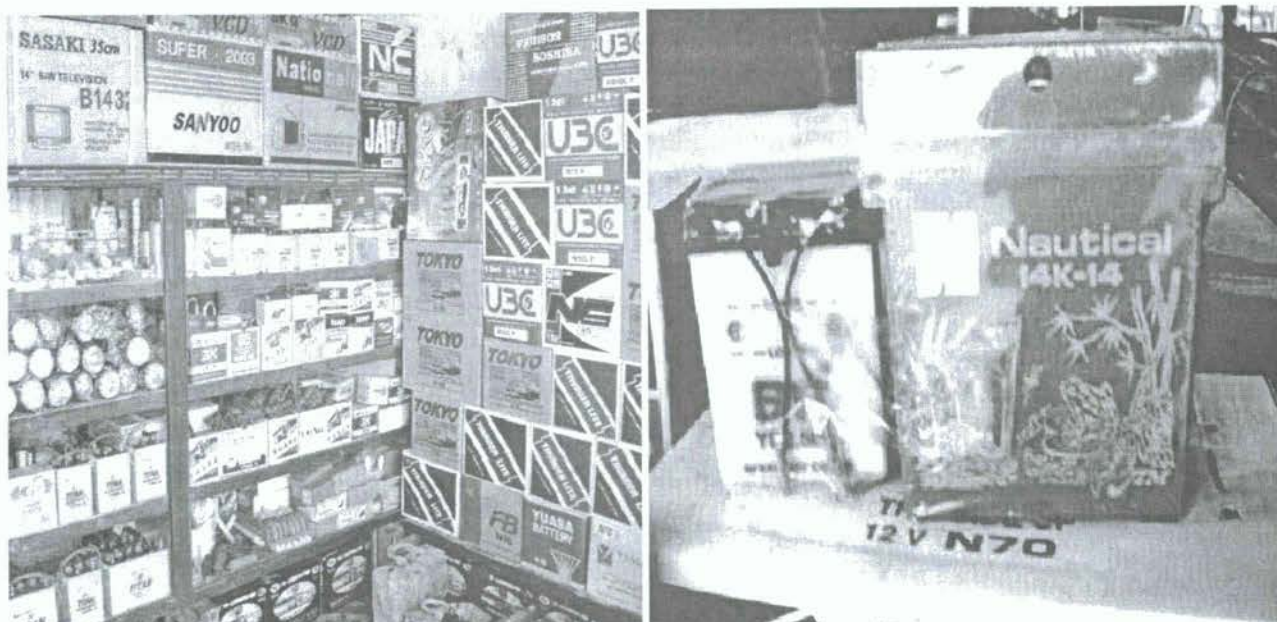
Picture 4: Battery spares and the acid used for topping up a new battery

The shops also service batteries, that is, the staff will test a battery to determine whether it needs to be replaced, topped up with deionized water or recharged. Many batteries in use still require the caps to be removed when being charged to permit the gases given off to escape to atmosphere. In some instances during charging the electrolyte can spill out of the top of the battery as the electrolyte “bubbles” fiercely. In these instances, and when batteries are being topped up, the owner had built a small bunded area to place the batteries in when being serviced to prevent spillage onto the paved area outside the shop. Usually, the shops had sufficient recharging units for about 20 batteries.

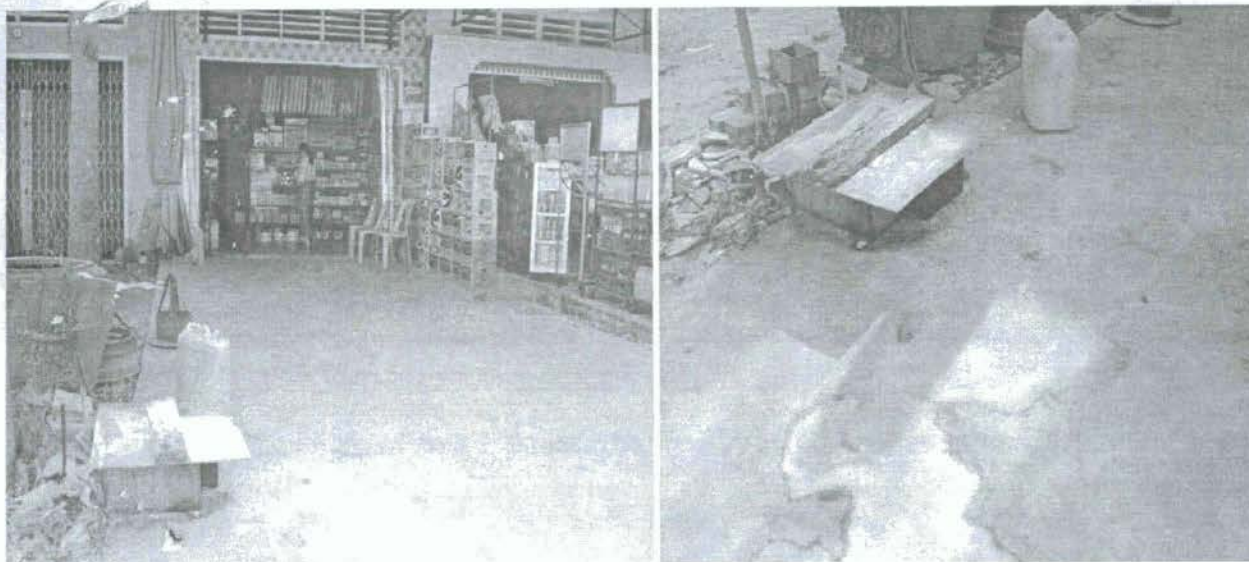
It was the downtown retail shops with battery charging units that seemed to have the most acid spillage and caused bad smells as gases generated during charging escaped to atmosphere. The small bunded area designed to place the batteries when being serviced were contaminated by damaged batteries, but the premises were generally clean and tidy. It was clear that any acid spillage had been washed directly to the public drainage and sanitation system or allowed to percolate into the groundwater and channeled into the canal without any treatment contaminating the water (see picture 5).

Picture 5: The battery acid is allowed to run into the public drainage system

Problems had been identified in the battery retail shops and improvements need to be made in order to prevent the damage to human health and the environment caused by ULAB. The recommendations are:

- Most of the staff, including the owner of the retailing shop has a lack of knowledge of the potential problems caused by the battery acid and the threat posed by lead to human health and the environment. Therefore, in the short term a training course on the safe handling and management of ULAB, including the risks of adverse health effects could help them prevent health problems and environmental damage.

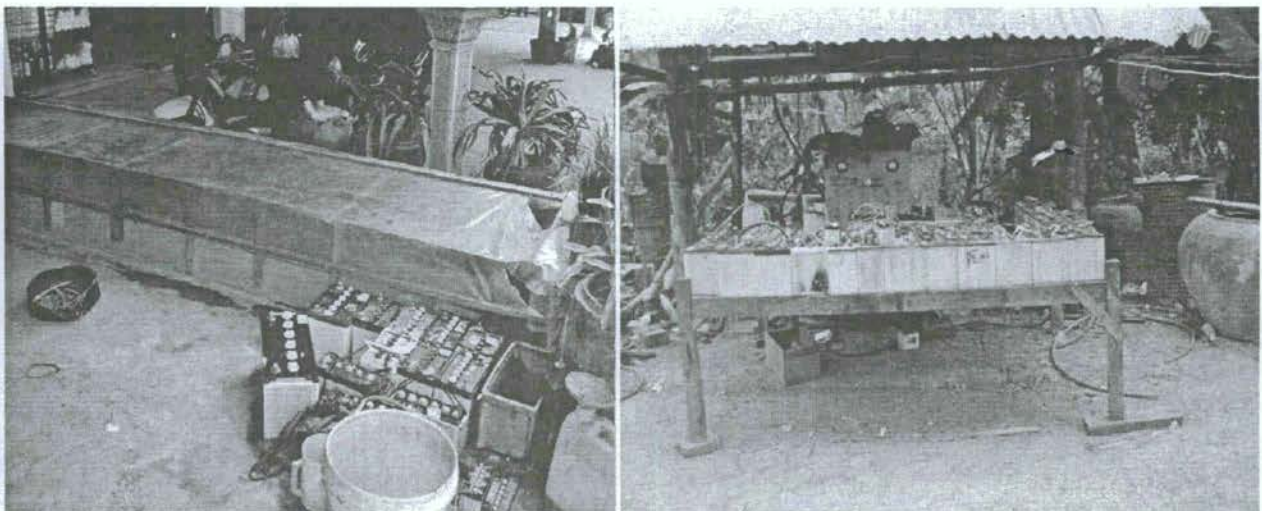
**Picture 6:** Typical a battery recharging shops in the downtown and remote areas

30 battery recharging shops located in remote and downtown areas of Battambang Province, Svay Rieng Province, Sihanoukville and Phnom Penh were visited during the survey. These shops were engaged in servicing and reconditioning batteries and collecting ULAB for resale to the waste recyclers.

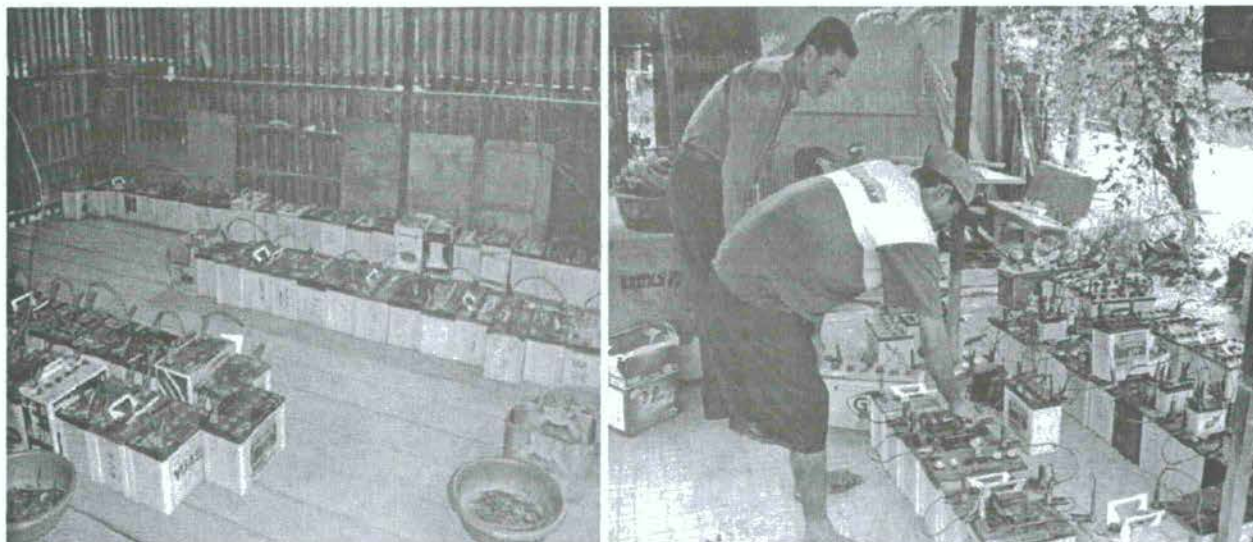
Forty to one hundred 12 volt automotive batteries are charged in series daily in the remote areas (see picture 7). Usually, a diesel generator is used to produce a DC current to recharge the batteries, especially in the remote areas, and this takes about 5 to 8 hours depending on number of batteries to recharge, the types and sizes. Normally battery acid consumption, to top up the electrolyte, is about 10 to 60 liters per month. Once recharged, a battery should normally last for 3 days, sometimes 5 days depending on the recharging technique, the demand on the battery, and the battery's age and quality.

**Picture 7: Batteries are charged in series**

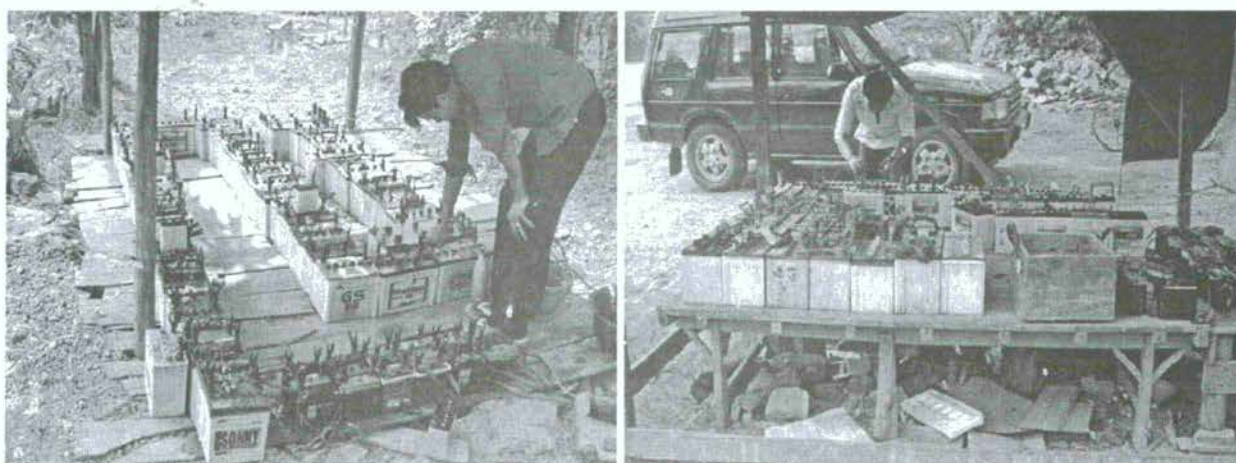
In the remote areas, the recharging shop areas were mostly under a thatched or zinc roof and open on all four sides, although some premises were under cover, especially those that doubled as the family home where everyone eat together and the children played in and around the charging zone. The floor was the natural soil or wooden decking which allowed the acid to spill easily onto the ground through the gaps and holes between the slats. (See picture 8)

**Picture 8: The battery acid is easily spilled onto the ground**

It was easy to see that the soil around the shops was contaminated by acid spillage and leaks that have occurred during the recharging processes. Some battery acid had been poured into tanks or some other

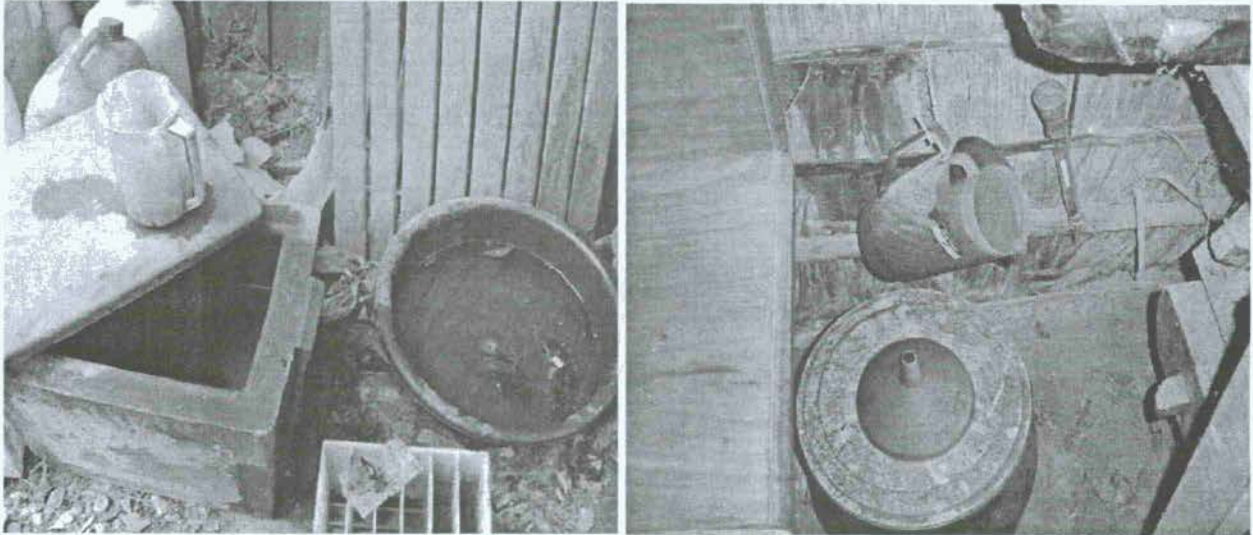
suitable plastic container and stored for reuse (see picture 9), but in most cases the acid drips and leaks onto the ground and finds its way into a drainage ditch near the shops.

**Picture 9: Battery acid in containers and drums under a bed inside the house for reuse**

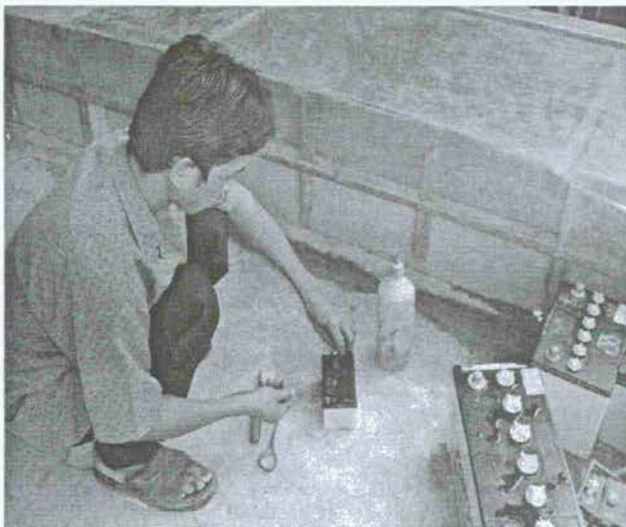
It is very important to wear personal protective equipment (PPE), such as gloves, goggles and masks, during the recharging process, due to the health risks posed by the safety hazards. Unfortunately, workers said that they found it inconvenient to wear PPE (see picture 10). Some workers had never worn PPE, but some just wear it when the battery acid bubbles due to a lack of understanding of personal safety (see picture 11). Interestingly, all the battery recharging workers, and some of those living close to recharging sites, recognized by themselves that there are increasing difficulties associated with skin burns and breathing problems. Furthermore, there is now a real concern among the task team because health and safety monitoring has never been carried out at battery charging and service centers.

**Picture 10: No gloves, goggles or mask**

- ✦ A training course on the Safe Battery Recharging Procedures and Sound Management of ULAB would minimize the suffering caused to workers by poor manual handling of the ULAB throughout the country.
- ✦ The dissemination of information to the public about ULAB hazards through media such as TV, Radio and newspapers would help them to understand the health and environmental risks and initiate actions to preventing the adverse effects caused by poor management of ULAB.

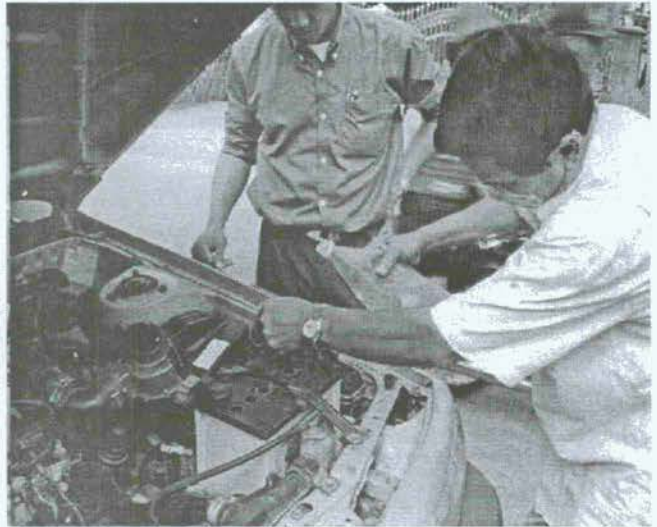
**Picture 11: Only a mask was worn**

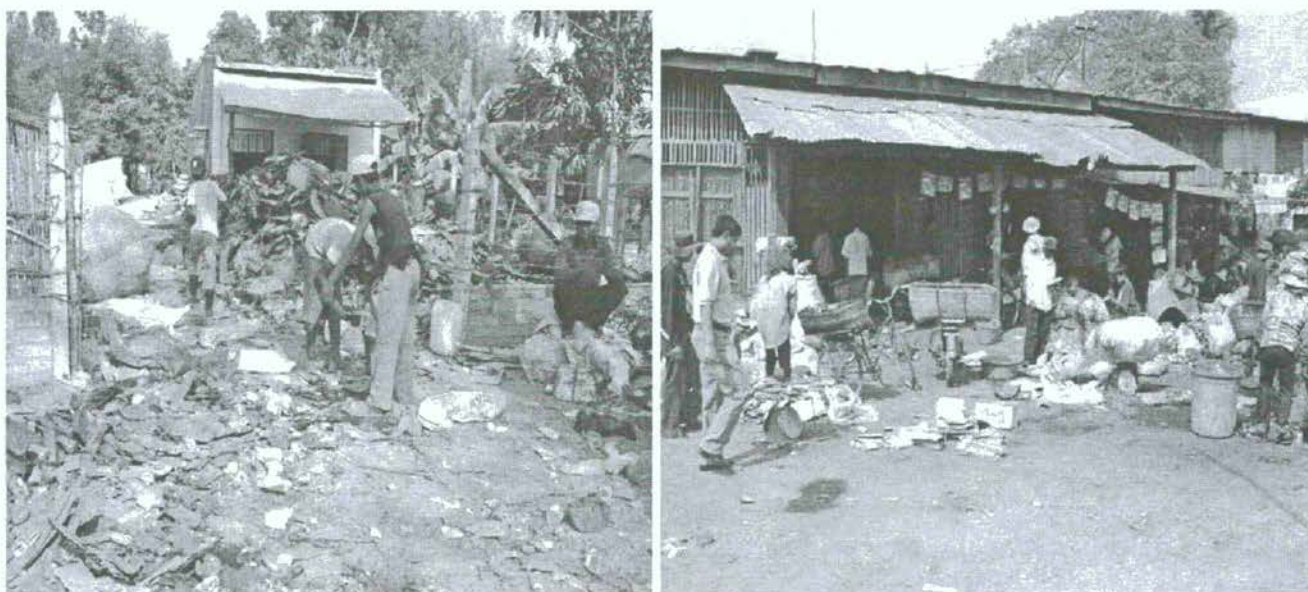
**Picture 12:** View of typical recyclable waste collection sites

15 of largest collection sites for recyclable wastes including ULAB were visited in the remote and downtown areas of Battambang Province, Svay Rieng Province, Sihanoukville and Phnom Penh Municipality. Most of the collection sites were constructed on a plot with the soil as the floor or base, except for just a few sites that were constructed on paved areas.

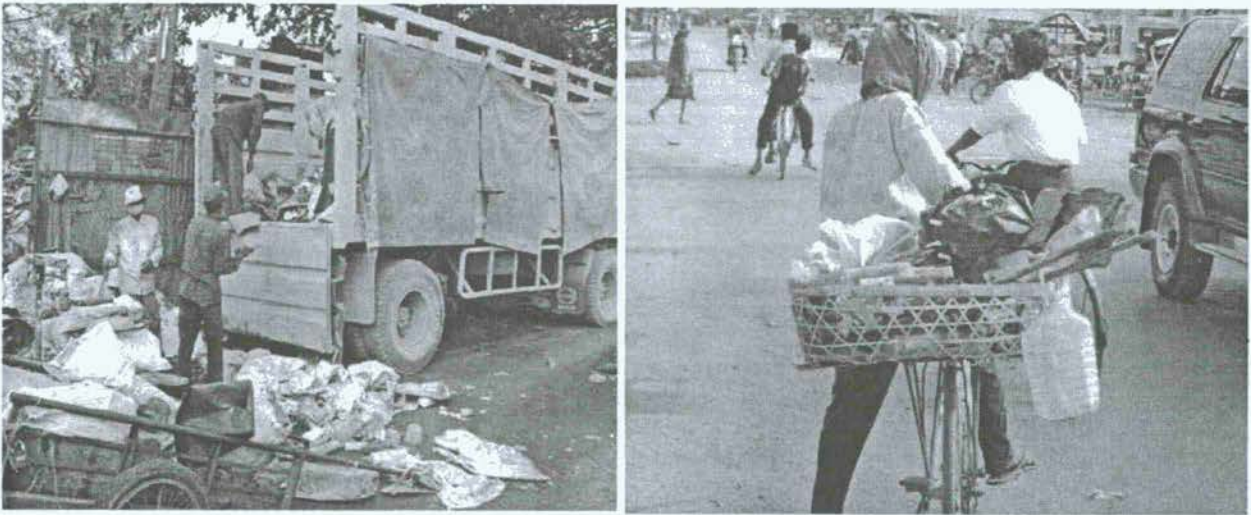
ULAB are collected by scavengers from small ULAB collection sites in various districts of the provinces and from local users. Usually, the scrap yard owner has his own collection network for ULAB all over the province and in many cases the neighboring province. The ULAB are transported by hand cart, bicycle, motorcycle and small truck to a recyclable waste collecting site. (See picture 13)

**Picture 13: Vehicles and Bicycles are used to transport ULAB to the Recyclers**

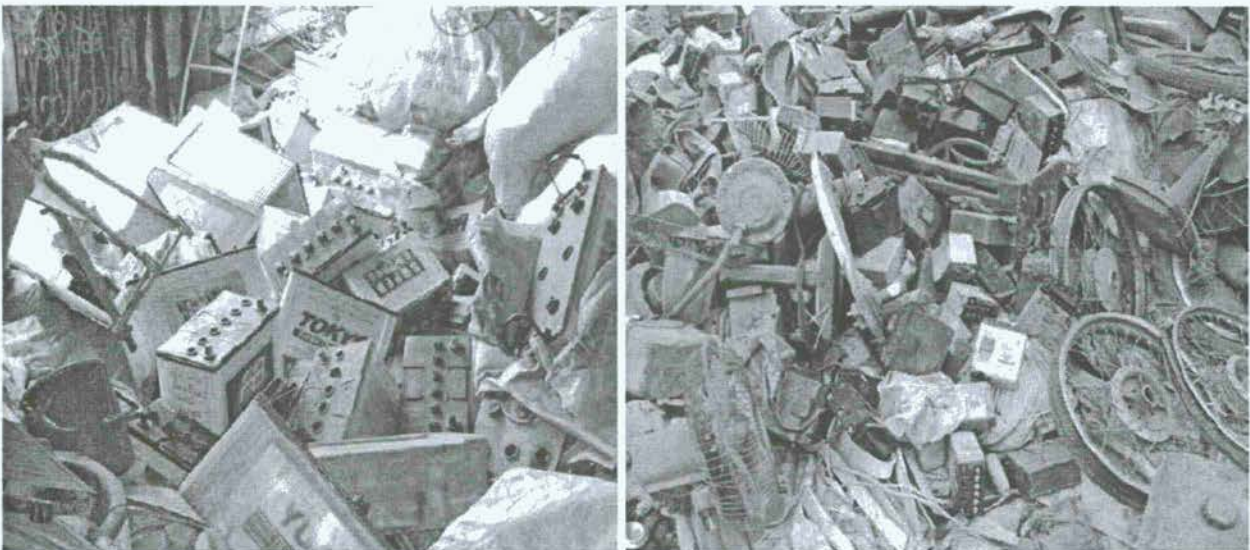
All ULAB are sold to merchants in Phnom Penh and then resold to dealers abroad for recycling. Before selling the ULAB they are stored in a secure room or compound together with other piles of recyclable waste. (See picture 14)

**Picture 14: ULAB Secure Compound and Storeroom**

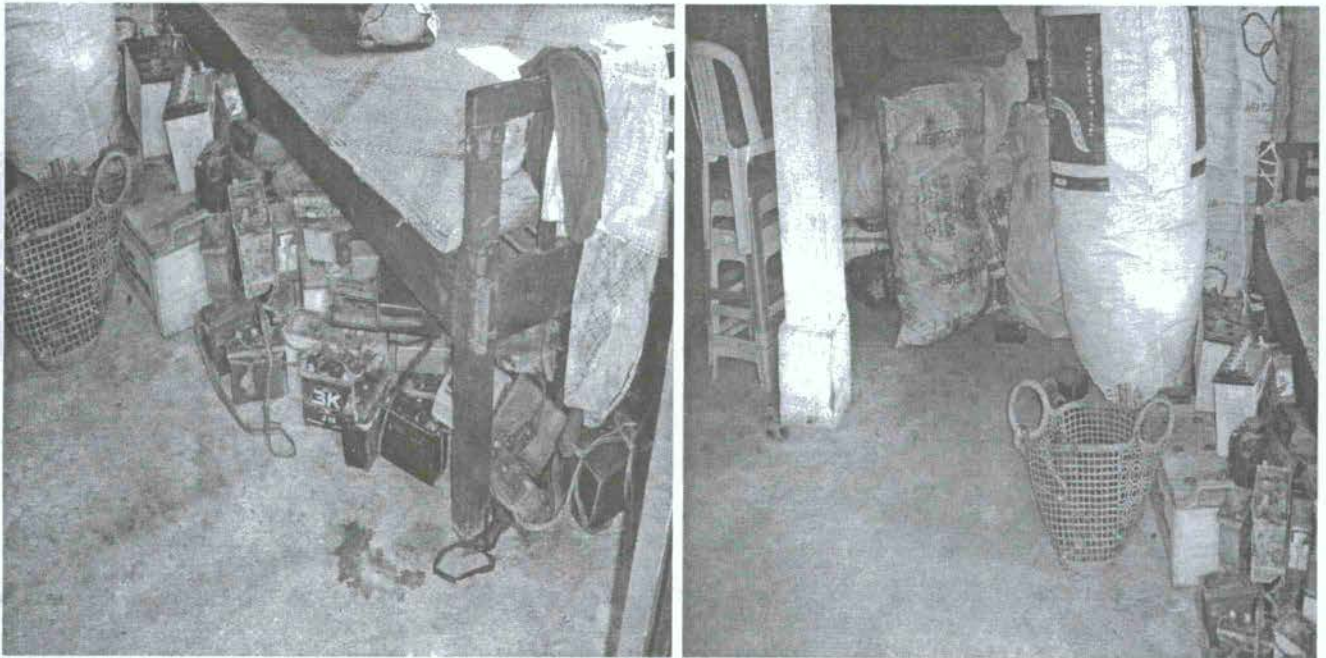
Generally, before selling the ULAB they are stored in a secure room or compound together with other piles of recyclable waste. Sometimes batteries were seen to be stored inside houses and on one occasion in a bedroom and under a bed. (See Picture 15).

**Picture 15:** The ULAB are stored inside the house and in the bedroom

- ✦ The careless storage of ULAB and electrolyte shows that workers, including the owners of the ULAB collection sites, are not aware of the hazards associated with the ULAB. Therefore, a training course on

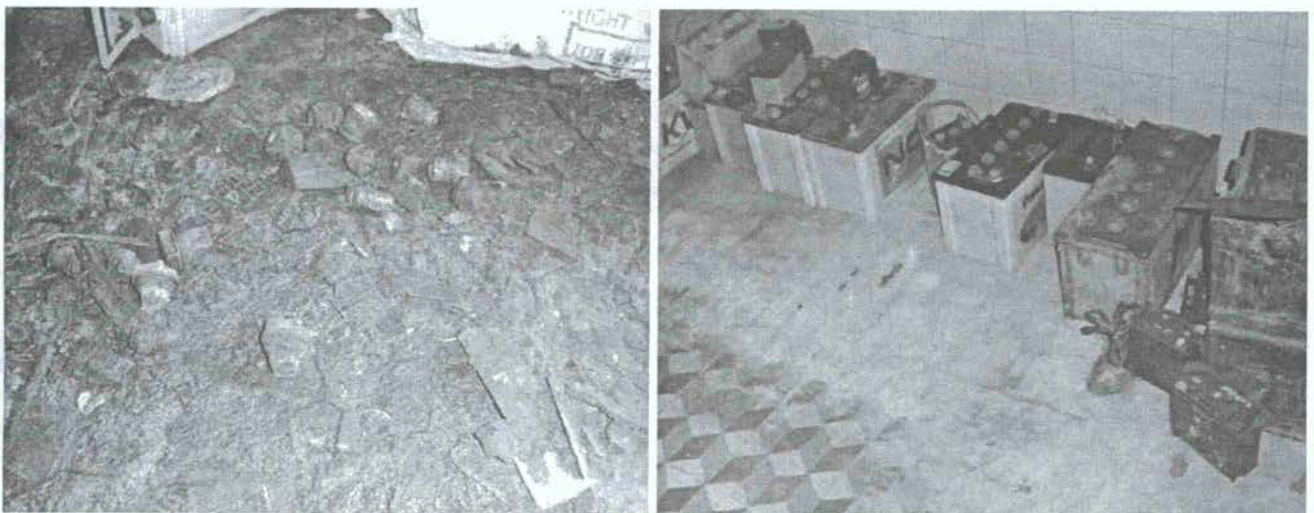
The floor of the room or compound is just soil that could easily be contaminated by spillage of battery acid. (See picture 16).

**Picture 16:** Acid spillage on soil and paved floor storerooms

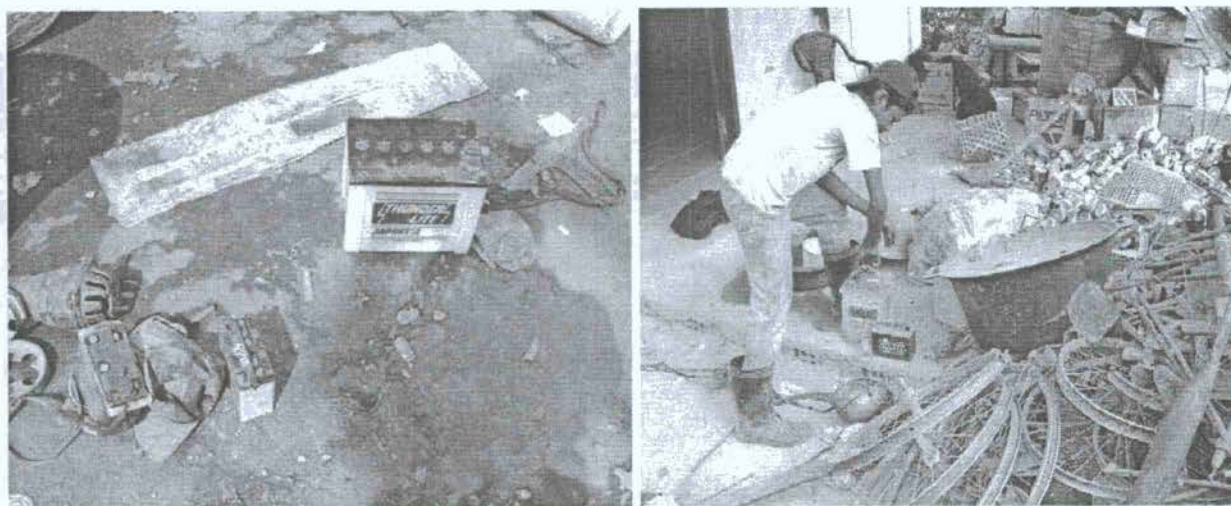
Battery acid drained directly into the ground, then found its way to a ditch and finally the public drainage and sanitation system, resulting in water contamination (see picture 17). There was no attempt to keep it in a tank or a container at the collection site. One of the most noticeable side effects of this poor practice was a bad odor in the storage room and around the premises.

**Picture 17:** Battery acid drained into the ground at the collection sites

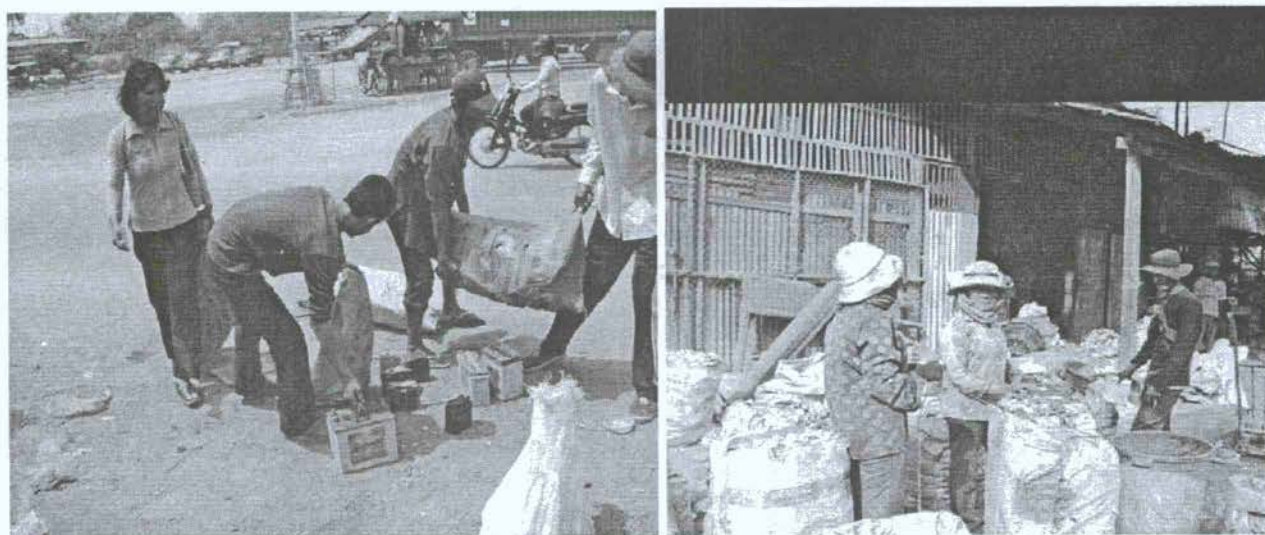
Workers were not wearing any gloves, goggles or masks when handling ULAB, except for a few scavengers and an owner who was working on other waste materials (see picture 18). Such behavior is particularly disappointing because in one case, the owner and the workers were aware of the risks of skin burns caused by the battery acid and still did not wear gloves, but no one seems to be aware of the hazards associated with occupational lead exposure. Furthermore, the workers had never heard about any educational programs related to the management of ULAB introduced by the relevant governmental agencies or NGOs.

**Picture 18:** Some scavengers were wearing masks or gloves, but others were not

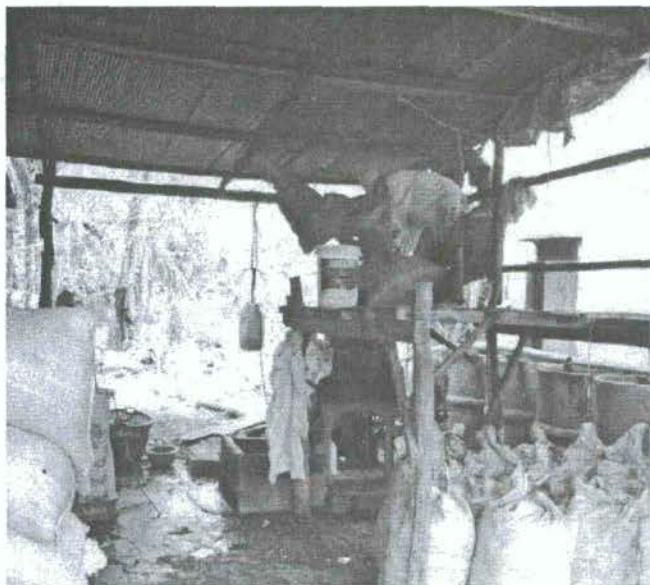
**Picture 19:** The plastics milling machine

Only one small scale ULAB recycling enterprise was found and visited. It is located in Thmor Koul District, Battambang Province, at the north of the country approximately 300 km from Phnom Penh and built on a plot of land. This unit has been operating since 1999. For the first three years, this enterprise only milled plastics, including ULAB cases that were bought from other scavengers, but for the last two years the enterprise has been recovering the lead from ULAB (see picture 19). All the ULAB are transported from the recyclable waste collection site to the enterprise in an open vehicle.

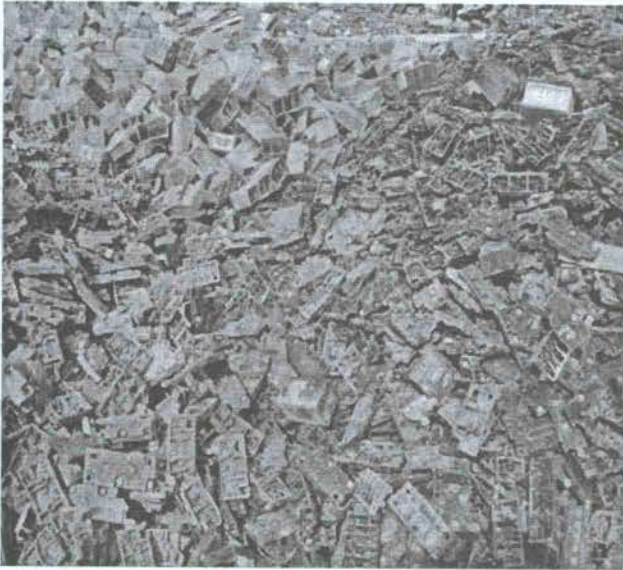
The red caps and the white or black battery cases are separated from the plates at another site outside the enterprise and are milled separately (see picture 21). The scrap plastic is sold in Phnom Penh and then sold on in Vietnam and sometimes, depending on the prevailing price; it has been sold directly to Thailand for recycling. The price of scrap plastic varies. White and red scrap is more expensive than black plastic scrap (see picture 22).

**Picture 21: Battery case separation site**

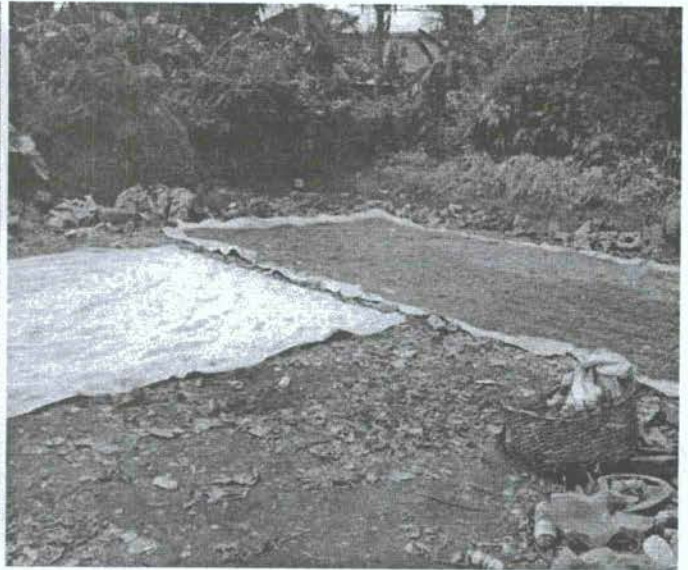
**Picture 22: Battery case scrap and caps**

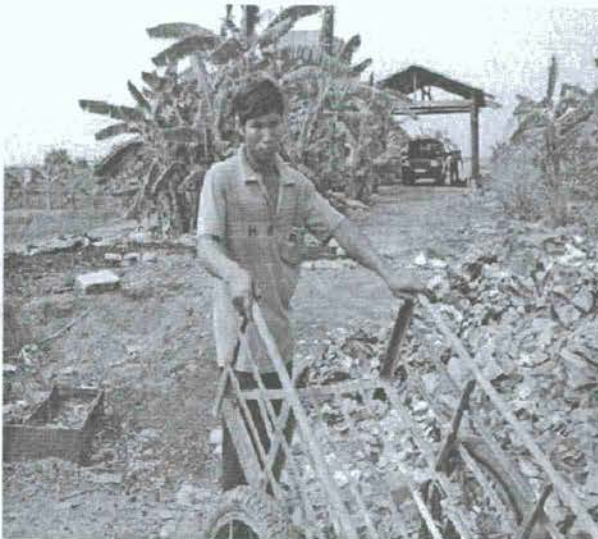
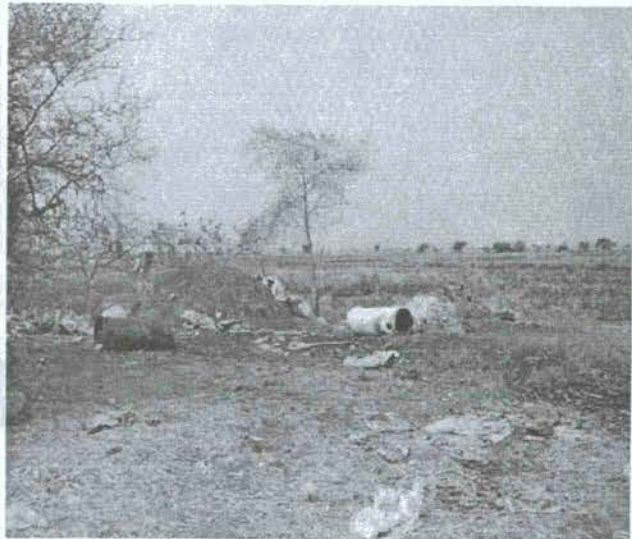
The recycling enterprise still has two separate lead smelting sites not located on the plot with the milling machine. The first one is a plot (60 x 100) surrounded by rice fields and about 8 km from the enterprise and 2 km from populated areas.

**Picture 23: Views of the first and second lead melting sites**

- The workers and neighbors are affected by lead and acid, therefore a temporary shut down of the lead melting site would be the best solution to eliminate the potential risks to the human health and the environment.
- Serious safety and health training is needed to educate ULAB melter staff in order to help them protect their health and the environment.
- A training course for the Sound Management of ULAB is essential for local government officials. The course must include the obligations required of Cambodia under the terms of the Basel Convention for the transboundary movement of hazardous waste and the Guidelines for the ESM of ULAB.

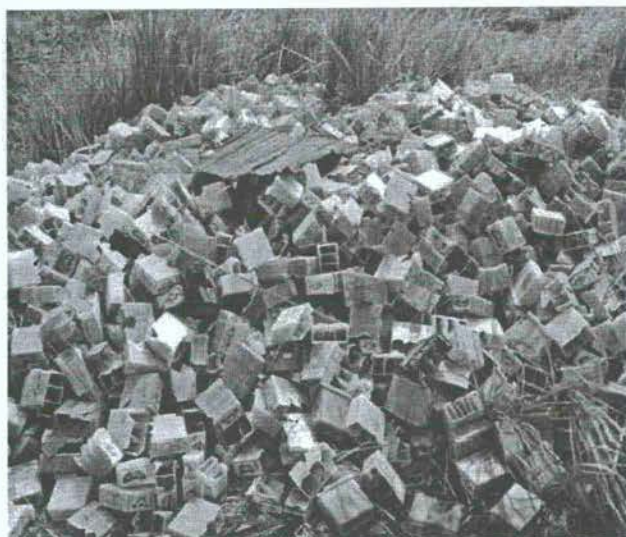
The ULAB breaking operation is manual. The lead bearing waste was placed on the ground near the smelting furnace (see picture 24). The battery cases are sent to the milling machine and the remainders, such as the plate separators, are put into a pile for incineration (see picture 25).

**Picture 24: Battery cases after breaking**

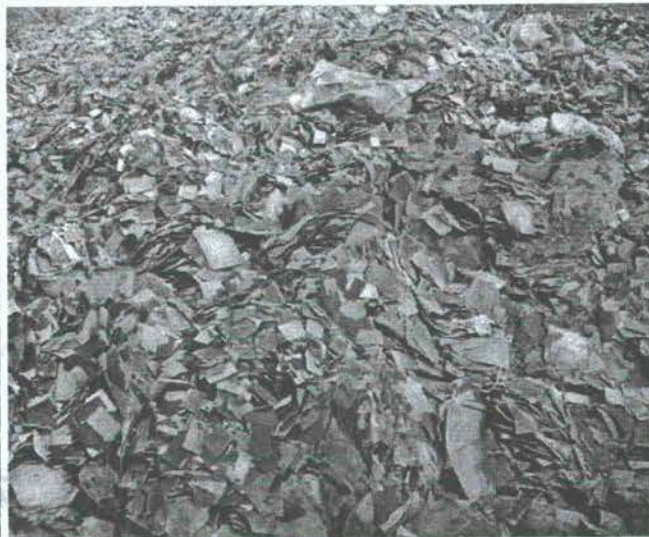
**Picture 25: Battery separators after burning**

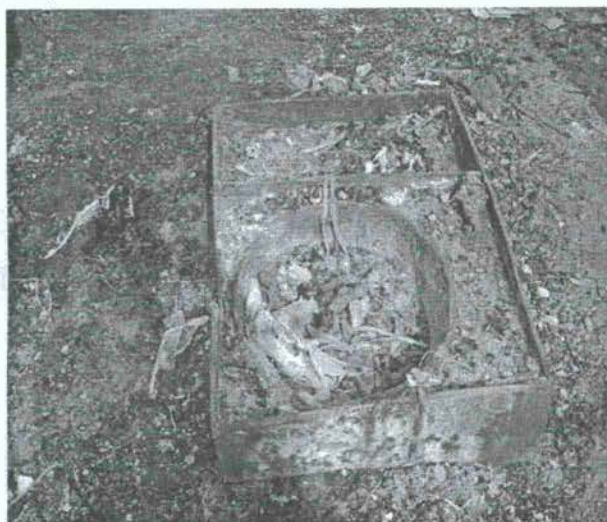
The lead bearing waste is melted in the open and without any form of ventilation or extraction using a small crude melting furnace made from a length of metal tube about 1 m long and 0.4 m in diameter (see pictures 26 and 27). Charcoal is added to the leaded scrap as it is charged to the melting furnace in order to encourage reduction of some of the battery paste (lead oxide) to produce metallic lead (lead bullion).

This technique is crude, but is the basis of “smelting” where the “reducing” agents are mixed with the leaded scrap to produce metallic lead. Adding the charcoal does raise the level of lead recovery from the scrap battery contents.

**Picture 26: Crude smelting furnace**

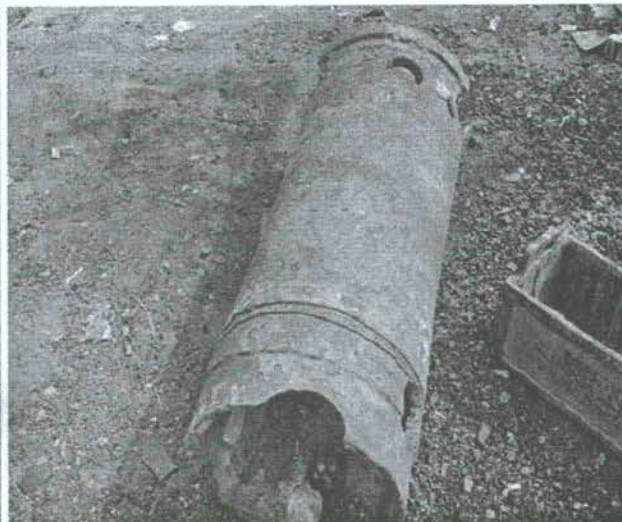
**Picture 27: The metal tube**

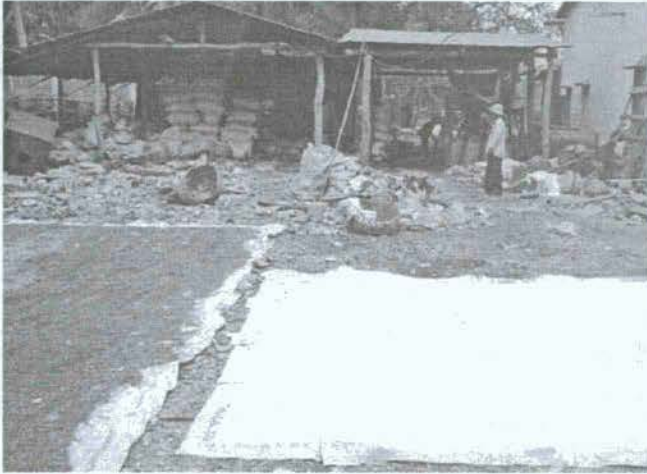
The environmental conditions at the enterprise and around the plot were not good due to a bad smell from the milling process and the piles of battery cases containing acid (see picture 28).

**Picture 28: Bad smell at the enterprise**

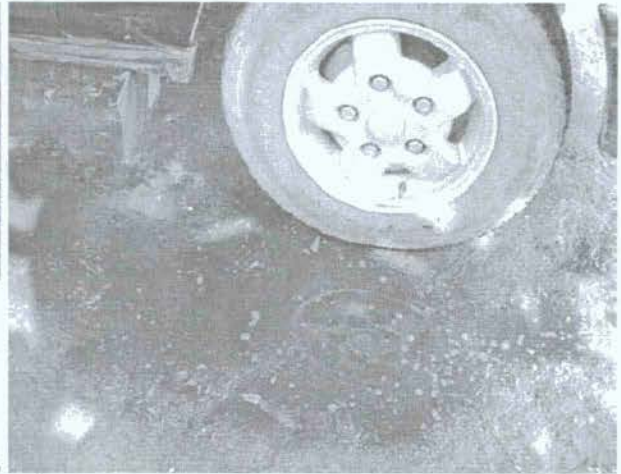
**Picture 29: Contaminated soil**

The breaking process area is under a corrugated zinc roofed hut open on all four sides. The floor is earth that is contaminated by spillage of the battery contents including the acid during the battery breaking process (see picture 29).

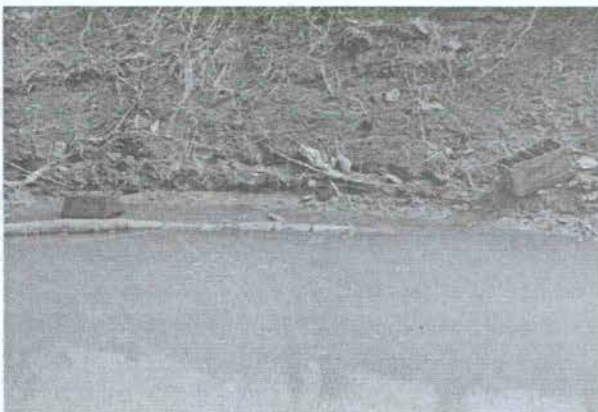
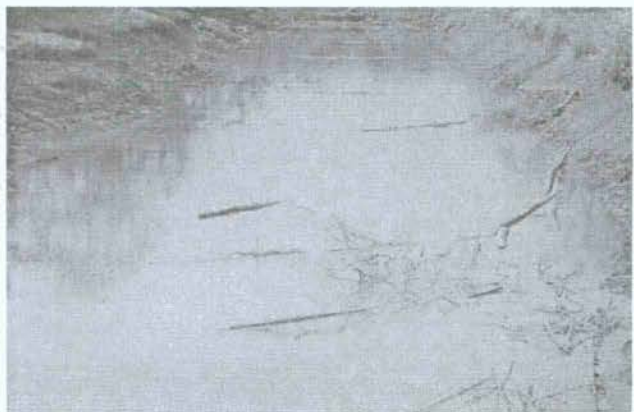
There are two big compounds close to the lead melting site with rubbish and waste burning in the open on the plot.(see picture 30). Ground and surface water either flows from the melting site into both compounds or the rice field during the rainy season. There were plenty of fish in the ponds and the fish are eaten by local people and the owner of the melter. Sometimes the water from the ponds has been drunk by the local people and used for irrigating farmland.

**Picture 30: The two compounds near the melting furnace site**

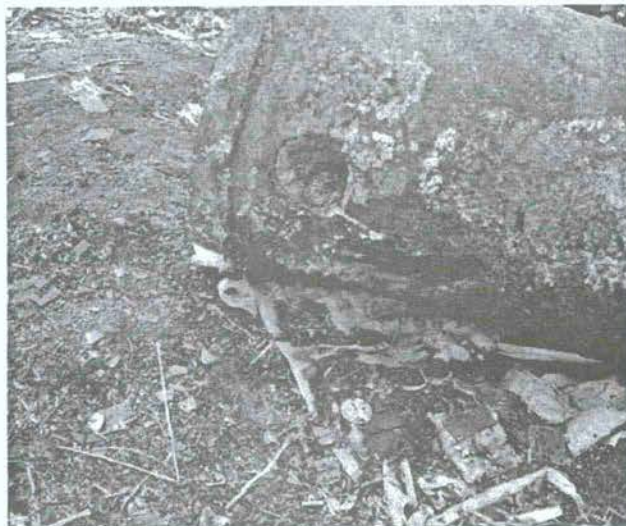
Furthermore, not only was a green tree close to the site becoming a white color and about to die, there were no wild animals present and a part of the thick metal furnace tube were also seriously corroded as pictures 31 and 32 show.

**Picture 31:** The corroded furnace tube

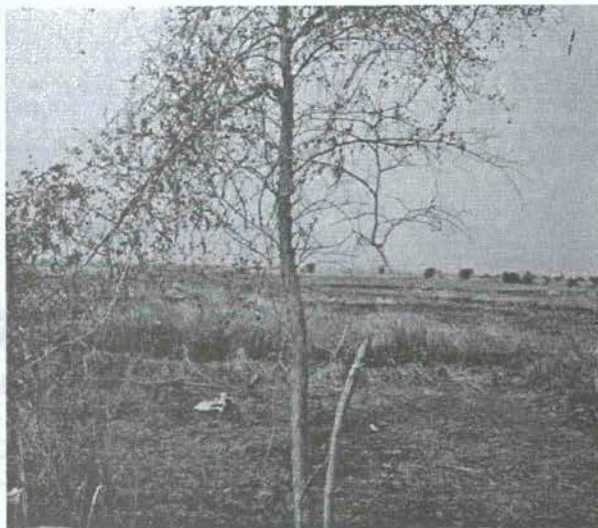
**Picture 32:** The green tree is now white

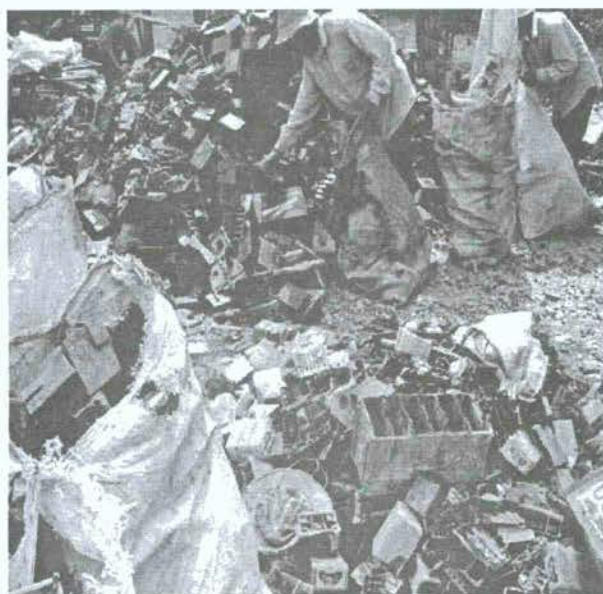
The workers at the sites were working without gloves, goggles or masks during the separating and milling processes, although they had been issued with both gloves and masks, but for some reason, were not wearing them (see picture 33).

**Picture 33:** No gloves, goggles or mask

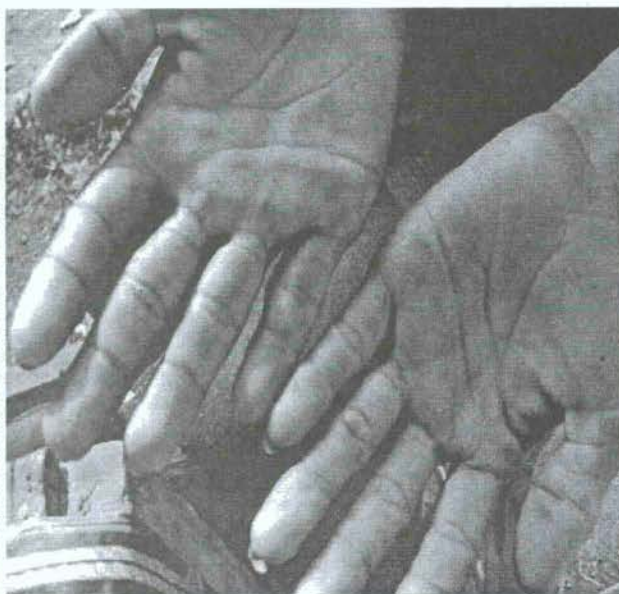
**Picture 34:** Palm burned by battery acid

Most of them were aware of the risks of burns to the skin caused by battery acid, but no one was aware of the hazards associated with occupational lead exposure. For instance, the ULAB breaking operation is manual and the workers were not wearing gloves, goggles or masks, resulting, not unexpectedly, in the palms of the hands visibly burned by the battery acid (see picture 34). The local people maintained they suffered from frequent headaches, found it very difficult to breath at night and there was a bad smell from the site. The workers not only suffered burns to the palms of the hands, but often had headaches, chest pains and breathing difficulties. Health monitoring, particularly blood lead monitoring is never done by the enterprise and it would appear that nobody takes responsibility for occupational health at the enterprise.

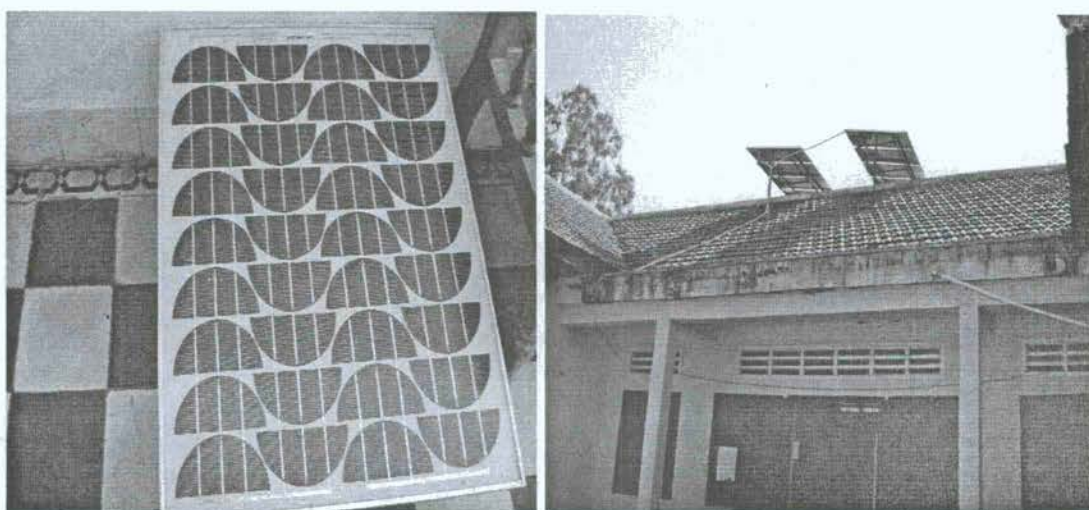
Solar energy Remote Area Power Supply units (RAPS) have only recently been introduced in Cambodia due to the cost of the equipment. Consequently, only a few RAPS units have been installed by local people. Mostly they have only been installed with government assistance or through international organizations or NGO aid programs at public schools, parks, municipal buildings and bridges (picture 35).

**Picture 35: RAPS installed at a public school in Svay Rieng province**

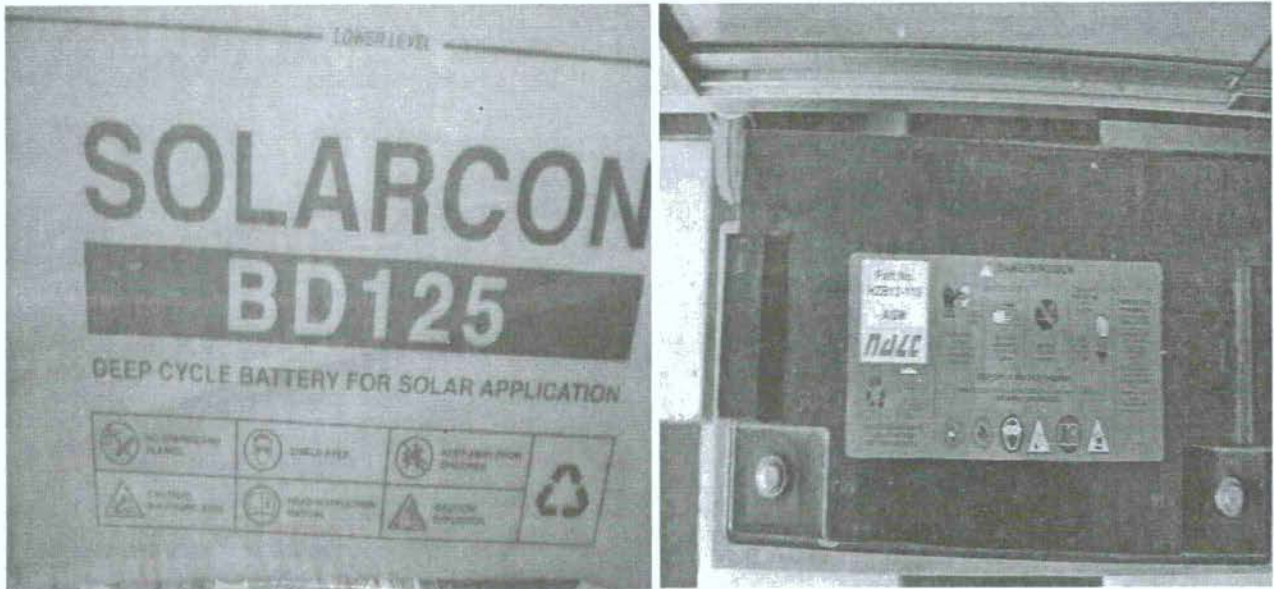
The RAPS consists of solar panels that convert sunlight into electrical power to charge specially designed deep discharge lead acid batteries. Generally, these batteries are used to provide AC electrical power for lighting, TVs, computers and IT equipment in place of the mains electrical supply when it is unavailable. Most of the deep discharge lead acid batteries are good branded names from Germany and Japan (picture 36). To date, around 10,000 such batteries have been imported into Cambodia by local private companies. These batteries are 50A, 70A, 100A, 120A and 200A and normally have an average life from 10 to 15 years, but in Cambodia its useful life is only 7 years only due to the hot climate.

**Picture 36:** Type of Deep discharge lead acid battery
