# Technical Report

## Status of Used Lead Acid Battery Management

## Kingdom of Cambodia

Prepared by Project Team  
Department of Environmental Pollution Control  
Ministry of Environment

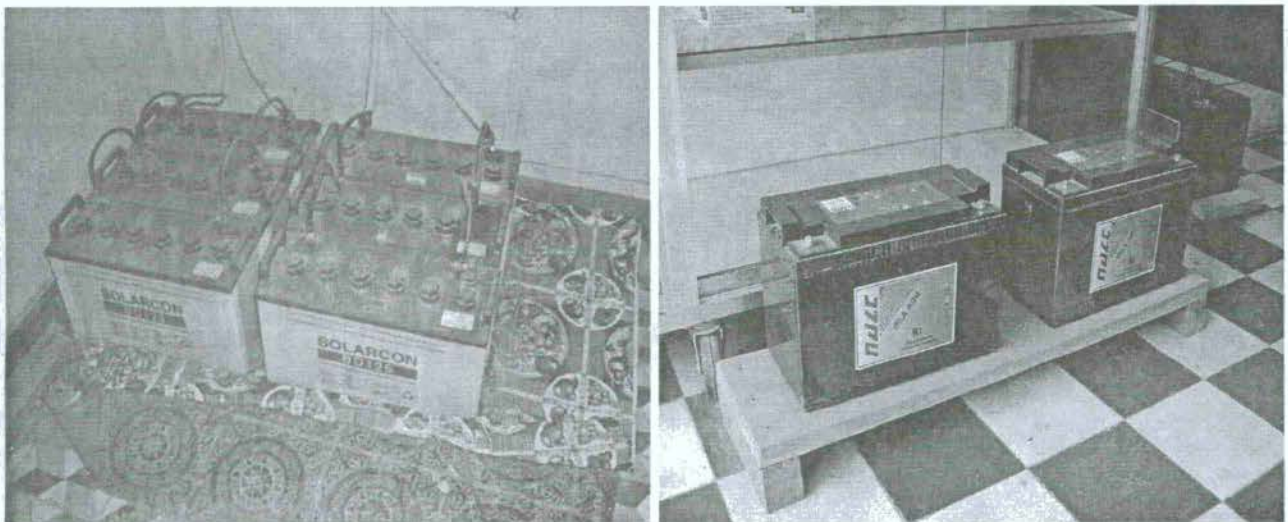
Normally, deep discharge lead acid batteries are stored in a secure room with ventilation controls. The floor of such a room is paved to prevent any spillage of battery acid damaging the surface or seeping into the ground (see picture 37). At the school in Svay Rieng province, it was noticeable that the storage room is clean and there was no acid or foul smell.

**Picture 37:** Battery storeroom

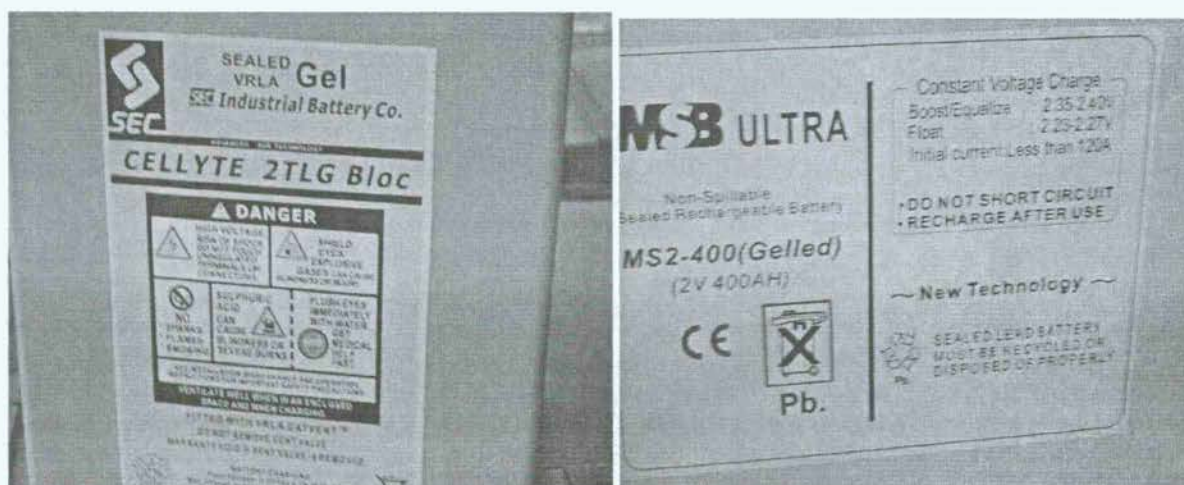
Noticeably, most of the batteries are branded names from Germany, Japan and Malaysia (picture 38).

**Picture 38: Valve Regulated Gelled Batteries**

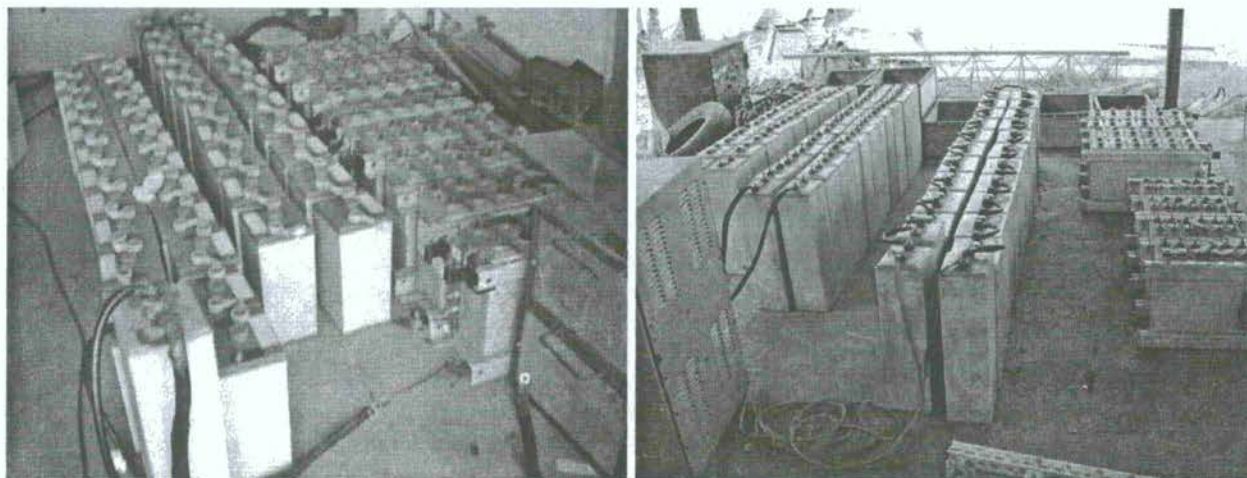
Environmental conditions are good. The Lead acid batteries are stored in secured places in the stations far away from populated areas. The floors of the rooms are paved to minimize spillage damage and contamination. The storages rooms are clean and there are no bad odors (picture 39).

**Picture 39: Battery Storeroom**
