The
KOSOVO
Conflict

Consequences

for the Environment

& Human Settlements

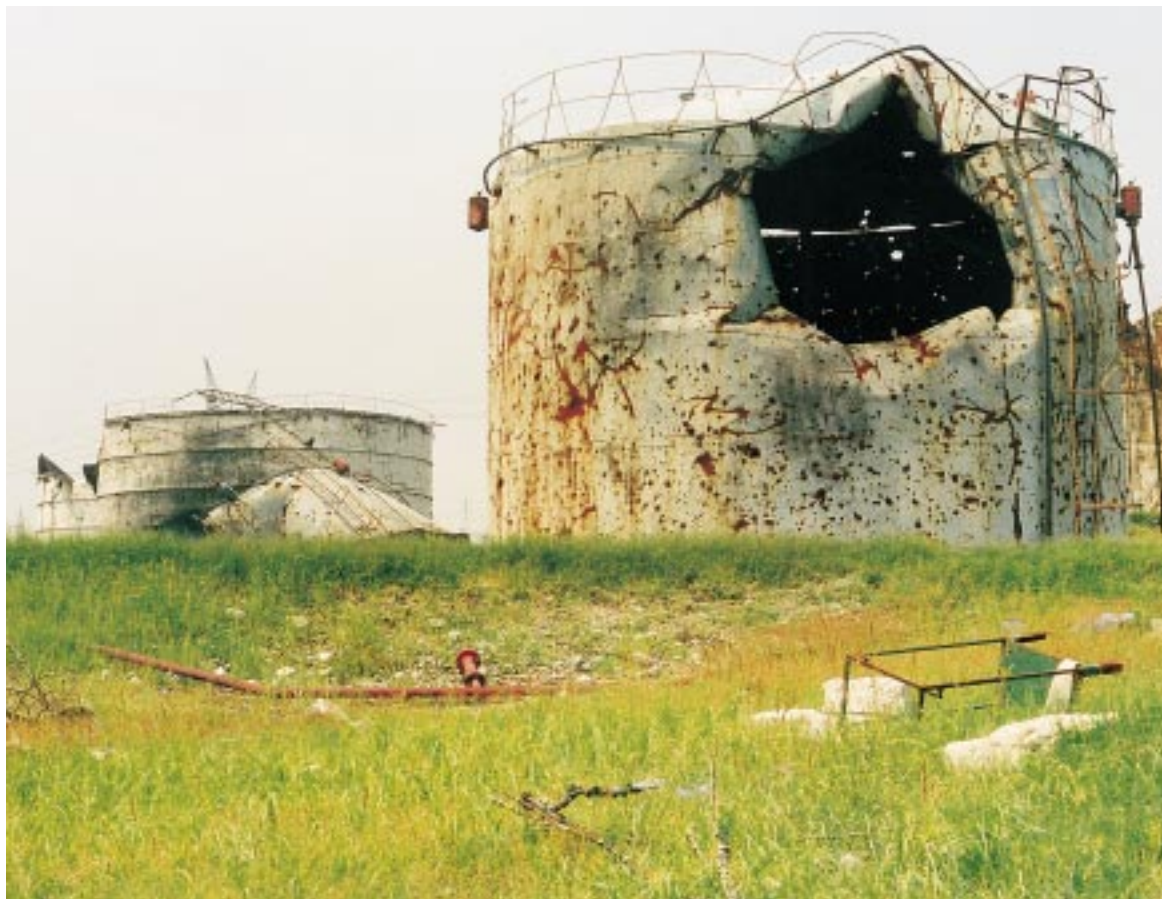
Bombed oil storage facility, Bor

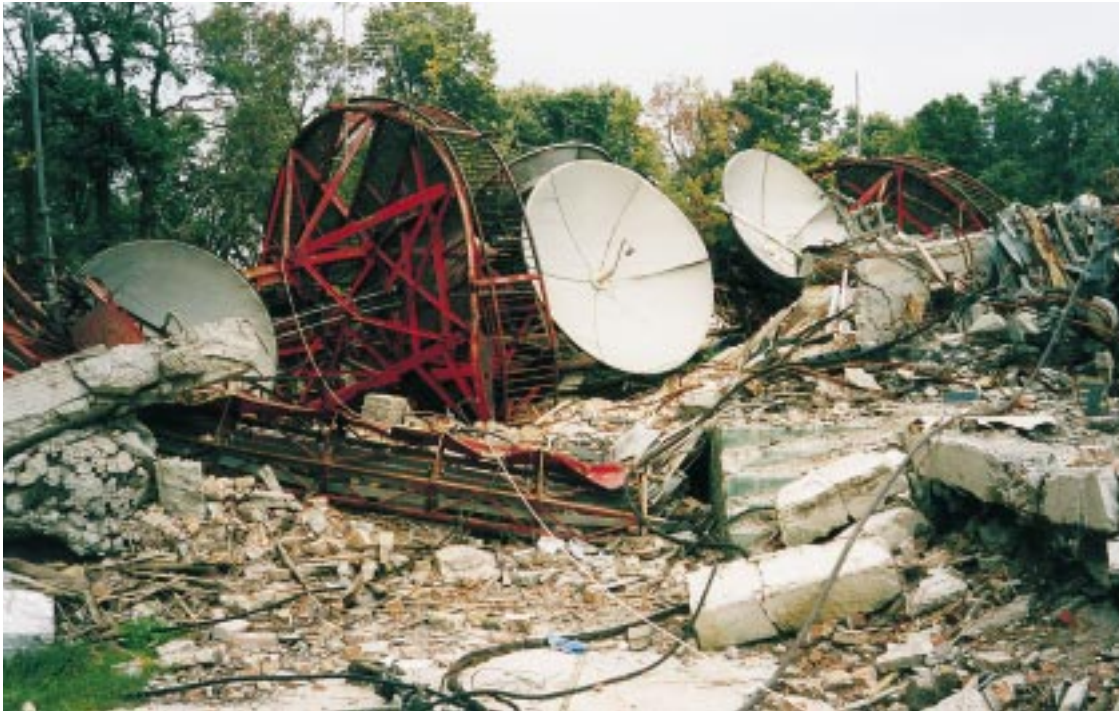
Telecommunications facilities located in Fruška Gora National Park were destroyed during the air strikes

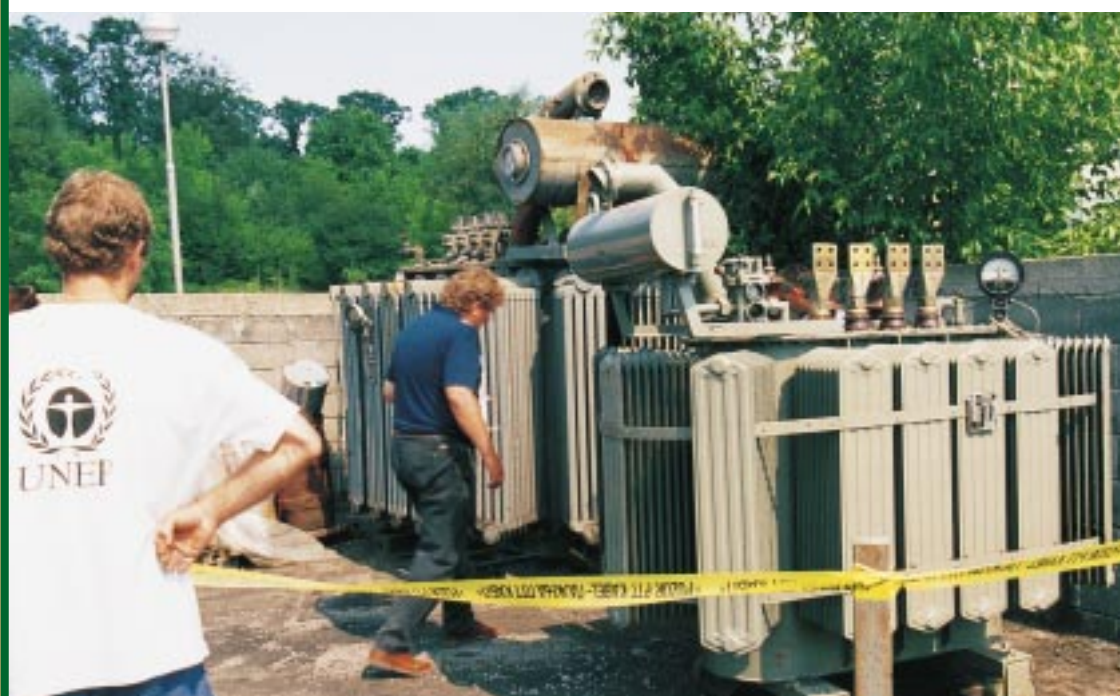
The Zastava complex was targeted twice during the conflict, on 9 and 12 April. Heavy damage was inflicted to the power station, car assembly line, paint shop, computer centre and truck plant. Some parts of the factory were completely destroyed, and production was halted.

Inspection of damaged transformers

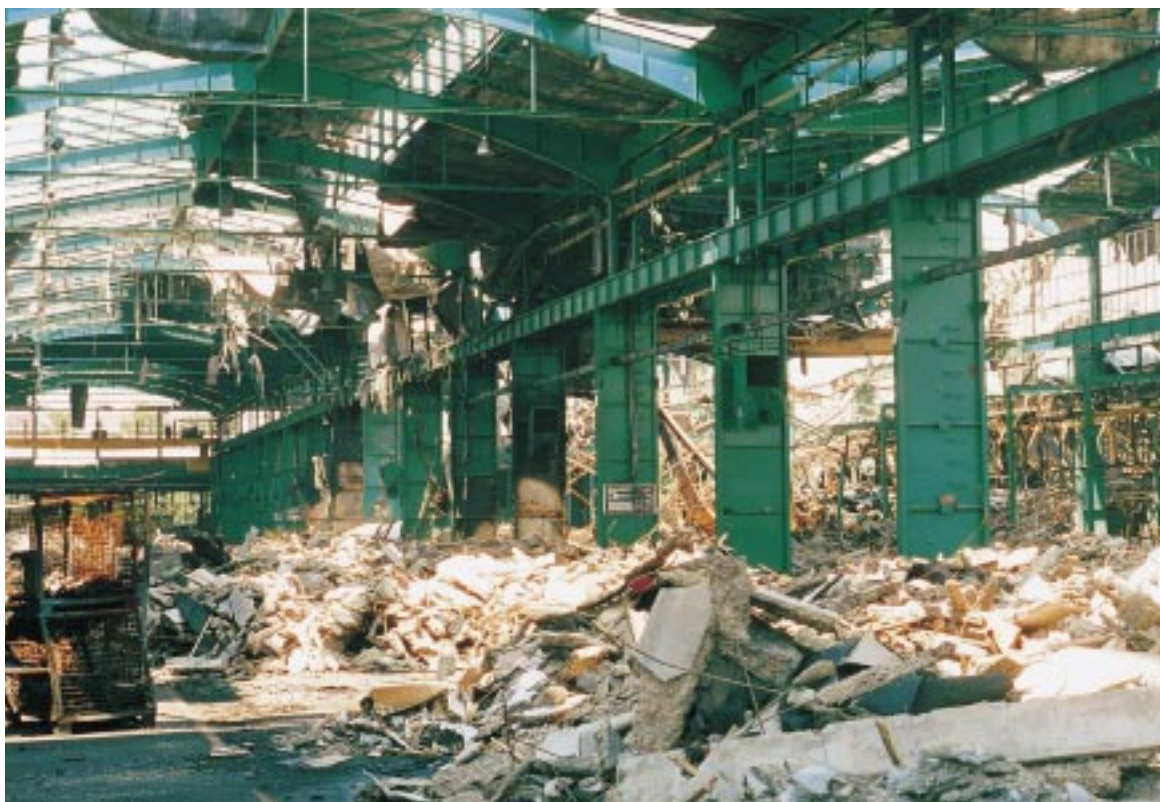
Destroyed factory hall, Kragujevac

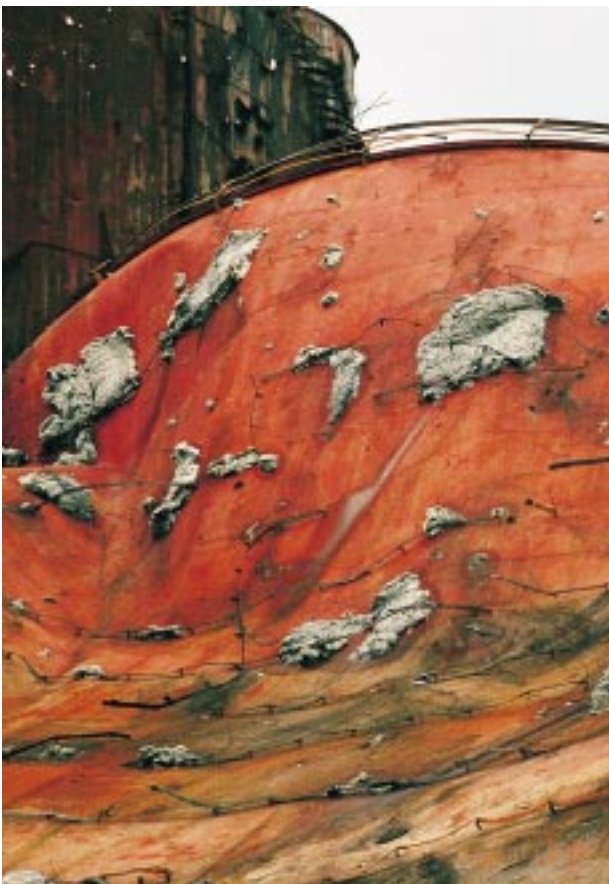
The refinery complex consists of production facilities and storage tanks for crude oil and oil products (mainly gasoline and diesel fuel). More than two-thirds of the 150 tanks were directly hit or seriously damaged by debris during at least twelve NATO air strikes (in the period 5 April – 9 June), and many consequently caught fire or leaked oil and oil products. Nevertheless, technicians were reportedly able to transfer some of the leaking substances to intact storage tanks, thereby reducing leakage into the soil and groundwater. Prior to the air strikes, the refinery staff also removed certain

Destroyed oil tank at Novi Sad

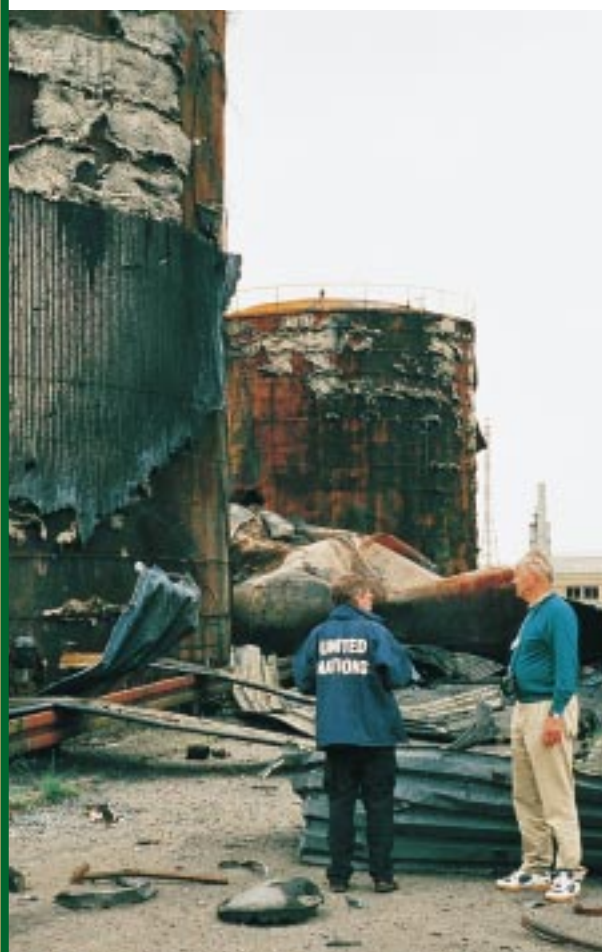
Inspection of damaged oil tanks

The 'Jugopetrol' oil depot, which mainly served the Bor copper industry, was completely destroyed during the air strikes. However, all eight storage tanks were reported to have been emptied shortly before they were hit. Because the oil depot was empty, only minor fires occurred and no oil was spilled. Nevertheless, some transformers at the depot's electrical station had been damaged or destroyed.

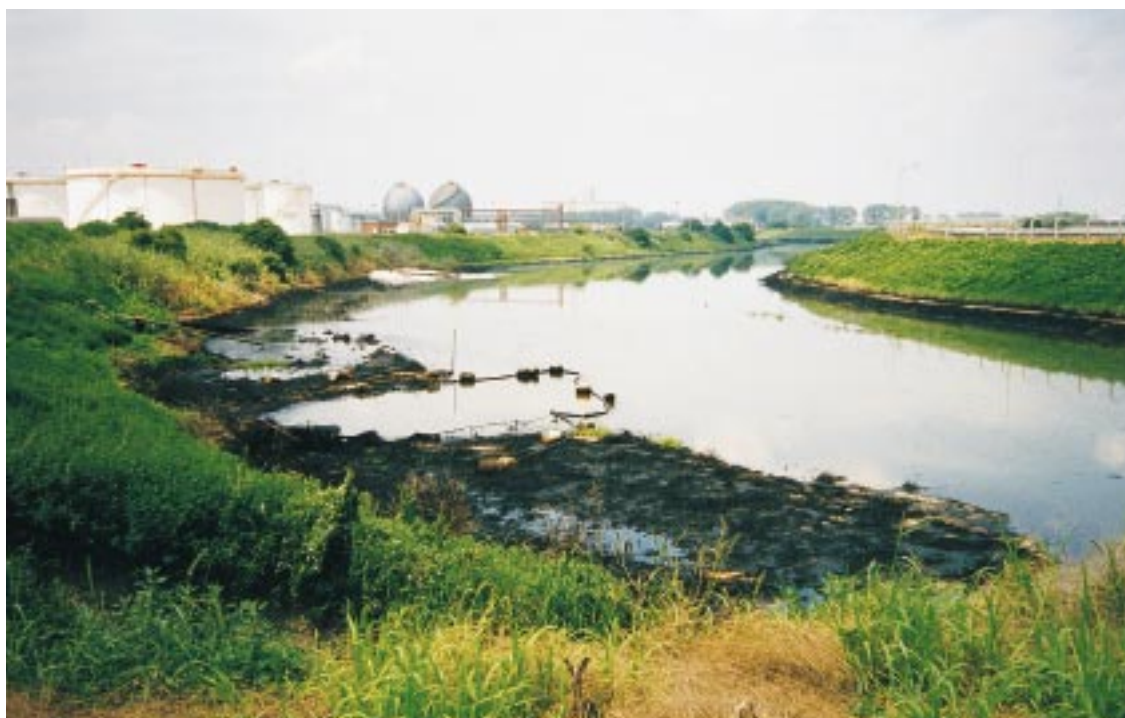
The wastewater canal at Pančevo which flows into the Danube River

- a) consider the wastewater canal as an environmental hot spot, with special risk to the aquatic environment of the Danube, and implement the following

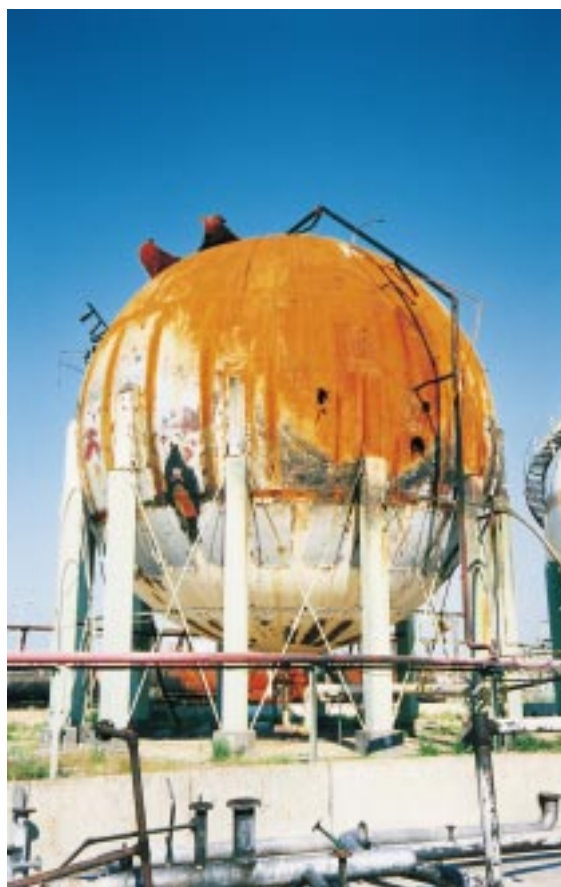
Damaged VCM tank at the petrochemical plant in Pančevo

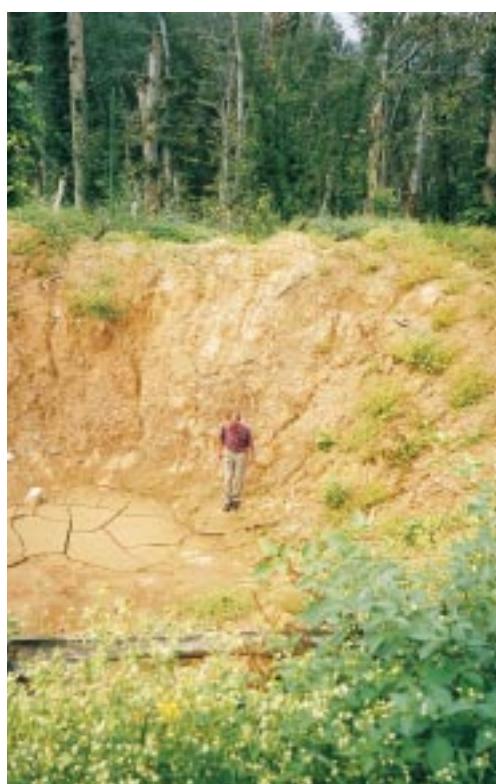
Bomb craters in Fruška Gora National Park Photo: BTF

- 17 Clearance of unexploded ordnance remaining in protected areas (primarily cluster bomblets) should be undertaken and measures implemented to issue warnings and restrict access to certain areas.
- 18 There is an urgent need to rebuild the nature conservation infrastructure and management system in Kosovo; as a first step, efforts should be made to recover all relevant information on biodiversity in the province.
